Nebraska State Penitentiary Useful Life Engineering Study

Lincoln, Nebraska

Alvine No. 2021 8777
January 2022

Prepared for:
State of Nebraska
Department of Correctional Services
Lincoln, Nebraska

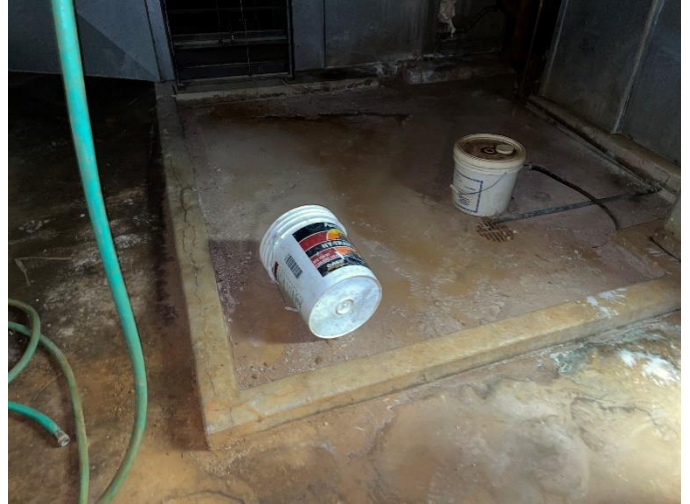
Photo ANC-S4: Deteriorated Curb in Mech Room 2B68
Foodservice

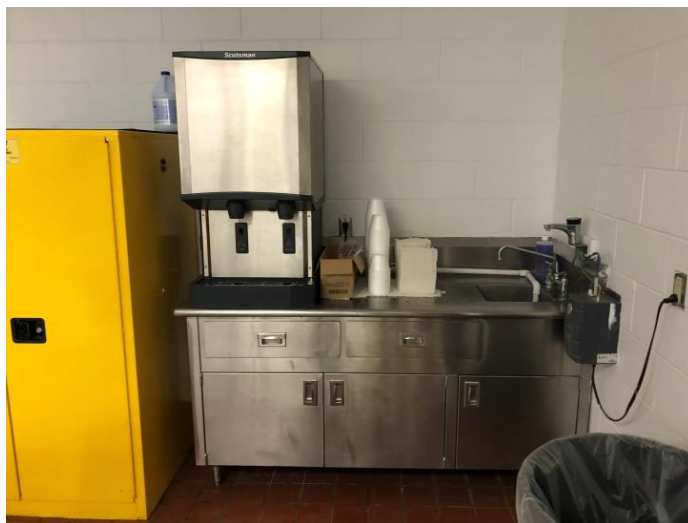
The hot water dispenser in employee dining area is an older unit and shows signs of extensive use. See Photo ANC-FS1. Also, the existing ice/water dispenser appears to not have a water filter assembly.

Photo ANC-FS1: Existing Hot Water Dispenser

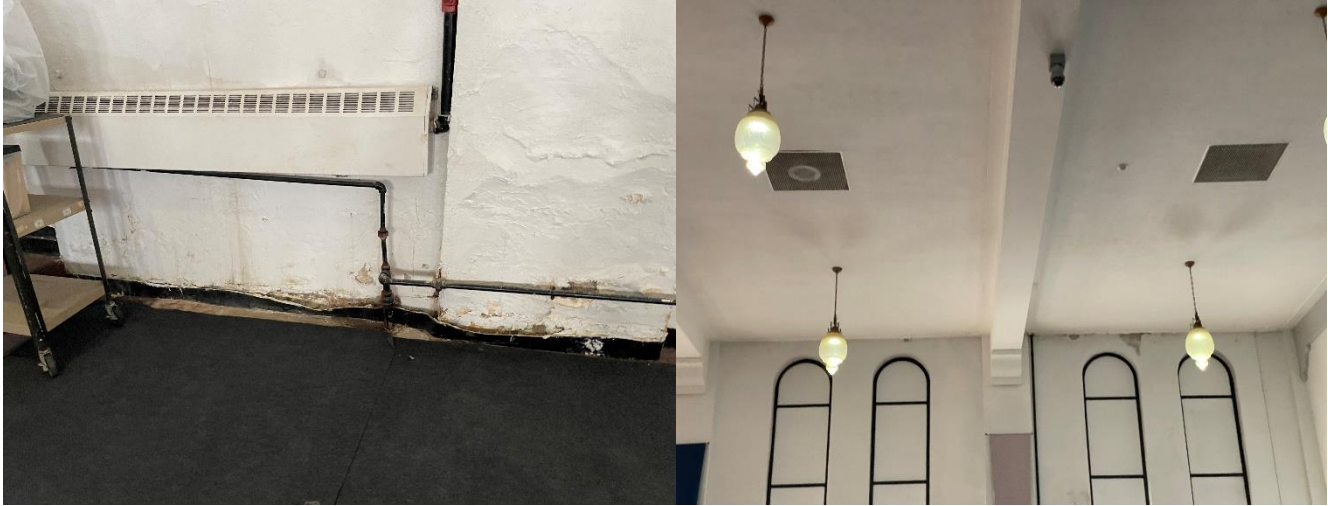
There is evidence of moisture infiltration in some of the exterior walls. This appears to be a long-term problem. See Photo CHAP-S1.

CHAP-S1: Moisture Damage at Lower and Upper Wall

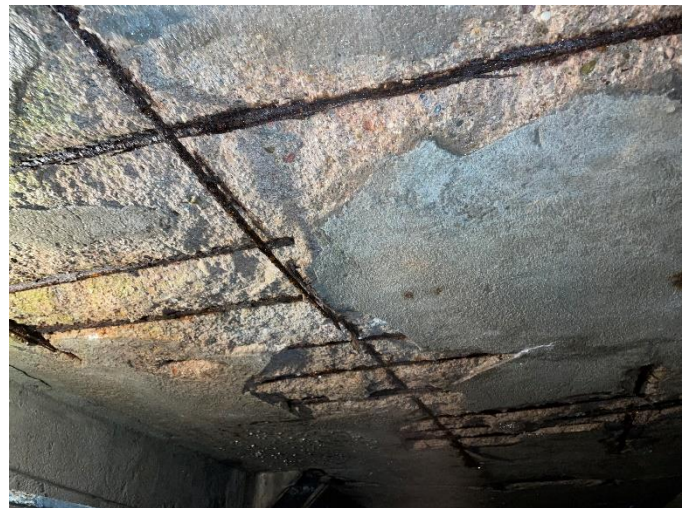
CHAP-S3: Deteriorated Tunnel Lid

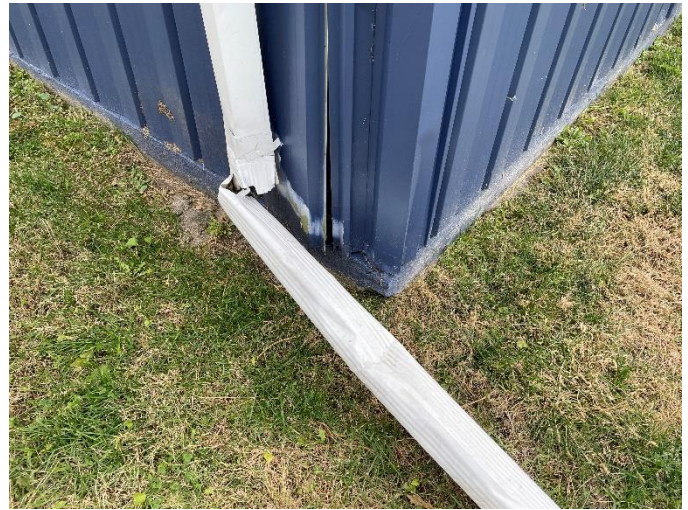
Photo CERT-S2: Example of Impact Damage to Exterior Panels

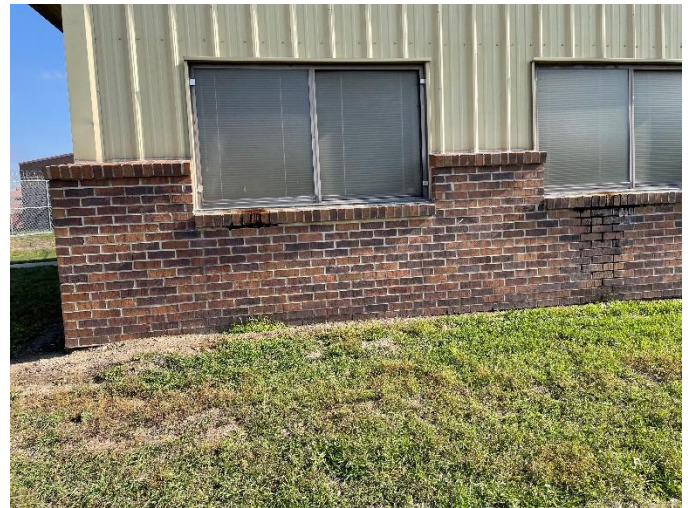
Photo EDU-S2: Sealant and Moisture Issues

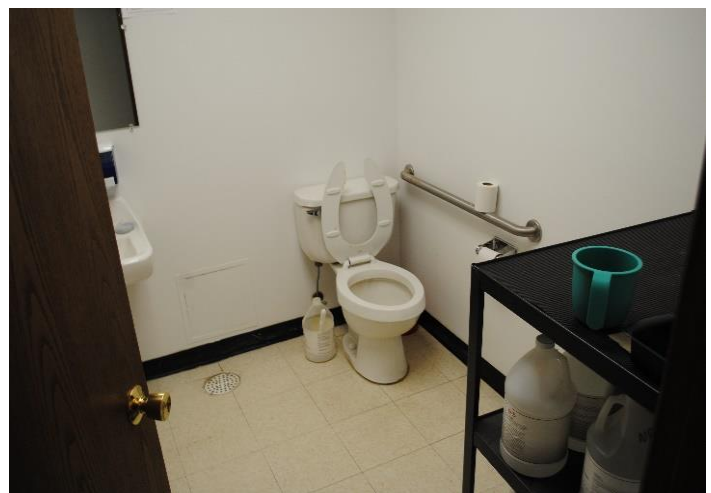
The FTO was built pre-ADA. The toilet rooms do not have adequate space and are missing grab bars to meet current standards.

Photo FTO-A2: Typical Existing Toilet Room

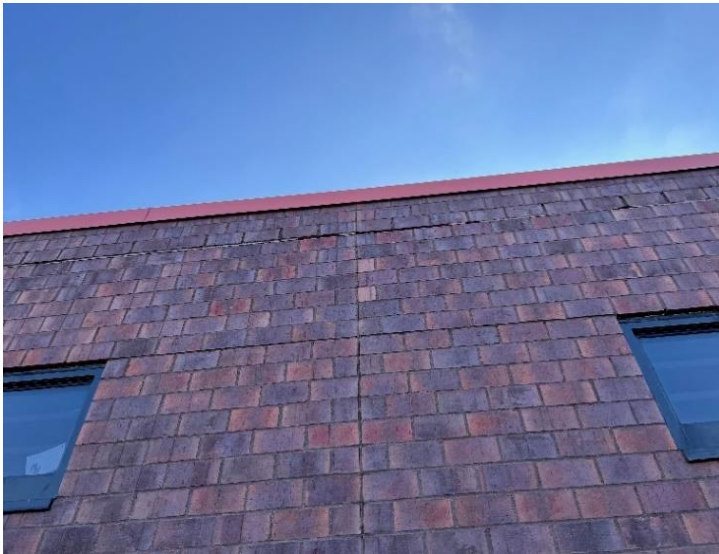
A horizontal crack near the top of the north wall of the northeast wing is nearly continuous. It appears previous repairs were attempted and those have also failed.

Photo HU1-5-S2: Cracked Brick at Parapet

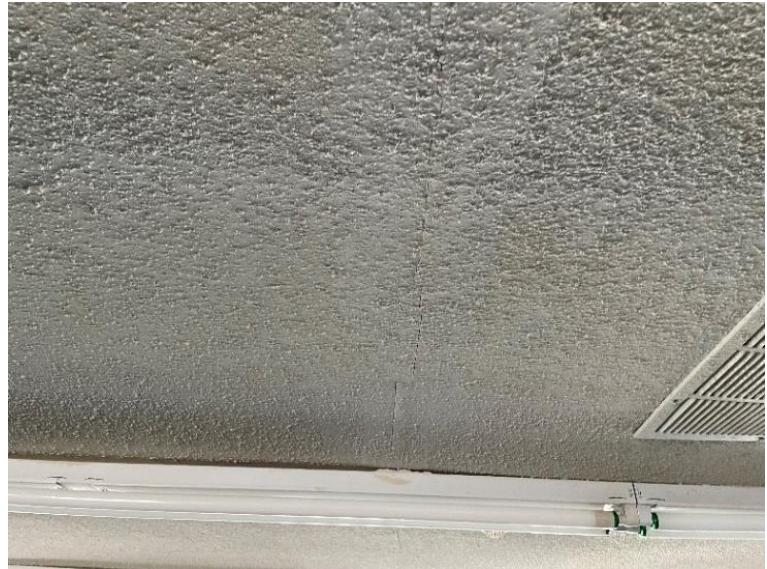
Photo LIB-S1: Cracked Gypsum Sheathing

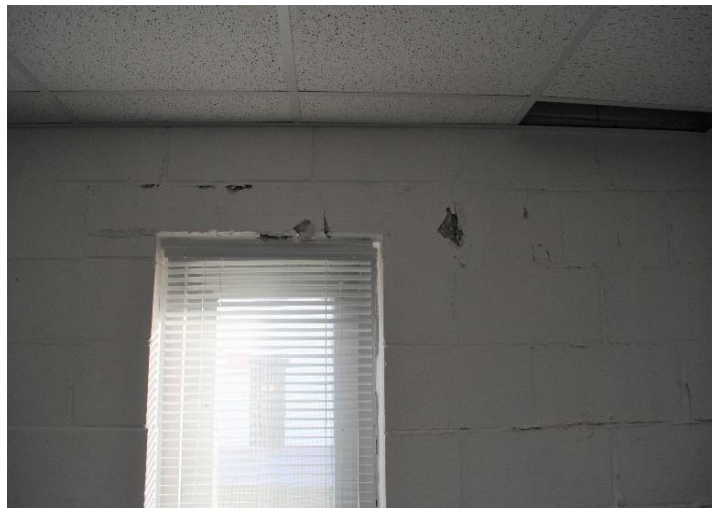
Photo MENT-A1: Interior Wall Damage Above Window

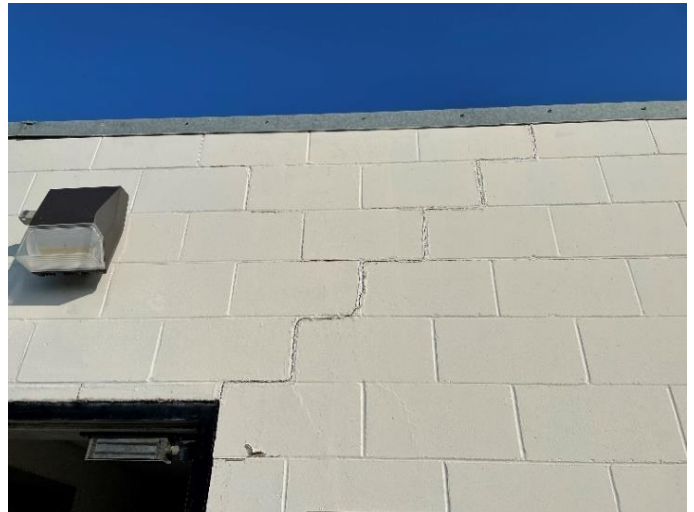
Photo MENT-S2: Previously Repaired Masonry Cracks

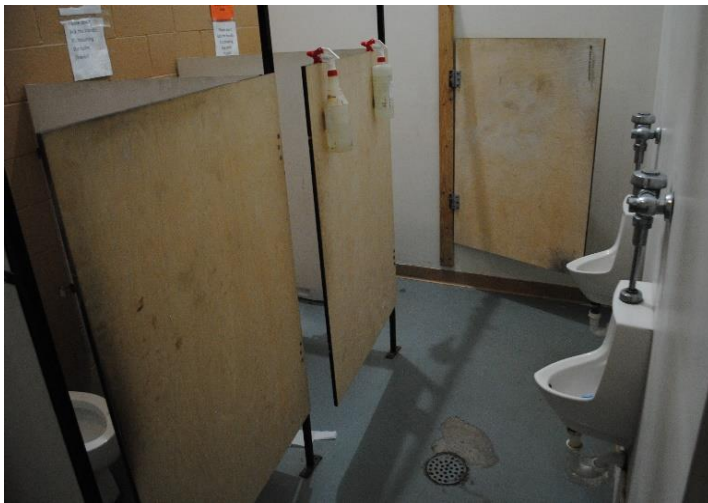
Photo PVB-A2: Non-ADA Compliant Toilets

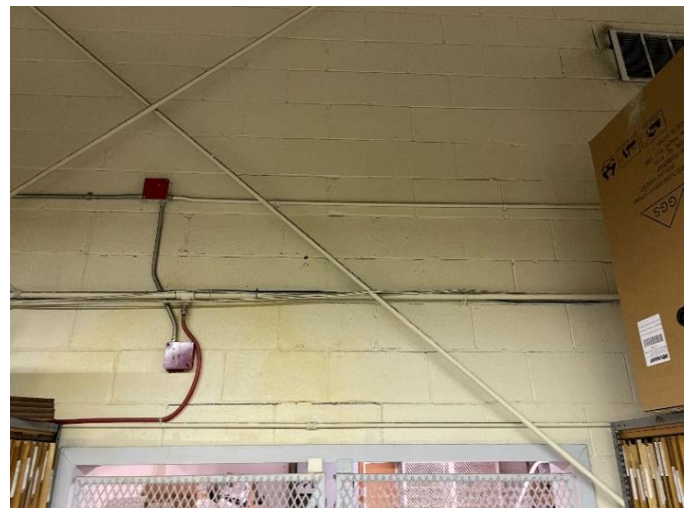
Photo PVB-S1: Cracked CMU Partition

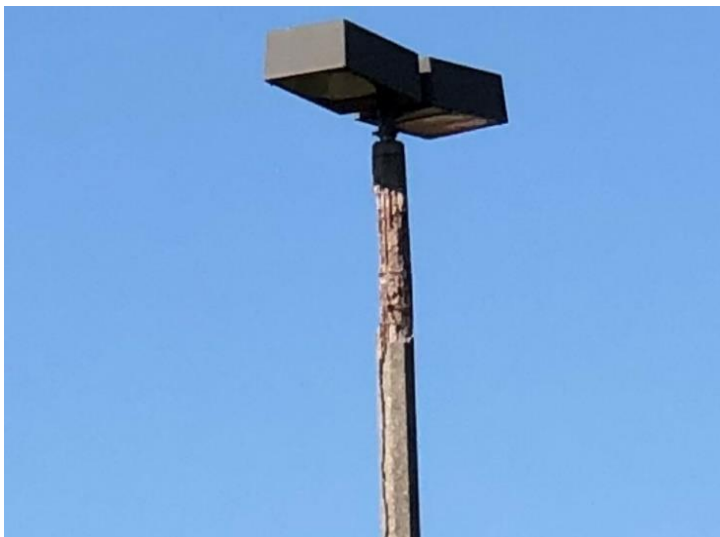
Photo LTG-2: Enlarged Image of Concrete Light Pole South of Housing Unit No. 5. (Note Severe Pole Deterioration with Reinforcing and Interior Conduit Visible)

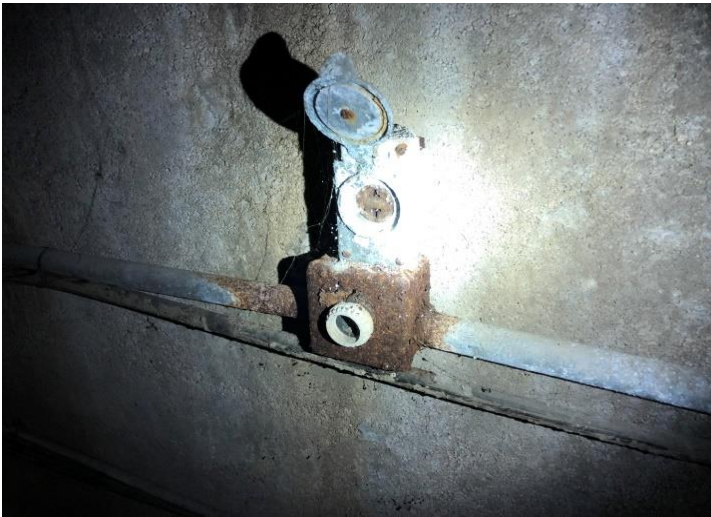
Photo UT-E1: Representative Photo of Rusty Tunnel Lighting and Receptacle Box, Lamp is Missing

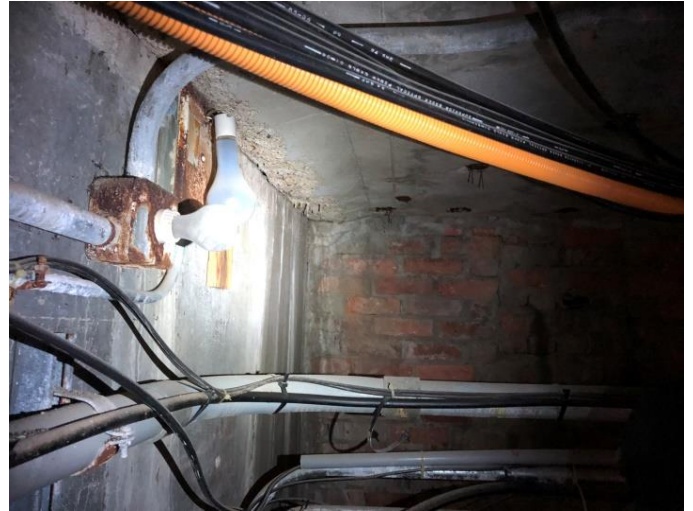
Photo UT-E2: Representative Photo of Rusty Tunnel Lighting. Neither Fixture is Operational

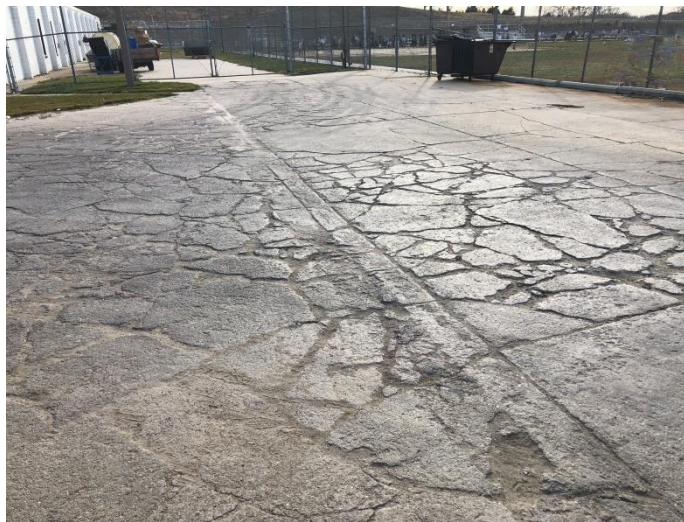
Photo PAVE-1: Poor Pavement Near HU6
