Nebraska State Penitentiary Useful Life Engineering Study

Lincoln, Nebraska

Alvine No. 2021 8777
January 2022

Prepared for:
State of Nebraska
Department of Correctional Services
Lincoln, Nebraska

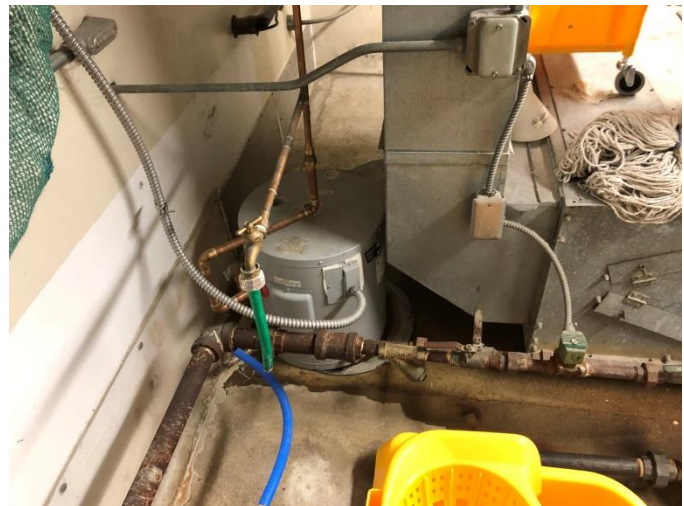
Photo ACT-M1: Existing Electric Water Heater

An electric water heater exists, which is about 10 years old. See Photo ACT-M1. The water heater was observed to be actively leaking water. The domestic hot water piping has no pipe insulation installed.

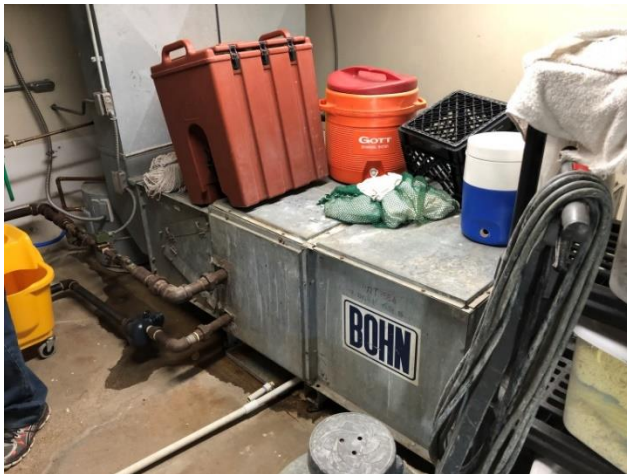
Photo ACT-M2: Existing AHU

The HVAC system is composed of one air handling unit (AHU), one air-cooled condensing unit (ACCU), a thermostat, direct-buried underfloor supply air ductwork serving floor registers along the perimeter of the building, and two restroom exhaust fans. The AHU is original from 1975 and has a steam heating coil and a direct expansion (DX) refrigerant cooling coil. See Photo ACT-M2.

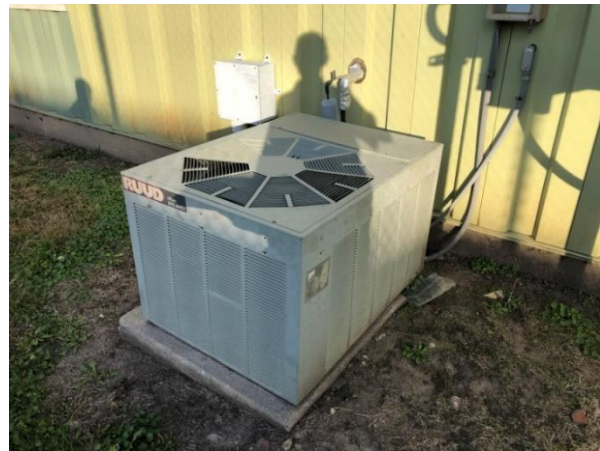
Photo ACT-M3: Existing ACCU

The steam piping and refrigerant piping are both missing pipe insulation. The ACCU is from the 1990s. See Photo ACT-M3. There is an outdoor air louver in the exterior wall for ventilation purposes, but it has been disconnected from the AHU's return air ductwork and is capped. As a result, the buildings only source of ventilation air is from operable windows which are only used during mild weather conditions.

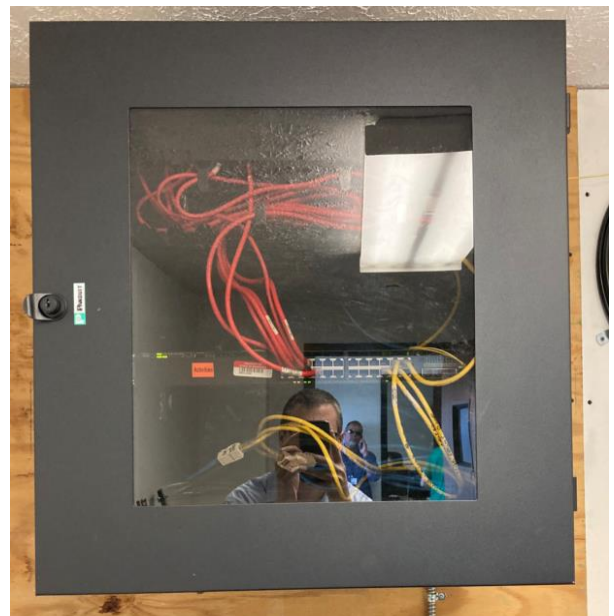
Photo ACT-T1: Existing Telecom Cabinet

There is an existing lockable wall-mount telecommunication cabinet located in Storage 112 that serves data for the entire building. The building is served by a 24-strand, single mode fiber optic cable that runs back to the telecommunications rack located in the basement telecommunications room of the Laundry Building (LAUN). The horizontal data cabling serving the building is all Category 6 copper cabling, which is in line with current industry standards for horizontal copper cabling. There is an uninterruptible power supply (UPS) within the telecommunications rack that supports the telecommunication network. The telecommunication cabinet is not properly grounded per BICSI standards.

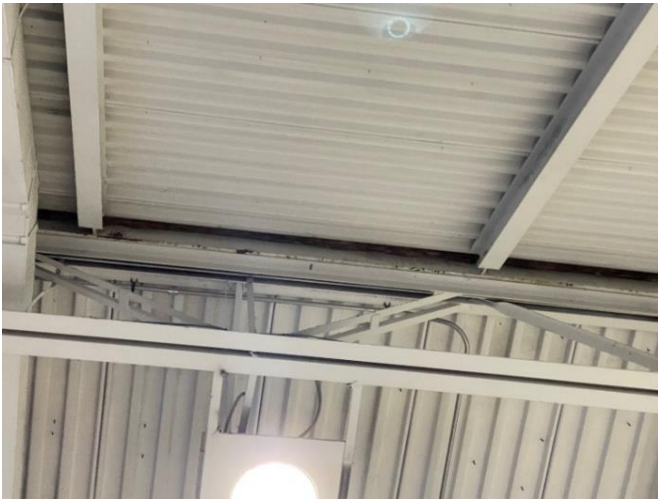
Photo ANC-S1: Rusting Gym Roof Framing

With exception to the gym at the south end, the building is reinforced concrete slabs at the second floor and roof supported by interior concrete columns and concrete beams and columns at the perimeter. The gym roof is framed with long-span steel bar joists with steel beam and short-span steel bar joists at the southernmost end, all supported by CMU bearing walls. Rusting was present where the roof transitioned from the high flat roof to the sloped roof at the south end.

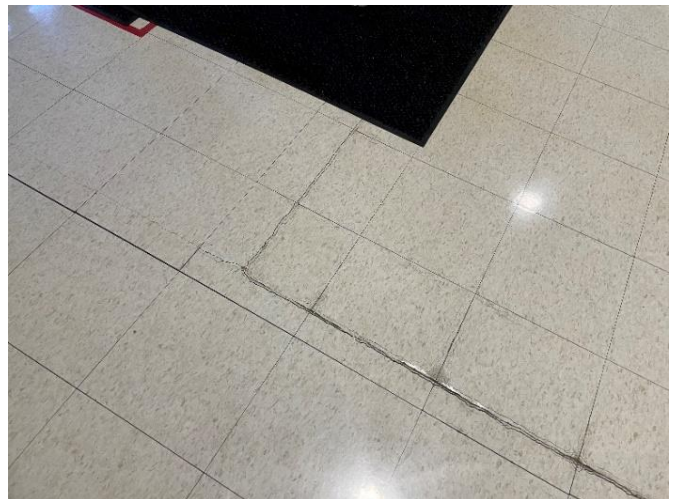
Photo ANC-S2: Cracks in Gym Flooring

Cracks are present in the gym flooring. Review of the original building documents suggest there may have been a recessed portion of the floor that may have been infilled and corresponds with the cracks. Additionally, there may be a slab control joint at this location. This does not appear to be a structural concern.

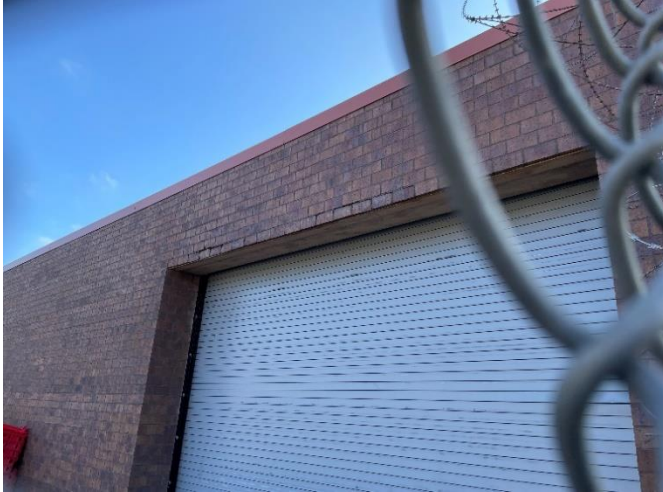
Photo ANC-S3: Damaged Brick at Kitchen Receiving

Brick above the kitchen receiving door was damaged, most likely from vehicular impact. The concrete curb around a floor drain in Mechanical Room 2B68 is severely cracked and deteriorating.

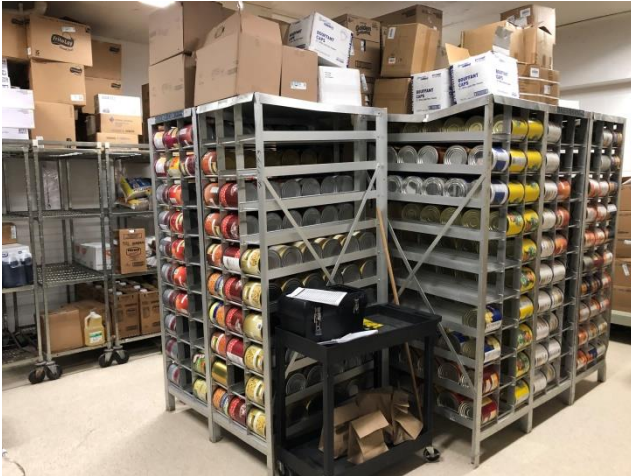
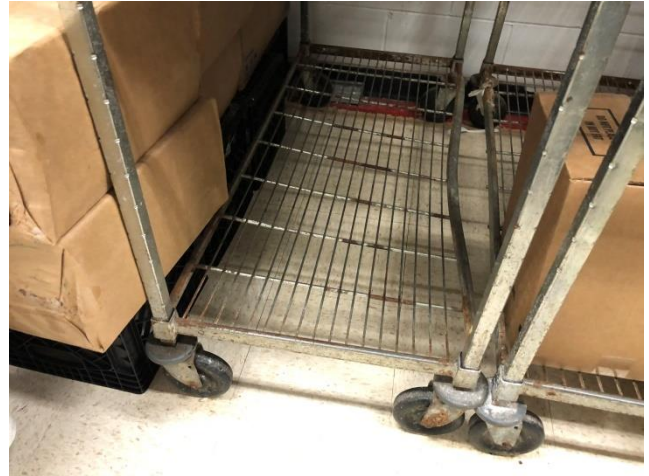
The can racks and track wire shelving in the dry storage room show signs of being heavily used, as they have bent tops and shelves, and some units are showing signs of rust. See Photos ANC-FS2 and ANC-FS3.

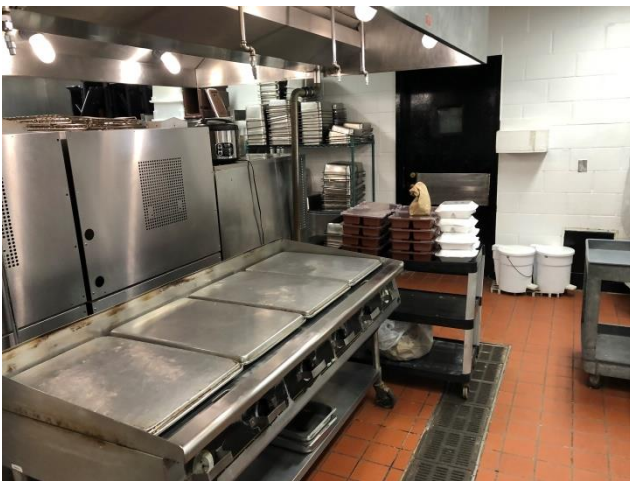
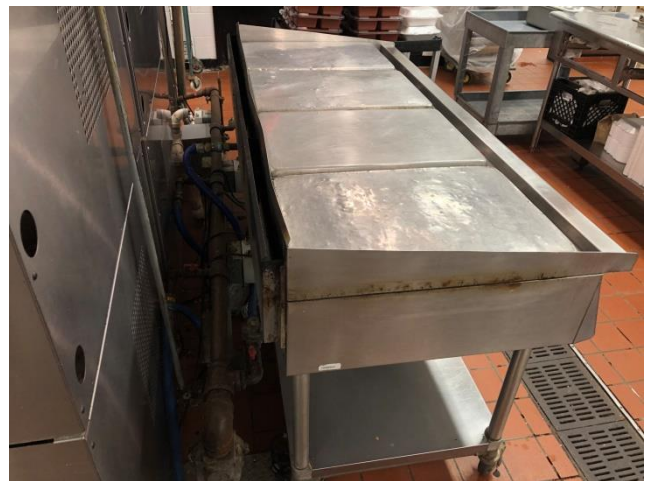
The griddle with stand appears to be heavily used (loss of control knobs, shows signs of high heat and unit has numerous dents) and shows signs of end of serviceable life. See Photos ANC-FS4 and ANC-FS5. The mixer is an older discontinued model, and appears to be extensively used and shows signs of end of serviceable life. See Photo ANC-FS6. The conveyor toasters appear to be heavily used. See Photo ANC-FS7.

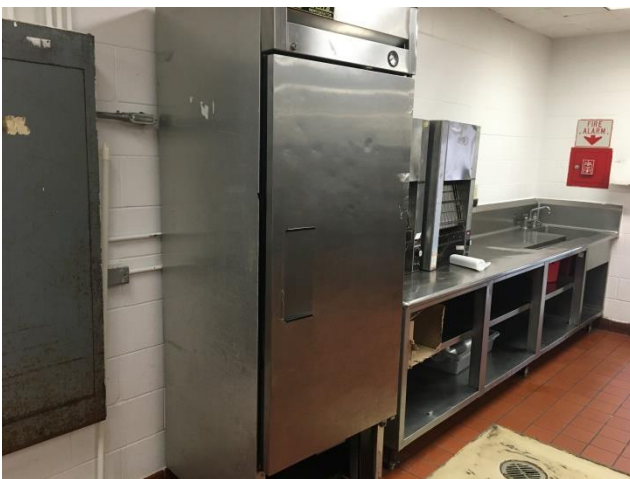
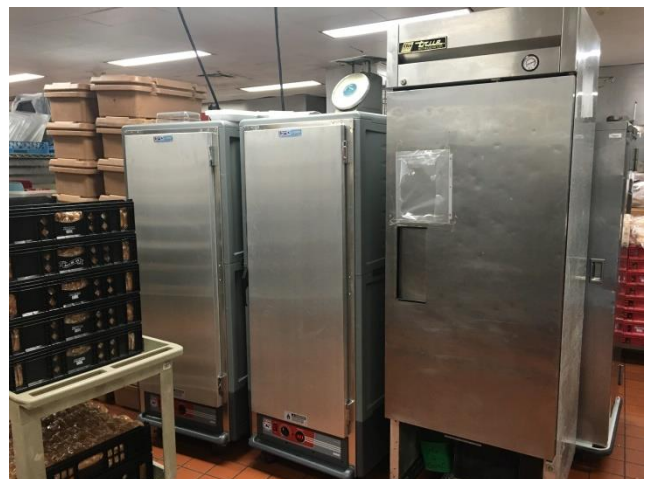
The reach-in refrigerators are older units and appear to be extensively used (both units are missing bottom front panels and have numerous dents on exterior), and show signs of end of serviceable life. See Photos ANC-FS8 and ANC-FS9.

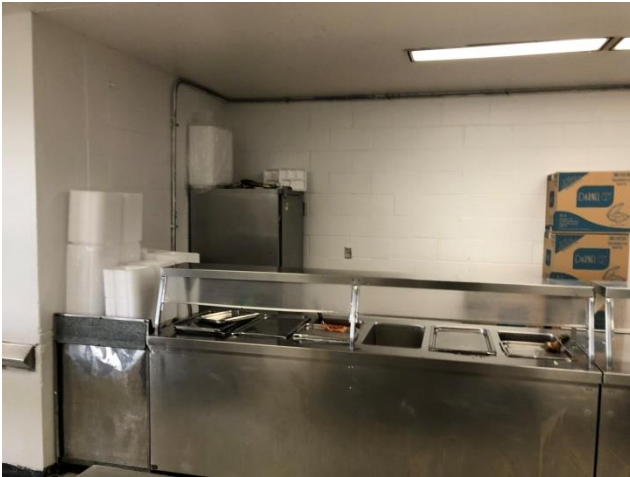
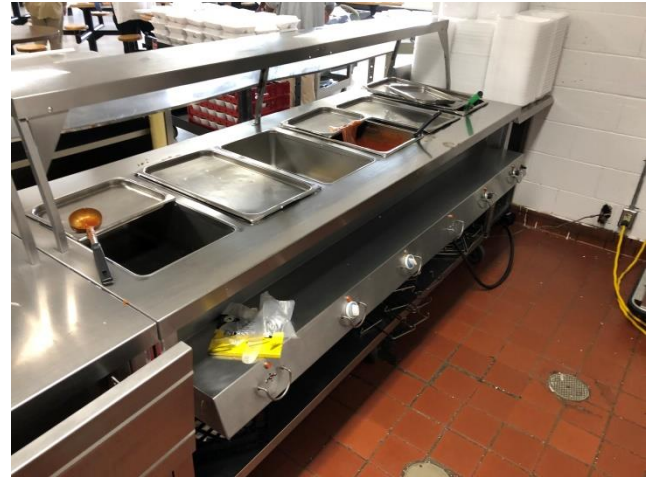
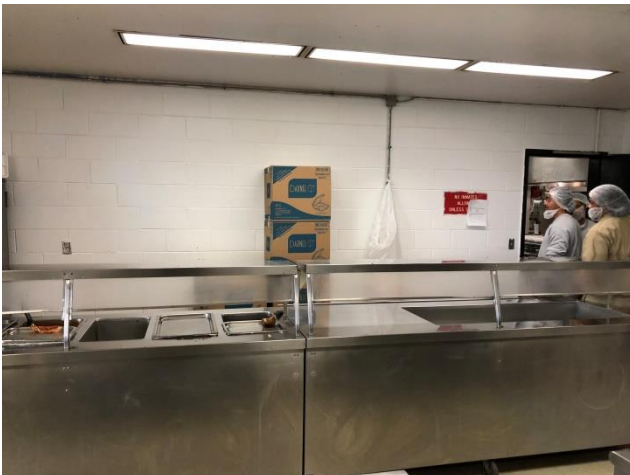
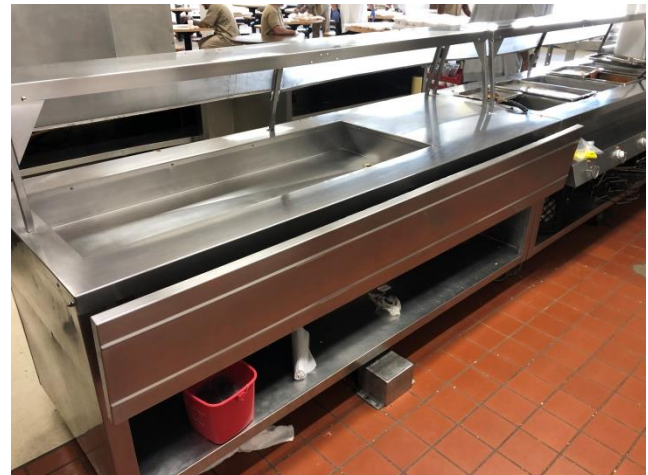
All serving counters (utility counter, hot serving counter, refrigerated/cold serving counter) appear to be extensively used (loss of control knobs and scratched sneeze guards), and show signs of end of serviceable life. See Photos ANC-FS10, ANC-FS11, ANC-FS12, and ANC-FS13.

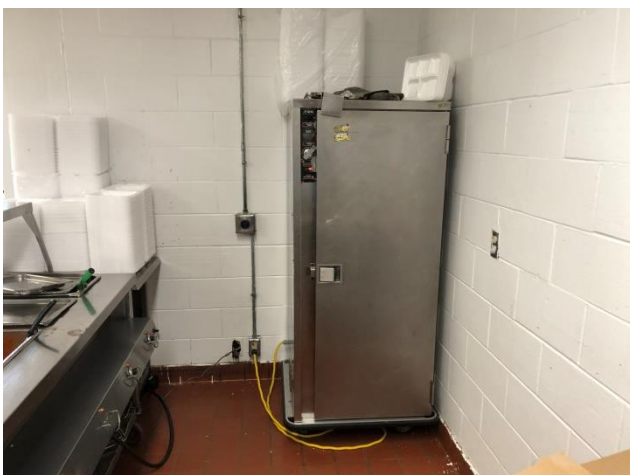
Photo ANC-FS14: Existing Mobile Hot Cabinet

Mobile hot cabinet in serving area appears to be an older unit and shows signs of extensive use. See Photo ANC-FS14.

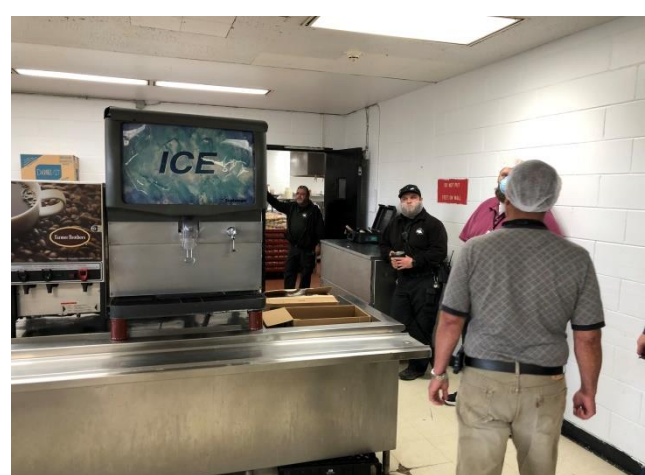
Photo ANC-FS15: Existing Ice/Water Dispenser

Ice/water dispenser in serving area shows signs of extensive use. See Photo ANC-FS15.

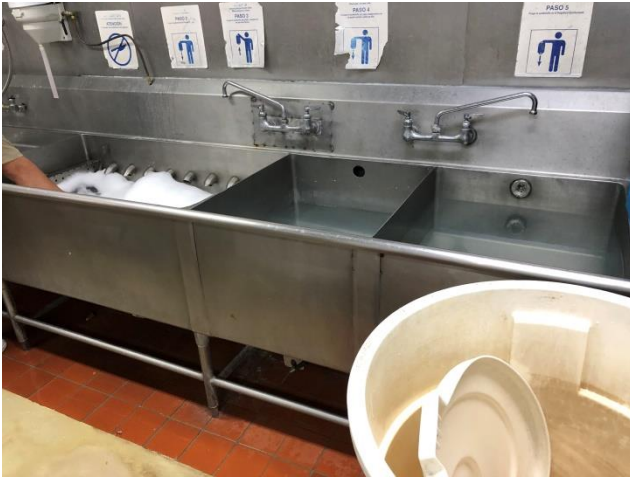
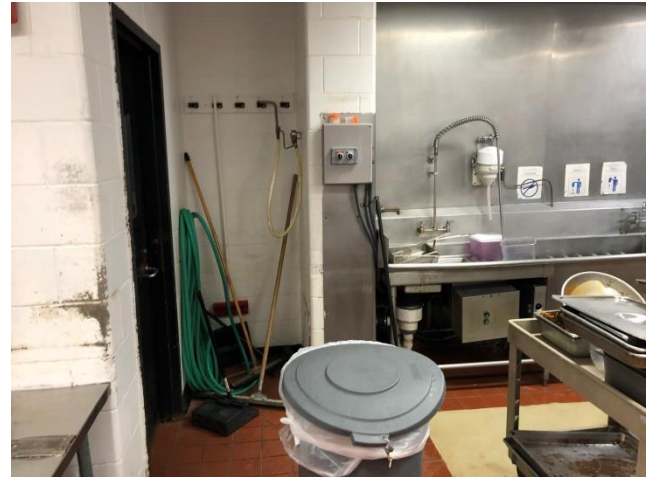
The scullery sink and pre-rinse assembly appear to be original and shows signs of being heavily used (missing parts). See Photos ANC-FS16 and ANC-FS17.

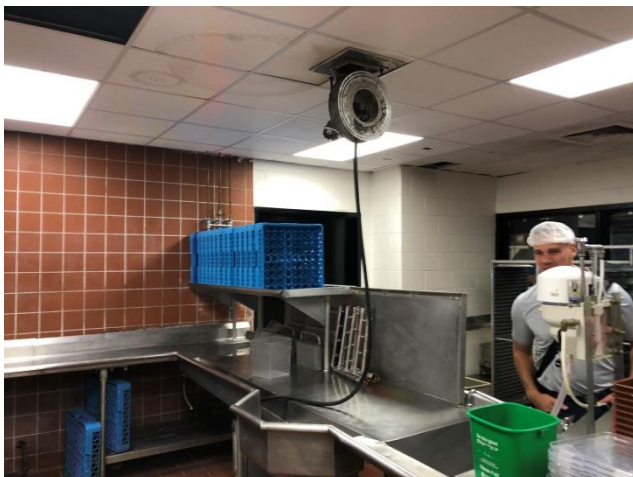
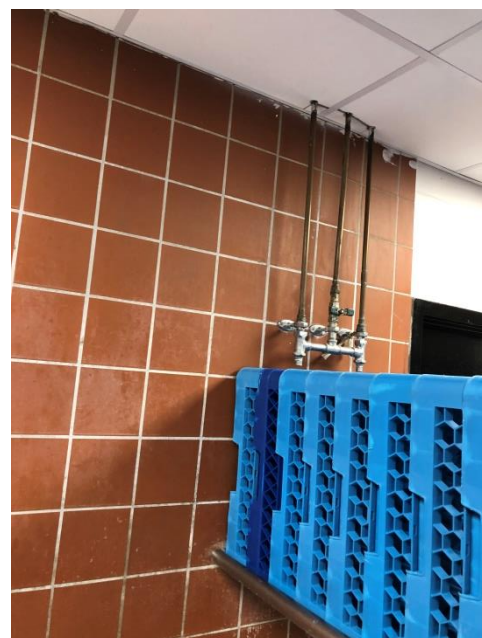
The hose reel spray assembly (at ceiling) and mixing valve (at wall) in the dish wash room appear to be original. They show signs of being heavily used and are at end of serviceable life. See Photos ANC-FS18 and ANC-FS19.

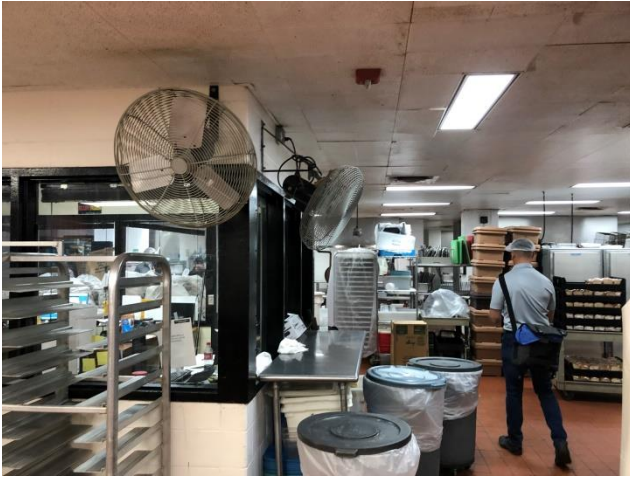
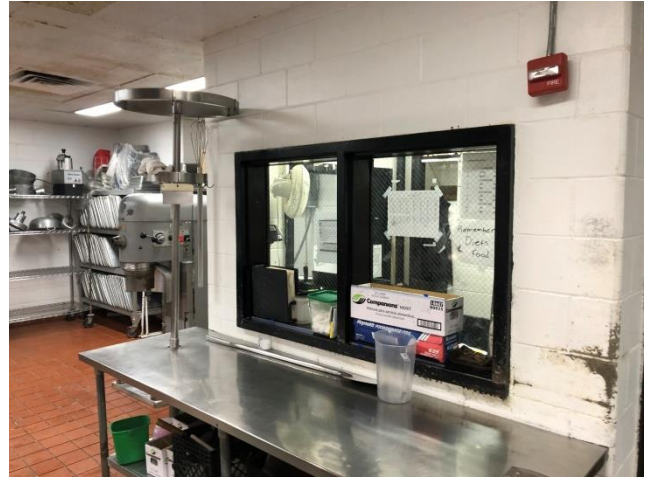
The work tables appear to be original units and show signs of heavy use. Some of the units are in worse condition than others (dented countertops and bent/damaged legs). See Photos ANC-FS20 and ANC-FS21.

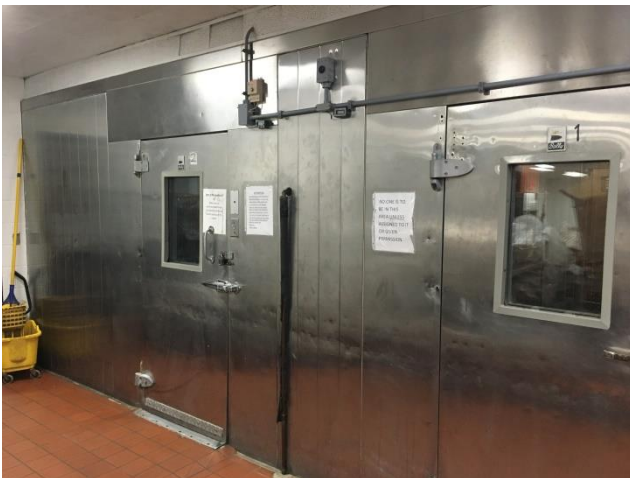
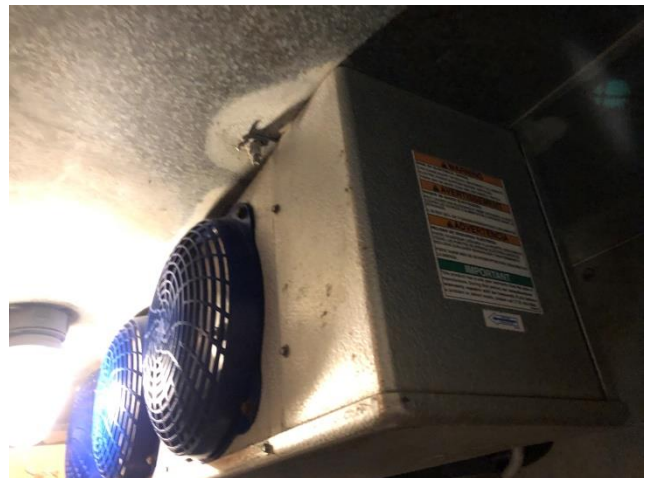
Walk-in coolers/freezer appear to be original box assemblies and show signs of end of serviceable life. Walk-in door hinges have been pulled off of wall panels and doors numerous times, as there are multiple holes from hinges being relocated (vertically). See Photos ANC-FS22 and ANC-FS23.

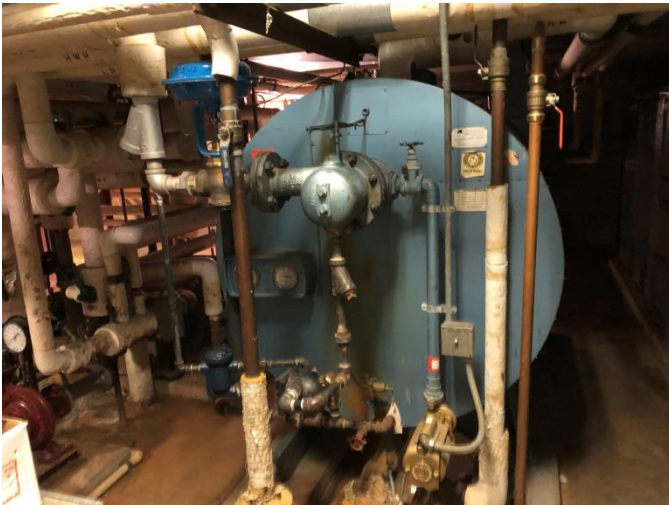
Photo ANC-M1: Existing Steam Water Heater

A steam water heater exists in the second floor Mechanical Room 2B68 which is original from 1981. See Photo ANC-M1. The water heater has a pneumatic steam control valve which serves a steam tube bundle in this 680-gallon water tank. There is only one tube bundle in this water heater.

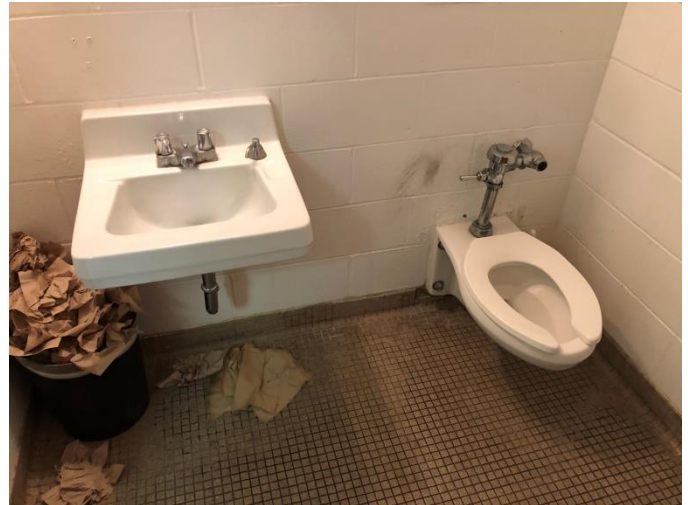
Photo ANC-M2: Typical Existing Plumbing Fixtures

With exception of the electric water coolers, the plumbing fixtures are original from 1981. See Photo ANC-M2 for typical plumbing fixtures. This building was built before the EPA Act of 1992 and before ADA, so the plumbing fixtures and flush valves are operating beyond their useful life and not conforming to modern water flow rates or ADA requirements. For a discussion on ADA issues, see architectural.

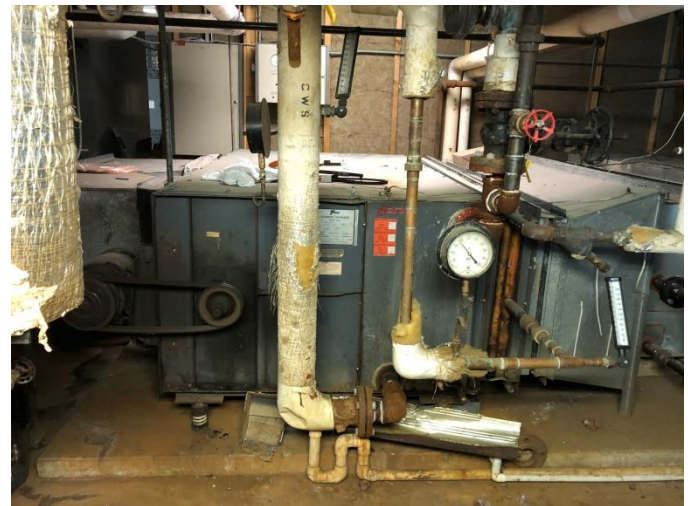
Photo ANC-M3: Typical Existing AHU

The HVAC systems are composed of eight AHU systems; a steam heat exchanger; perimeter finned-tube heating; hydronic four-pipe fan coils; and base-mounted, end-suction pumps with most equipment still original from 1981. Humidifiers do not exist for this building.

There are five constant-volume AHU systems and three variable-air-volume (VAV) AHU systems which include inlet guide vanes at the fans and terminal units. See Photo ANC-M3 for a typical existing AHU. Four of the eight AHU systems utilize return air ceiling plenums, including the skilled nursing facility AHU. Three of the AHU systems provide supply air and return air through the slots around the ceiling-mounted light fixtures. The AHU fans are composed of one or two fans on a common shaft which are operated by a belt-driven fan motor. Ventilation air is provided via outdoor air louvers mounted in the exterior walls. The temperature controls are still pneumatic, but there are direct digital control (DDC)

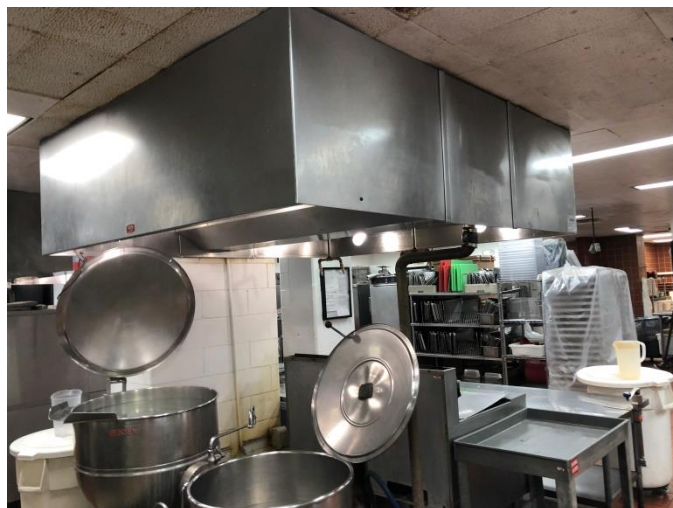
Photo ANC-M5: Existing Kitchen Exhaust Hood

The kitchen exhaust hoods are original from 1981 which makes them about 40 years old and due for replacement. The kitchen exhaust ductwork is welded black steel, but fire-rated duct insulation is not installed, which is required by the International Mechanical Code (IMC) and by National Fire Protection Association (NFPA).

It is recommended to replace both of the kitchen exhaust hoods with two similar-sized, modern, Type I exhaust hoods which are rated for grease exhaust air. The welded black steel exhaust ductwork will be cleaned and reused, but a new grease rated exhaust fan will be provided. The hoods will be provided with 100% outdoor air make-up air at the perimeter of the hoods to help with the capture of moist grease laden air from the cooking equipment below. A make-up air unit (MAU) will be installed on the roof and ducted down to the kitchen exhaust hoods in the first floor kitchen. The MAU and the exhaust fan will be controlled in steps to correspond to having one or both kitchen exhaust hoods on at a time. The probable project cost for this scope of work is \$452,000.

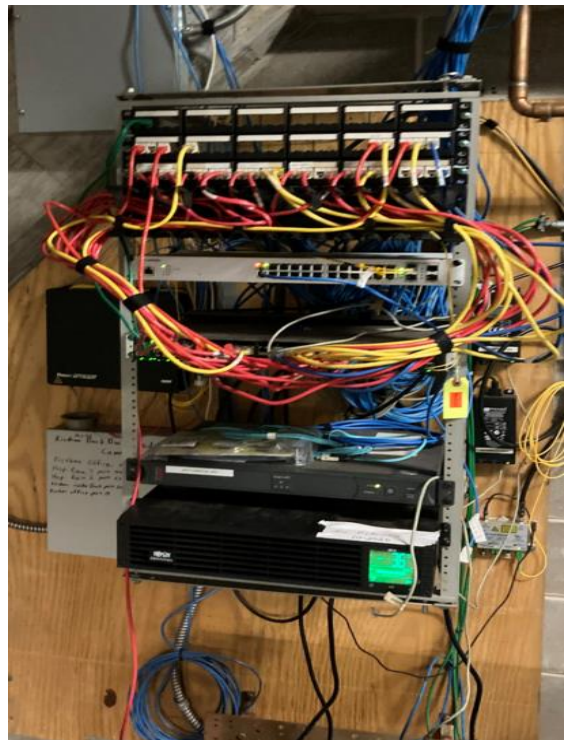
Photo ANC-T3: Existing Mechanical Room 2B68

near each telecommunications rack, and the racks are grounded. The telecommunications rack within Mechanical Room 2B68 is a shared space with other trades and should be within a lockable telecommunications cabinet to control against unauthorized access.

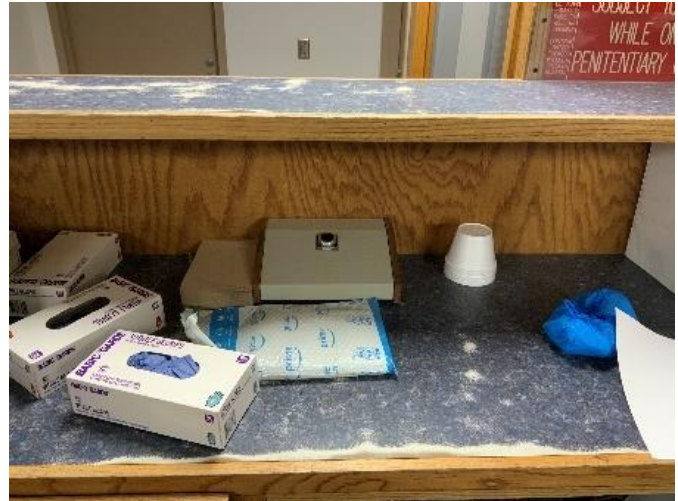
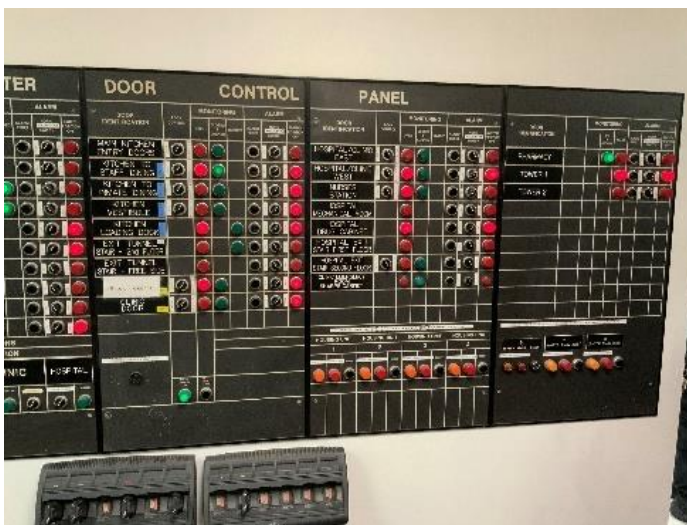
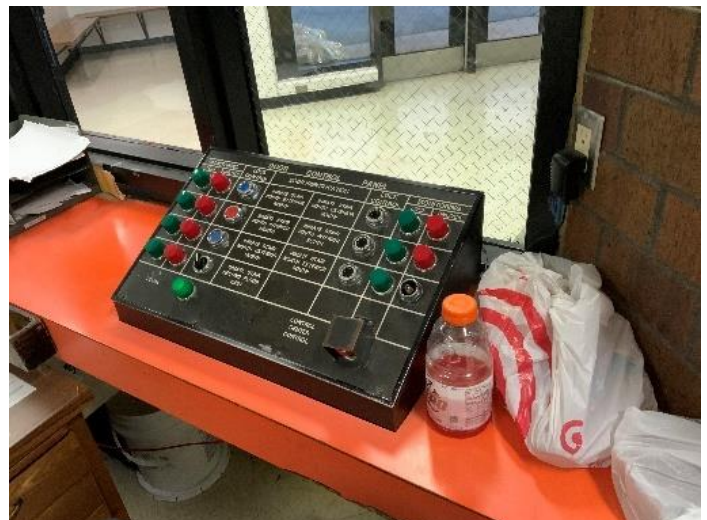
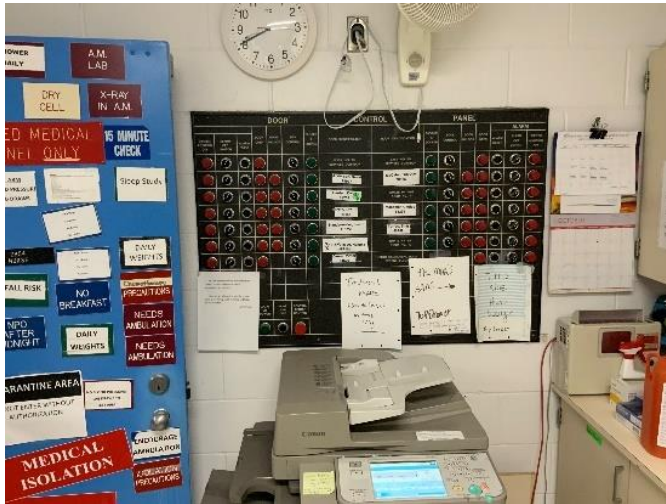
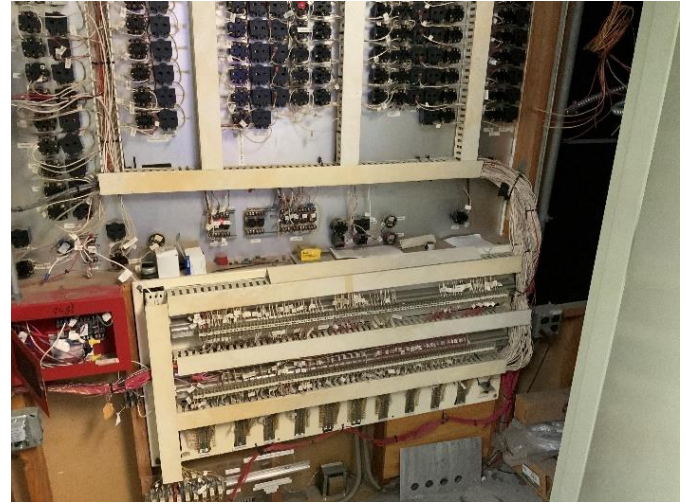
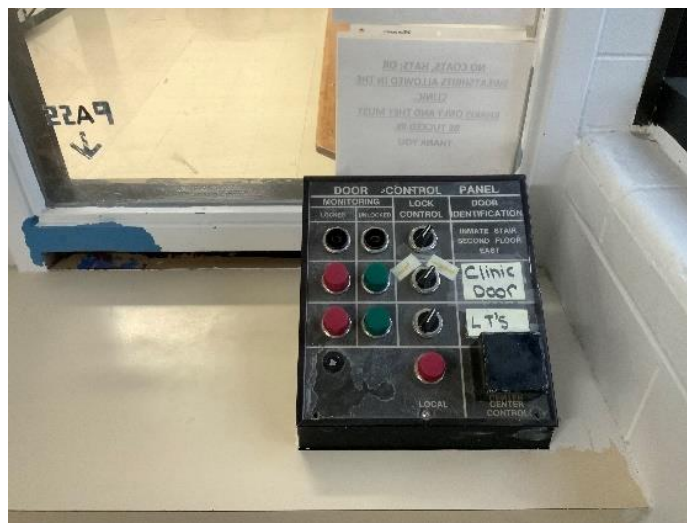
All control locations use obsolete control panels to control and monitor their areas. Control panels consist of rotary switches and old-type LED indicators installed on composite board (plastic/steel) with text engraved on their surface. Some panels are installed into desk mounted turrets, and some are wall-mounted. The master control station has the capability to turn ON/OFF all local control panels, but cannot take control of doors controlled by local control panels. The existing doors are hard-wired into door control relays and switches.

**Photo ANC-SEC1: Existing Door Control Panel -
Basement Level - Public Entrance**

**Photo ANC-SEC2: Existing Door Control Panel -
Master Control Room**

**Photo ANC-SEC3: Existing Door Control Panel –
Turnkey Entrance**

**Photo ANC-SEC4: Existing Door Control Panel –
Nurses Office**

**Photo ANC-SEC5: Existing Door Control Panel –
Medical Area Entrance**

**Photo ANC-SEC6: Existing Door Control Panel – Door
Control Relays and Switches (behind panels)**

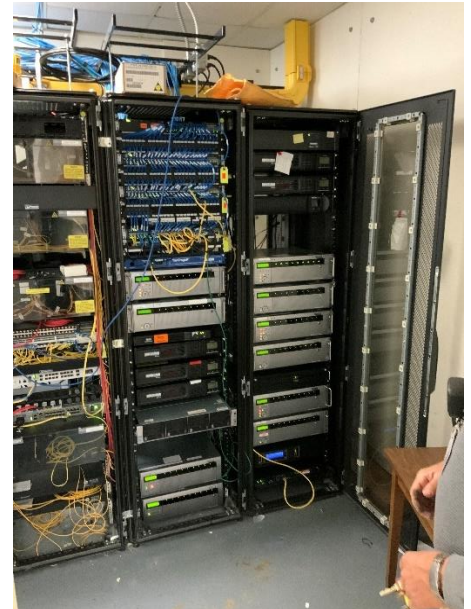
The existing video surveillance has existing IP cameras managed by an obsolete Panasonic PMPU server with Panasonic ND400 storage arrays. Most cameras are low resolution Panasonic internet protocol (IP) fixed and pan-tilt-zoom (PTZ) cameras. All video surveillance servers and recorders are installed in this building. The main video observation room is installed in this building.

Photo ANC-SEC8: Video Surveillance System Servers and Recorders

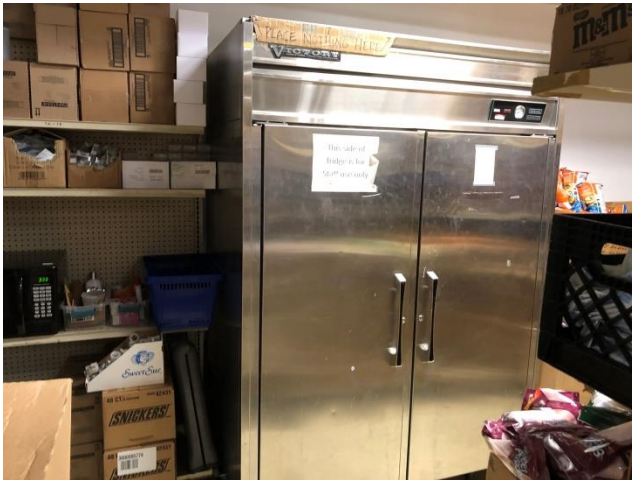
The reach-in refrigerator appears to be an older unit and nearing the end of its serviceable life. The interior cavity of the unit is showing signs of rust/corrosion along the panel joints. See Photos CAN-FS1 and CAN-FS2.

Photo CAN-FS1: Existing Reach-in Refrigerator

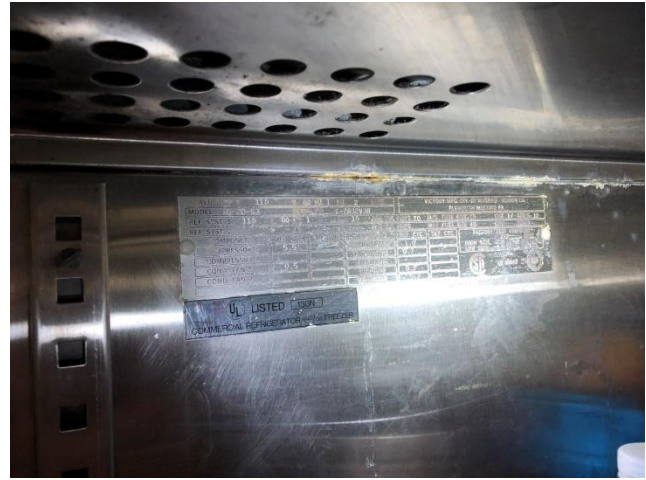
Photo CAN-FS2: Existing Reach-in Refrigerator Interior

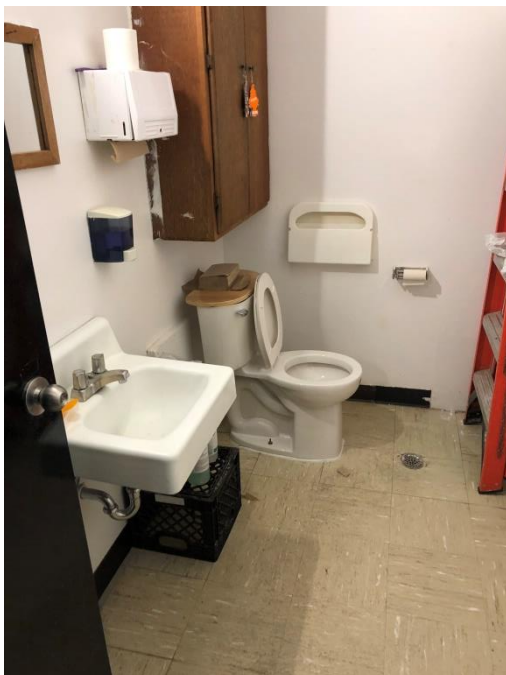
The domestic hot water is provided to this building from a water heater in the Soap Factory (SOAP). The plumbing fixtures are a mixture of ages. The flush tank water closet is about five years old, but the lavatory appears to be original from 1981. See Photo CAN-M1. This building was built before the EPA Act of 1992 and before ADA, so the lavatory and faucet are operating beyond their useful life and not conforming to modern water flow rates or ADA requirements. For a discussion on ADA issues, see architectural.

Photo CAN-M1: Existing Plumbing

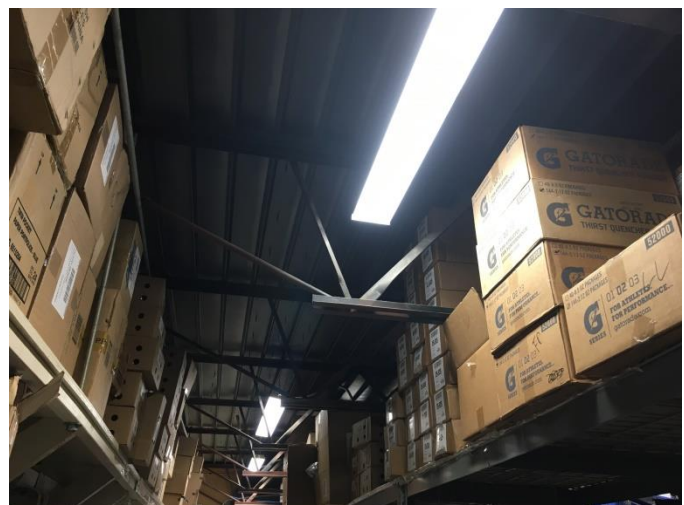
This building does not have a fire sprinkler system. Boxes of items are stacked up to the bottom of the roof deck. See Photo CAN-M2, which would need to be reduced if a fire sprinkler system was added.

Photo CAN-M2: Stacked Boxes up to Roof

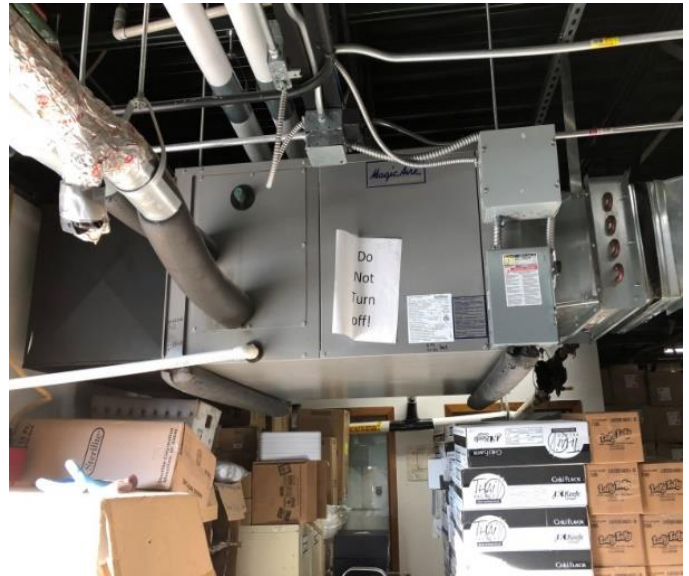
The HVAC system is composed of two AHUs one ACCU thermostats, and one restroom exhaust fan. The west AHU is from 2012 and has a steam heating coil and a chilled water cooling coil. See Photo ACT-M3. The steam piping, chilled water piping, and cooling coil condensate are all routed over food items which need to be avoided. There is not any mechanically introduced ventilation air provided for this building.

The east AHU, ductwork, and exhaust fan are original from 1981, which makes them about 40 years old; while the west AHU is from 2012, which makes it about 9 years old. According to ASHRAE, most fans and coils have a median service life of about 20 years. As a result, the existing east AHU and the exhaust fan are operating beyond its expected useful life.

Photo ACT-M3: Existing AHU

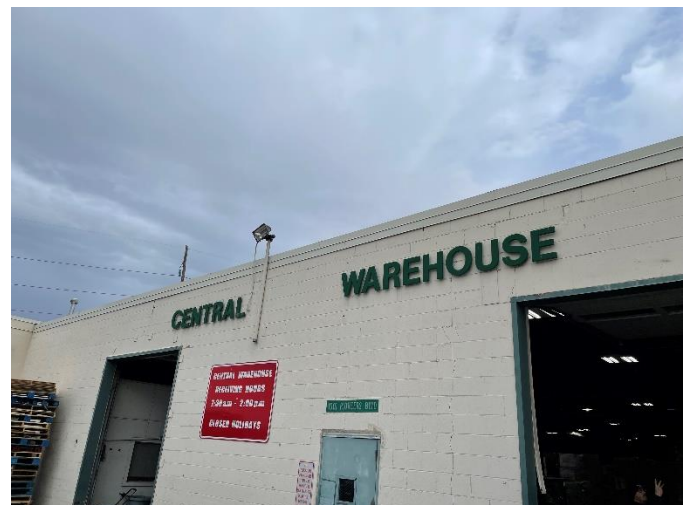
Cracks are present in the south-central CMU wall. No control joints were observed in this wall.

Photo CW-S1: Cracked CMU

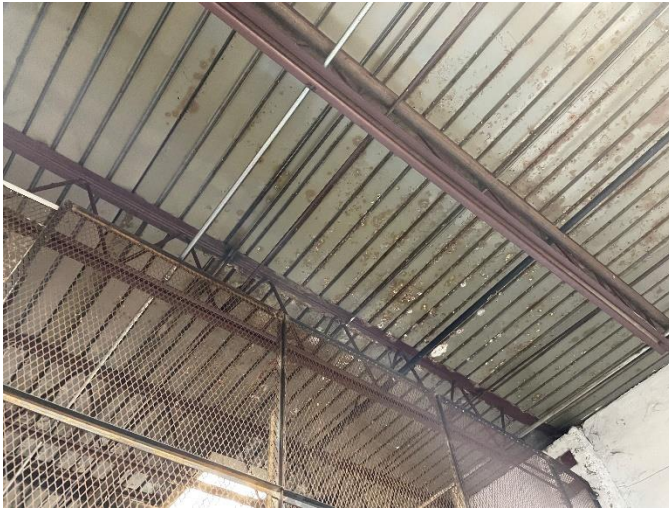
The metal roof deck at the west bay is installed upside down. This significantly weakens the deck and does not provide adequate support for rigid insulation installed on top of the deck. Additionally, small areas of rusted deck are also present, estimated to be less than 10 percent of the deck area.

CW-S2: Rusted Roof Deck Installed Upside Down

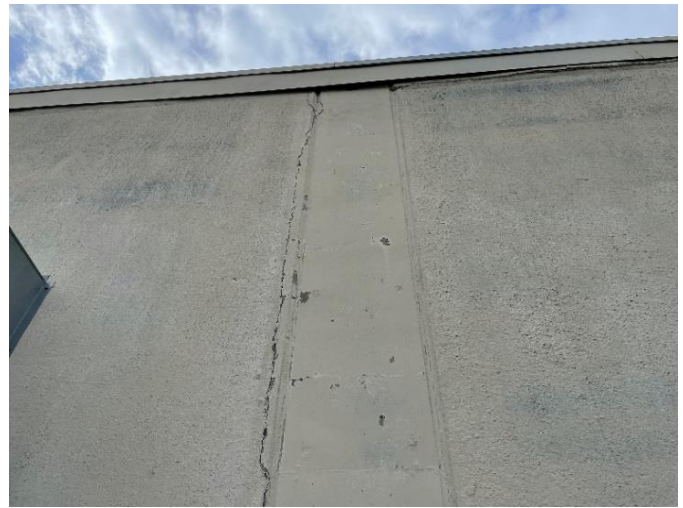
Cracking is present in the exterior concrete walls at or near control joint reveal locations.

CS-S3: Cracked Concrete Walls

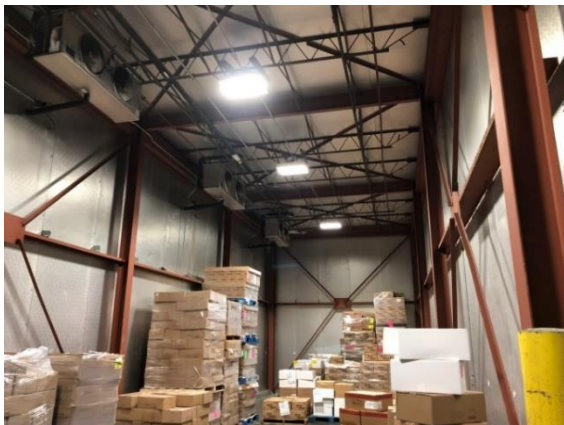
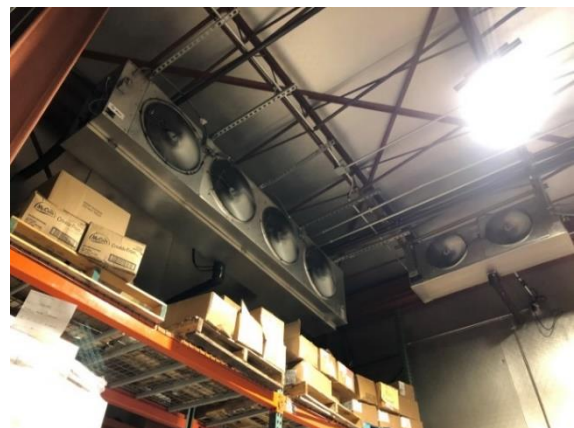
The existing walk-in freezer contains a total of five evaporator coils, of which four appear to be original equipment from 1999. The larger (fifth) evaporator coil was added to aid in holding the proper temperature inside of the freezer compartment. See Photos CW-FS1&CW-FS2.

Photo CW-FS1: Existing Freezer Evaporator Coils

Photo CW-FS2: Existing Freezer Evaporator Coils

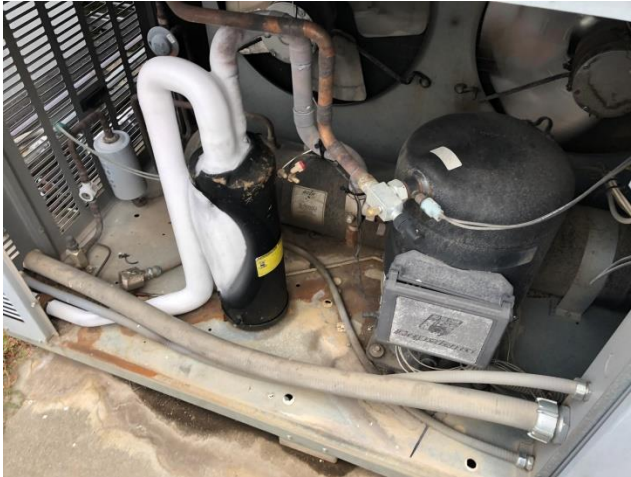
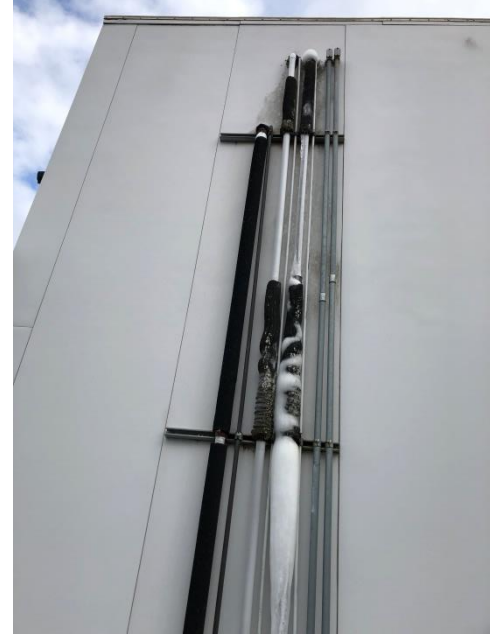
The existing insulation on the refrigeration piping (between the condensing units outside and the evaporator coils) is in poor condition, as it is missing in areas and deteriorating in other areas. See Photos CW-FS3&CW-FS4. This results in cold dissipating in the pipe and allowing ice to build-up around the refrigeration piping (especially at the exterior of the compartment). This reduces the efficiency of the refrigeration system by not providing the proper operating temperature at the evaporator coils.

Photo CW-FS3: Existing Older Condensing Units

Photo CW-FS4: Existing Refrigeration Piping

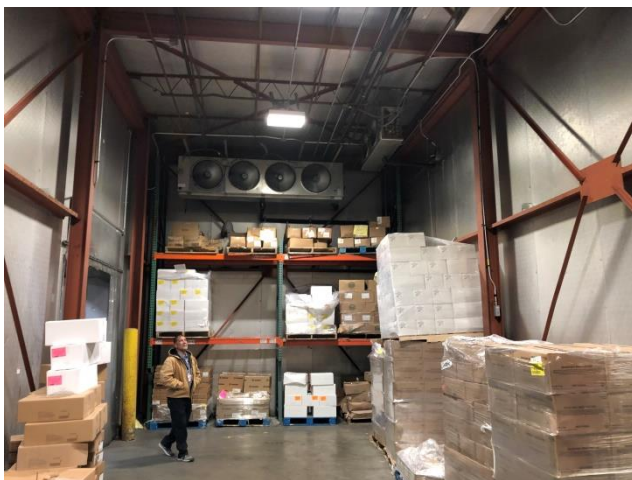
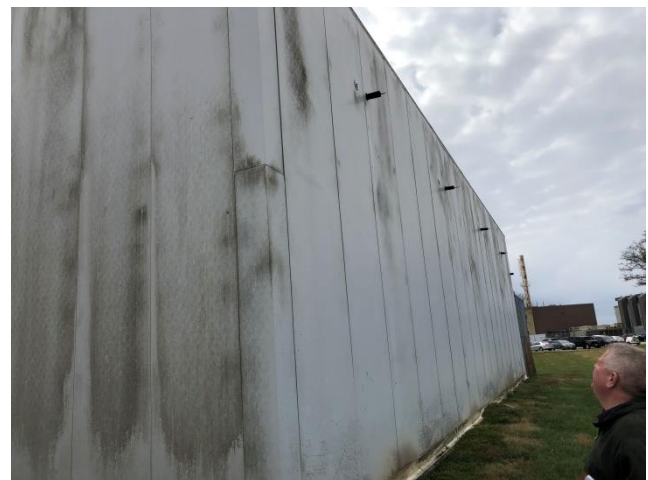
The condensate drain lines from all five evaporator coils appear to be routed straight through the wall panel of the walk-in freezer compartment to the exterior of the building without any traps. See Photos CW-FS5&CW-FS6. This results in warm/humid air infiltrating into the walk-in freezer compartment through the condensate drain piping and being dispersed throughout the interior of the box by the evaporator fans.

Photo CW-FS5: Existing Freezer Evaporator Coils

Photo CW-FS6: Existing Evaporator Coil Drains

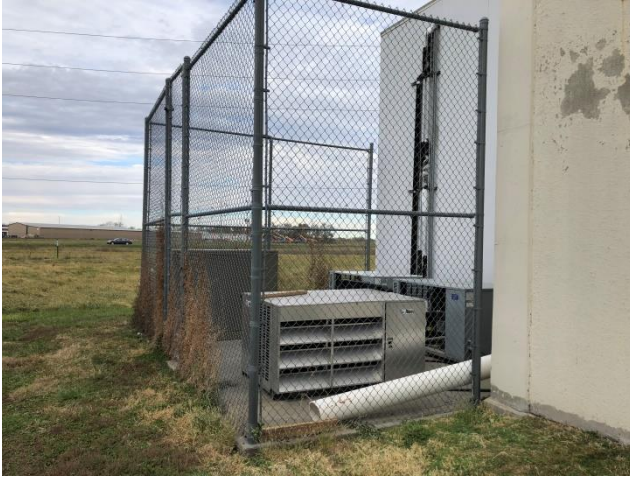
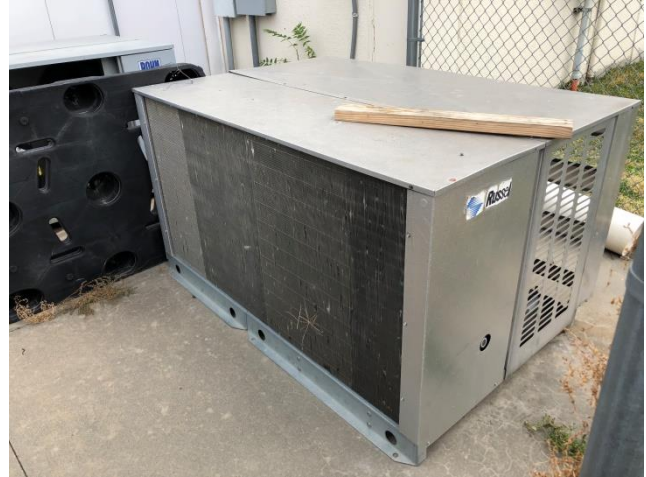
Regarding the location of the newer/larger Russell condensing unit, it has been located directly in front of the hot air discharge (exit) side of the two older condensing units. See Photos CW-FS7&CW-FS8. This results in the newer condensing unit bringing in warmer air into the air in-take side, making it less efficient for cooling the unit. Photo CW-FS8 shows that a plastic pallet has been attached to the end of the newer condensing unit to help prevent the hot air from blowing into the newer condensing unit.

Photo CW-FS7: Existing Freezer Condensing Units

Photo CW-FS8: Existing Large Condensing Unit

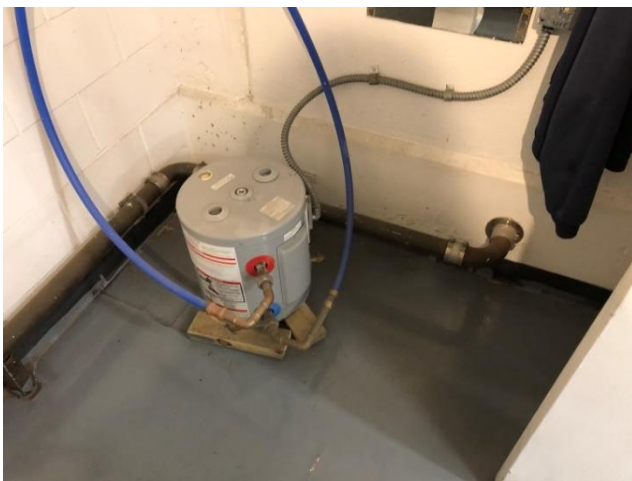
Two electric water heater exists which are both about five years old. See Photo CW-M1. The domestic hot water piping has no pipe insulation installed.

Photo CW-M1: Typical Existing Electric Water Heater

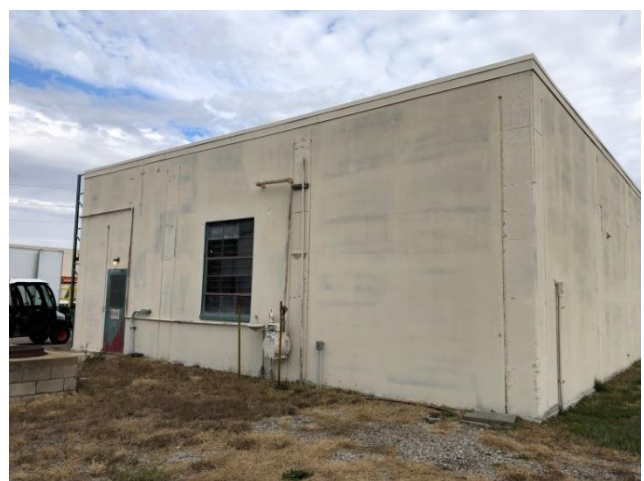
The building is served by two natural gas meters with one on each end of the U-shaped building. The southwest gas meter and piping appears to be at least 40 years old and is shown in Photo CW-M2.

Photo CW-M2: Existing Natural Gas Meter at SW Wall

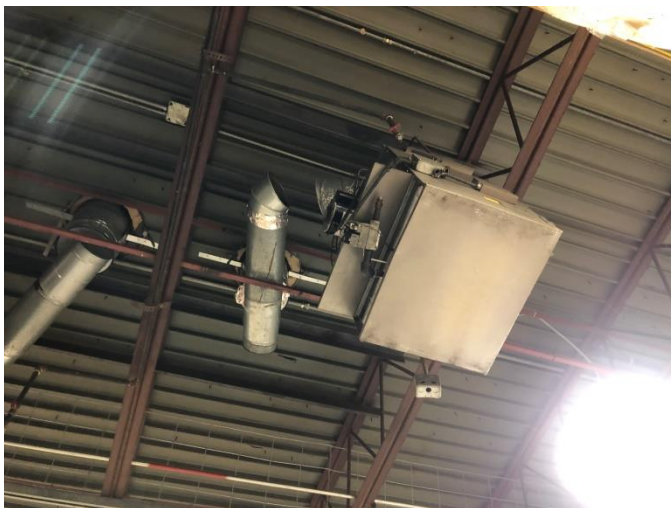
The HVAC system is composed of eight natural, gas-fired unit heaters of which, three do not work. See Photo CW-M4. There are two rows of natural gas infrared radiant heaters in the middle warehouse area.

Photo CW-M4: Existing Abandoned Gas Unit Heater
