Nebraska State Penitentiary Useful Life Engineering Study

Lincoln, Nebraska

Alvine No. 2021 8777
January 2022

Prepared for:
State of Nebraska
Department of Correctional Services
Lincoln, Nebraska

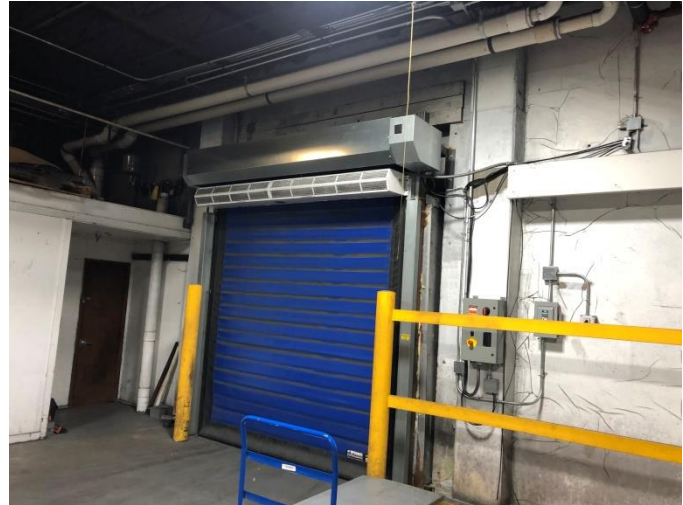
**Photo CW-M7: Existing Air Curtain at Rapid Open
Freezer Door**

The unit heaters vary in age from about 25 years old to only about one year old, with half being older and half being newer. The two ductless mini-split heat pump systems are about one year old, and the gas furnace with ACCU split system is about five years old. The natural gas infrared radiant heaters were installed in the last couple of years, but the exhaust fans and associated ventilation air control dampers are about 30 years old. The air curtain is only a couple of years old.

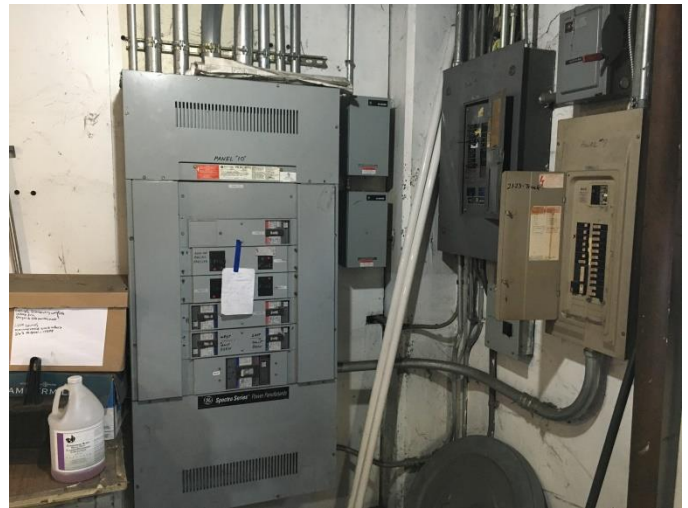
The power distribution system is comprised of several different vintages of electrical gear. See Photo CW-E1. Most all of the equipment is serving beyond its useful service life and needs to be replaced. Convenience receptacles are of varied vintages as well. Convenience receptacle mounting heights are not compliant with modern ADA standards.

Photo CW-E1: Main Electrical Service

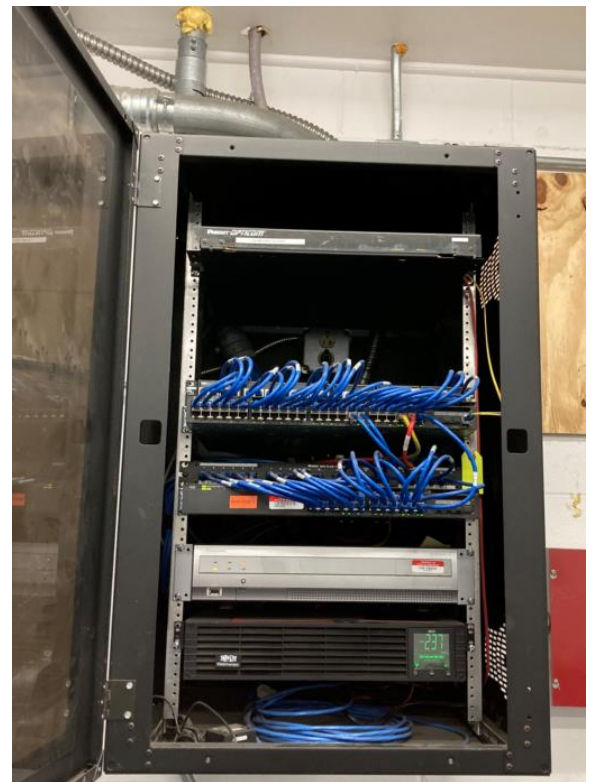
There is an existing, lockable, wall-mount telecommunication cabinet located in Office 111 that serves data for the entire building, including the central receiving warehouse. The building is served by a 24-strand, single mode fiber optic cable that runs back to the telecommunication rack located in Mechanical 102 of the CERT building. The horizontal data cabling serving the building is all Category 6 copper cabling, which is in line with current industry standards for horizontal data cabling. There is a UPS within the telecommunications rack that supports the telecommunication network. The telecommunications cabinet is not properly grounded per BICSI standards.

Photo CW-T1: Existing Telecom Cabinet

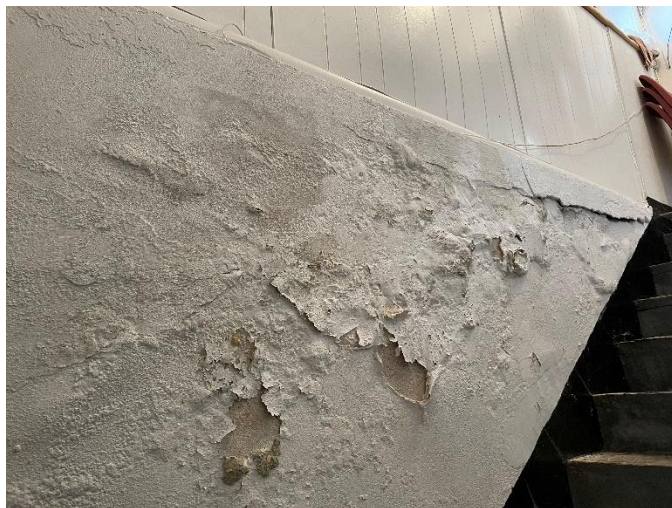
The surface of the stair wall into the tunnel is delaminating, apparently from moisture infiltration. See Photo CHAP-S2.

CHAP-S2: Moisture Damage at Tunnel Stair

This is like CHAP-S1. Moisture is most likely migrating through the wall. The exterior face of the wall most likely needs to be waterproofed. The probable project cost for this scope of work is \$27,000.

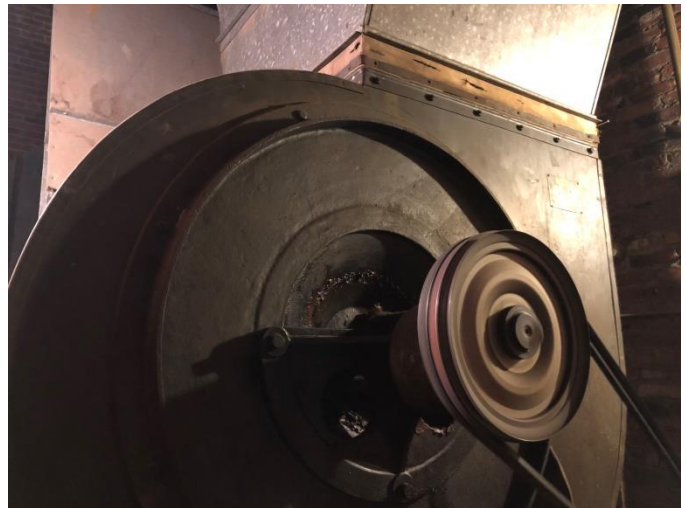
The HVAC system is composed of two original 1930s AHUs and perimeter steam finned tube with no controls. Since there is no control over the heating systems when the steam is on, it is hot in the CHAP; and the windows need to be opened on mild days to keep from overheating the CHAP. Chilled water was extended to the CHAP's basement in 2003, but has never been put to use. The AHUs are original from 1931, except for the fan motors, and each AHU has a steam-heating coil with no control either. See Photo CHAP-M1. The building's only source of ventilation air is from operable windows which are primarily used during mild weather conditions.

Photo CHAP-M1: Existing South AHU

CHAP-M1: HVAC System Replacement

The HVAC systems are between 40 years old (for the condensate return pump and the steam finned tube) and 90 years old (for the original AHUs). According to ASHRAE, most fans, coils, and pumps have a median service life of about 20 years. As a result, the existing equipment is operating beyond its expected useful life and needs to be replaced.

It is recommended to replace the existing HVAC equipment, clean and reuse ductwork where possible, and to upgrade the building to an electronic centralized BAS. The new AHUs will be provided with fan arrays which are composed of multiple direct drive fans which can automatically speed up to provide redundancy in the event that one fan should fail. The AHUs will also include MERV 13 filters and UV lights at the cooling coils to provide improved indoor air quality for the occupants. Working in a historic building also brings more challenges than normal so, extra time and coordination is anticipated. The number one request from the chaplain is to provide cooling to the chapel. This HVAC project would also fix the deficiencies for the hot floor issue in the sanctuary, the unsafe AHU access pathway issues at the stage, and the hot basement issue. The probable project cost for this scope of work is \$1,510,000.

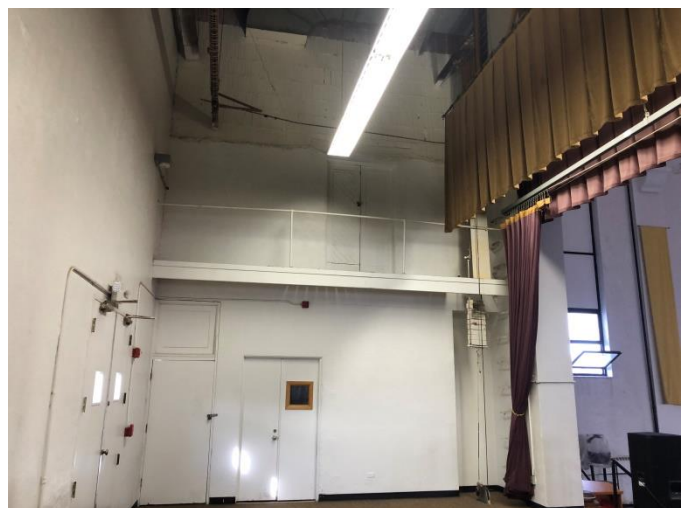
The AHUs exist on a mezzanine level which is about 12 feet above the stage and is accessed via an old ladder and wood catwalk system which do not meet current codes for safe access to mechanical equipment. See Photo CHAP-M2.

Photo CHAP-M2: Existing Access to AHUs

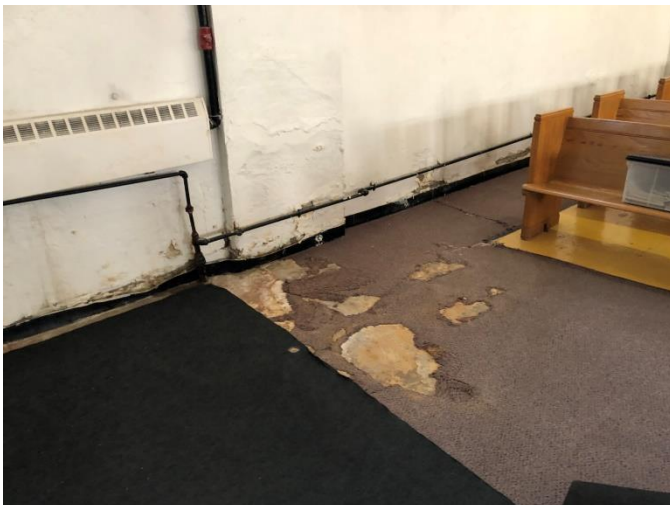
There is a leaking steam condensate pipe in the floor of the sanctuary near the north wall, which is causing the floor to be excessively hot. It is so hot that it has melted/vaporized the carpet, plus a rug that was then placed over the melted carpet. See Photo CHAP-M4.

Photo CHAP-M4: Melted/Vaporized Carpet and Rug

CHAP-A2: Full Carpet Replacement

The carpet in the entire chapel needs to be replaced. It is either bunching up or heavily damaged in just about every area of the building. The probable project cost for this scope of work is \$50,000.

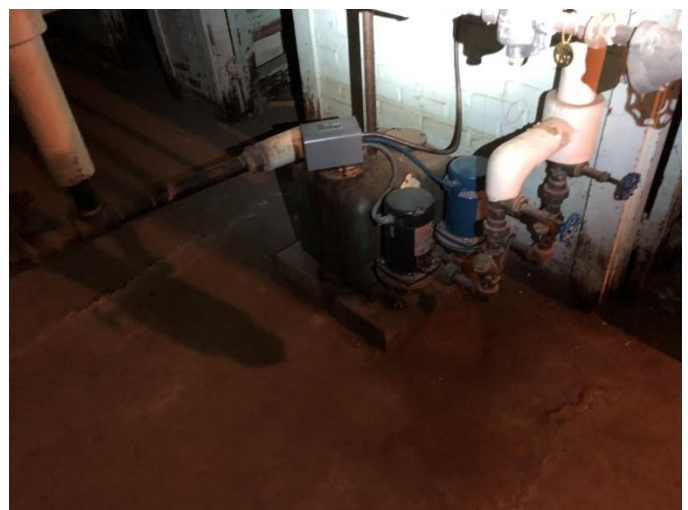
The basement is hot enough that you do not want to spend more than a couple of minutes down there, so those spaces are not usable when the steam system is on. It is hot because the steam service entrance is located there, and it has a steam condensate return pump. The condensate return pump has a receiver from 1981, but the pumps have been replaced over the years. The pumps cannot be insulated, but there is a lot of steam condensate piping that needs to be insulated. See Photo CHAP-M5.

Photo CHAP-M5: Existing Steam Condensate Return Pump

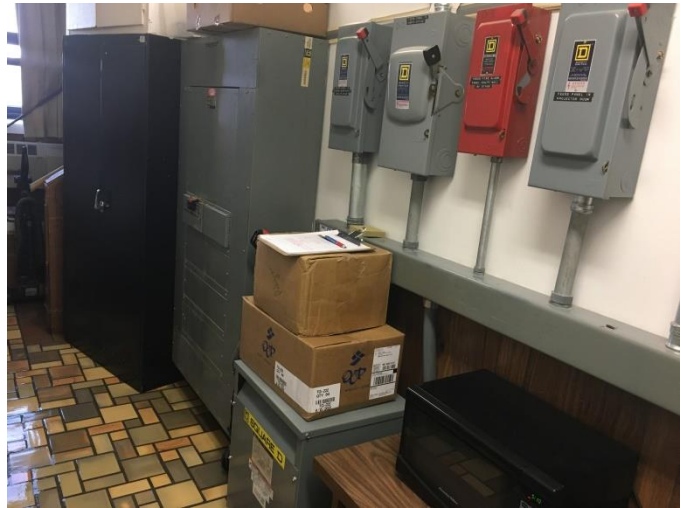
The main electrical panel is an older vintage-fused distribution panel. See Photo CHAP-E1. The branch circuit panels are older vintage as well and are serving beyond their useful service life and need to be replaced. Convenience receptacle mounting heights are not compliant with modern ADA standards.

Photo CHAP-E1: CHAP Electrical Service

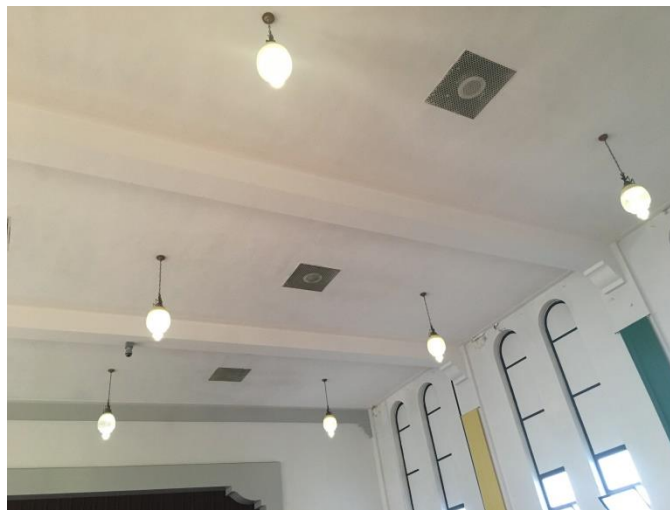
Lighting systems are a combination of incandescent and older fluorescent fixtures. The sanctuary has historic globe fixtures that should be retained, but re-wired and re-fitted with new sockets and LED bulbs. See Photo CHAP-E2. The remainder of the lighting has served beyond its useful service life and needs to be replaced. Emergency and exit lights appear to be newer vintage and are in serviceable condition.

Photo CHAP-E2: CHAP Sanctuary Lighting

CHAP-E2: Lighting System Replacement

Lighting throughout the building needs to be replaced. The original historic globes in the sanctuary should be retained and electrically updated with new wiring, sockets, and LED lamps. The probable project cost for this scope of work is \$453,000.

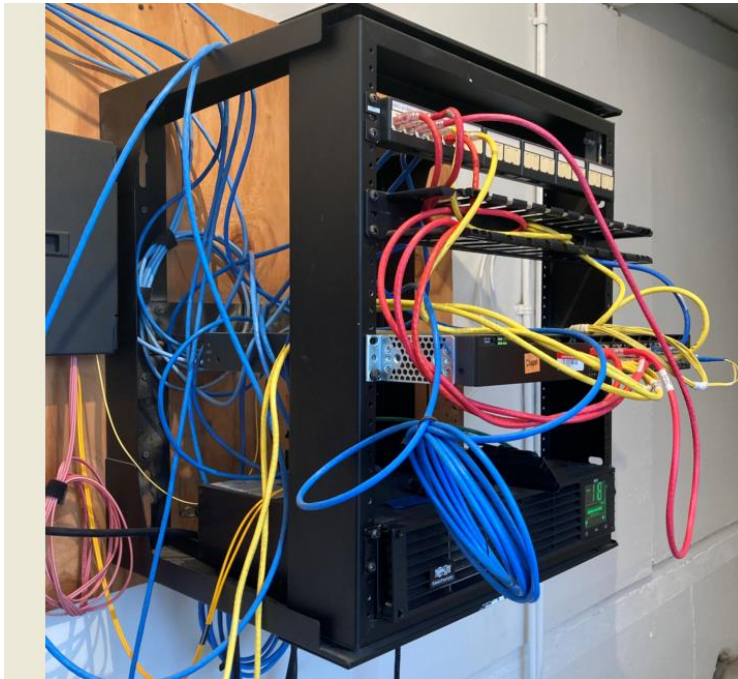
There is an existing wall-mount telecommunication rack located in Stairway 014 that serves data for the entire building. The building is served by a 24-strand, single mode fiber optic cable that runs back to the telecommunication rack located in the basement telecommunication room of the LAUN. The horizontal data cabling serving the building is all Category 6 copper cabling, which is in line with current industry standards for horizontal copper cabling. There is a UPS within the telecommunications rack that supports the telecommunication network. The telecommunications rack is not properly grounded per BICSI standards and is located in a stairwell that is open to the tunnels below.

Photo CHAP-T1: Existing Telecom Cabinet

The existing telecommunications rack is located in Stairway that is shared space to the tunnels below. BICSI standards recommend that telecommunications equipment cabinets should control against unauthorized access and in a controlled environment. It is recommended that the existing telecommunications wall mounted rack be relocated to a location where access to the rack can be secured and controlled. This will require the existing data cabling within the building to be re-done. Recommend building out a dedicated telecommunications room with proper security, cooling and grounding per BICSI standards. The probable project cost for this scope of work is \$110,000.

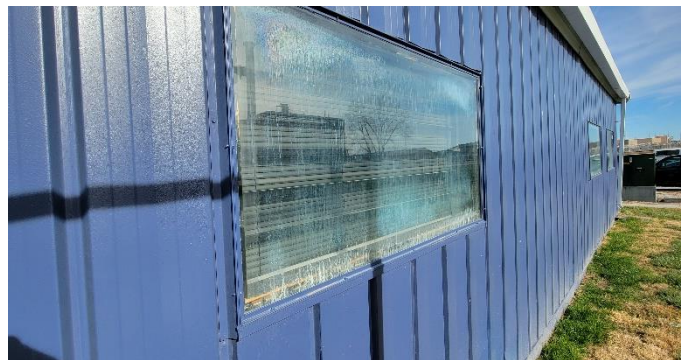
Photo CERT-A1: Typical Window at CERT

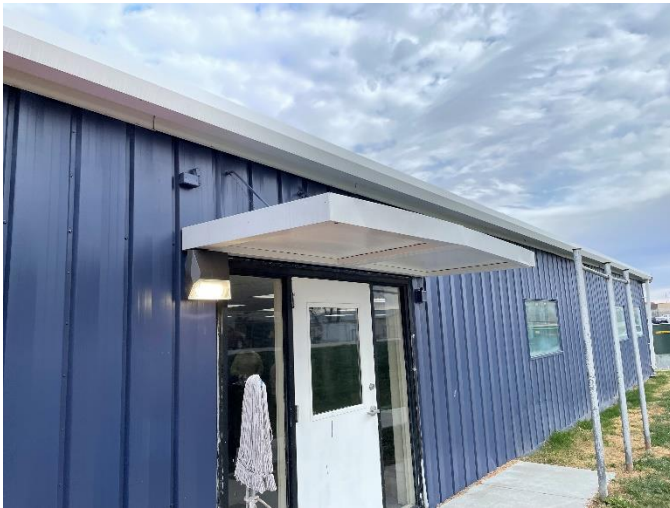
The building is a pre-engineered metal building manufactured by Armco. There is damage to canopy over the main door that appears to be from impact. There is also damage to the exterior metal wall panels at various locations around the building that also appear to be from impact.

Photo CERT-S1: Damaged Canopy

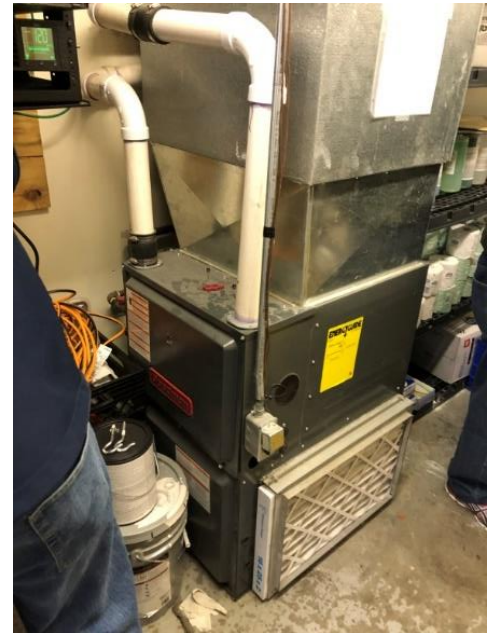
The furnace and ACCU are from 2012 which makes them about 9 years old. According to ASHRAE, furnaces and ACCUs have a median service life of about 15 to 20 years. As a result, the existing equipment still has useful life left in it.

Photo CERT-M2: Existing Gas Furnace Split System

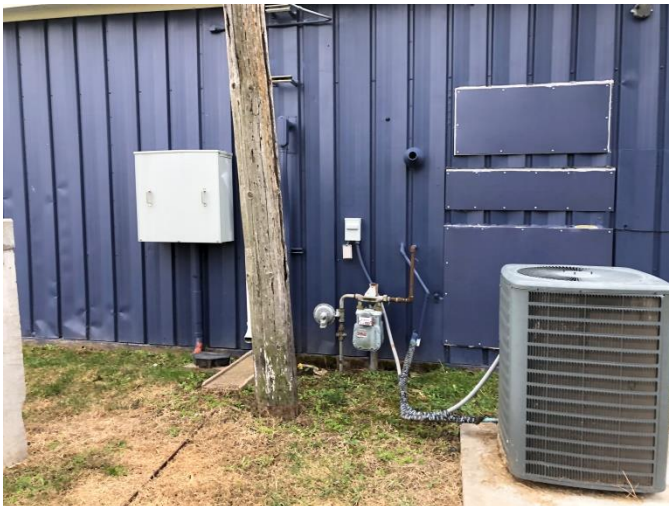
The ACCU is from 2012. See Photo CERT-M3. There is an outdoor air louver in the exterior wall for ventilation purposes, but it has been disconnected from the AHU's return air ductwork and is capped. As a result, the building does not have a source of ventilation air since the windows are not operable in this building.

Photo CERT-M3: Existing ACCU

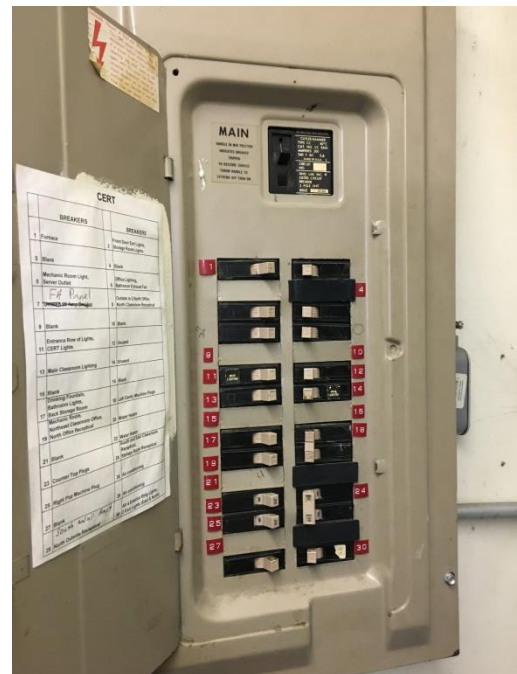
The main electrical panel is an older load center that likely dates to the original building construction. See Photo CERT-E1. Convenience receptacle mounting heights are not compliant with modern ADA standards.

Photo CERT-E1: Main Electrical Panel

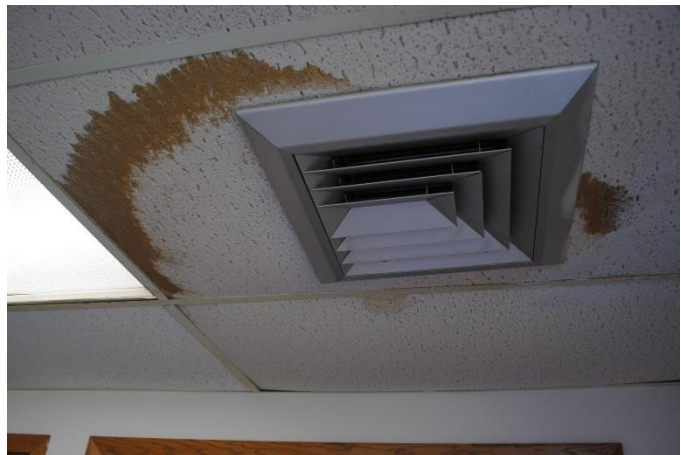
Photo EDU-A1: Typical Ceiling Stain in classroom

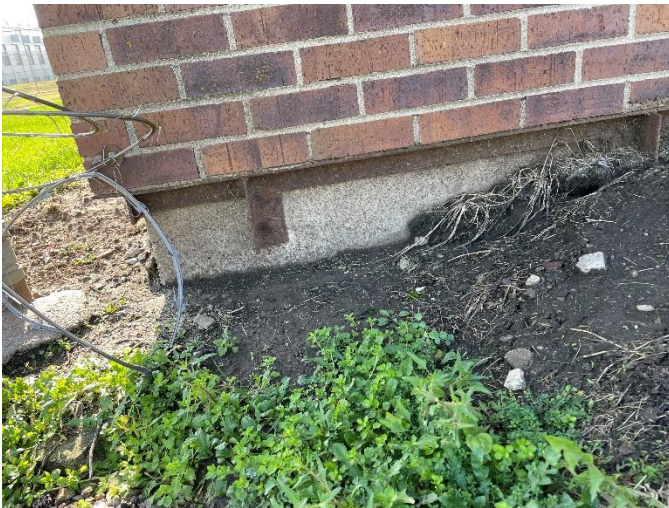
This building is a PEMB manufactured by Star. The exterior finish is metal wall panels with a brick wainscot. The brick appears to have been added to the exterior and is supported by a steel angle bolted to the foundation wall. See Photo EDU-S1.

Sealant at the top of the brick has failed and moisture is able to get between the brick and metal wall panels. There is also moisture infiltration in the brick sills at some windows. See Photo EDU-S2.

Photo EDU-S1: Brick Wainscot Supported by Steel Angle

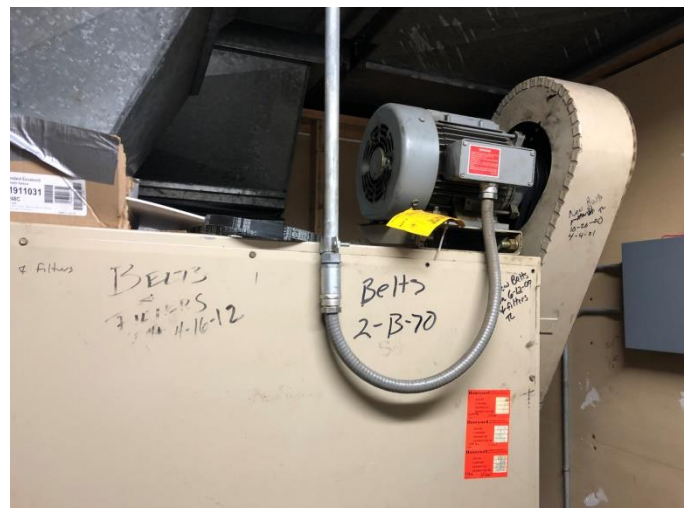
The HVAC system is composed of one AHU, a thermostat, above ceiling supply air ductwork serving ceiling diffusers, and one restroom exhaust fan. The AHU is original from 1981 and has a steam heating coil, as well as a chilled water cooling coil. See Photo EDU-M1. The cooling coil is noted as being replaced in 2012.

Photo EDU-M1: Existing AHU

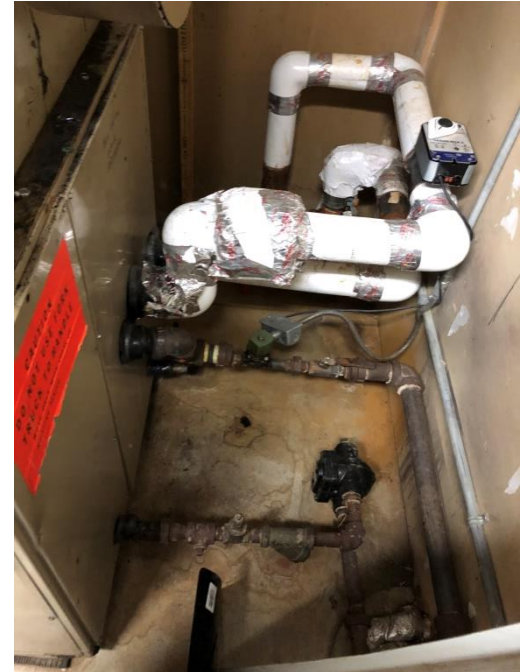
The piping serving the AHU is shown in Photo EDU-M2. The steam piping is missing all of its pipe insulation which makes the mechanical room hot in the winter.

Photo EDU-M2: Piping Connections to AHU

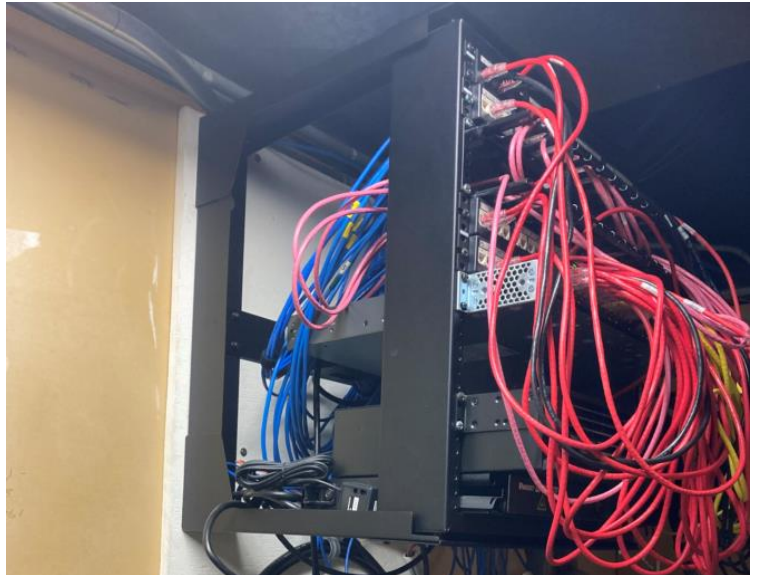
There is an existing wall mount telecommunication rack located in Mechanical 114 that serves data for the entire building. The building is served by a 24-strand, single mode fiber optic cable that runs back to the telecommunications rack located in the basement telecommunications room of the Laundry building. The horizontal data cabling serving the building is all Category 6 copper cabling, which is in line with current industry standards for horizontal copper cabling. There is a UPS within the telecommunications rack that supports the telecommunication network. The telecommunications rack is not properly grounded per BICSI standards.

Photo EDU-T1: Existing Telecom Cabinet

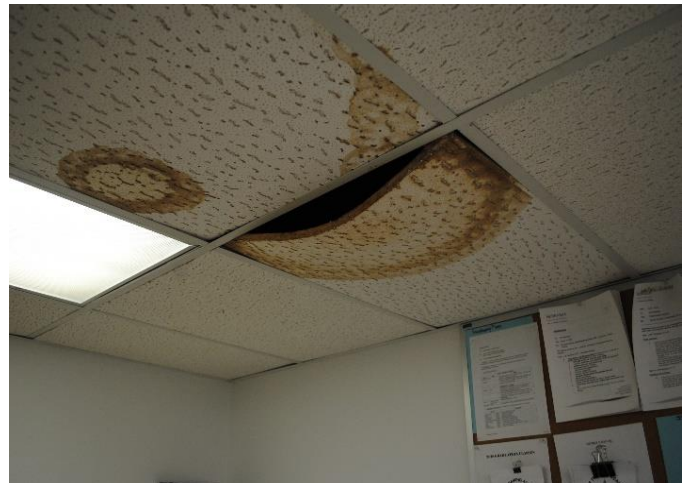
Photo FTO-A1: Typical Ceiling Stain

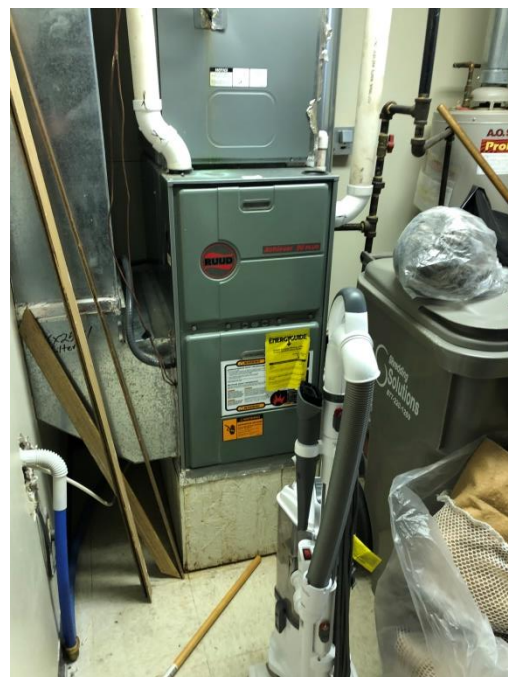
According to ASHRAE, furnaces and ACCUs have a median service life of about 15 to 20 years. As a result, the existing furnace still has useful life left in it, but the ACCU is at the end of its useful life.

Photo FTO-M2: Existing Gas Furnace Split System

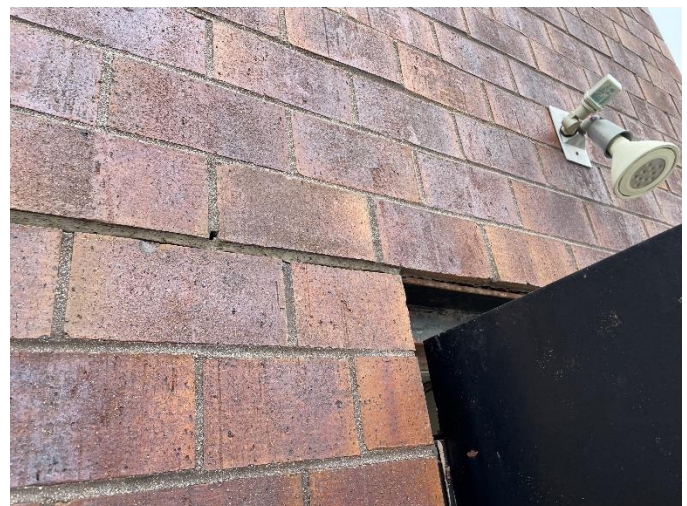
GT1 is a CMU and brick structure with cast-in-place concrete floors and intermediate landings. There were no noted structural items of concern; however, there are locations where sealant needs to be replaced.

Photo GT1-S1: Failed Sealant

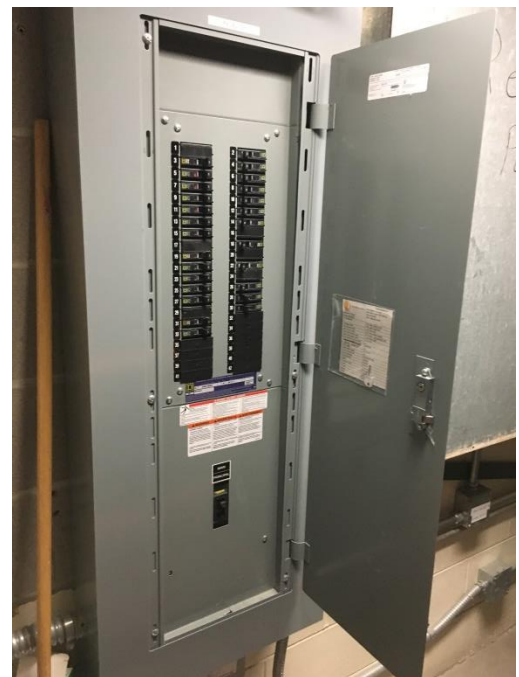
Power distribution equipment within this tower is relatively new and in good working condition. See Photo GT1-E1. Convenience receptacle quantities are fewer than what should be available for the occupancy and use of the tower. Convenience receptacle mounting heights are not compliant with modern ADA standards.

Photo GT1-E1: Existing Electrical Panel

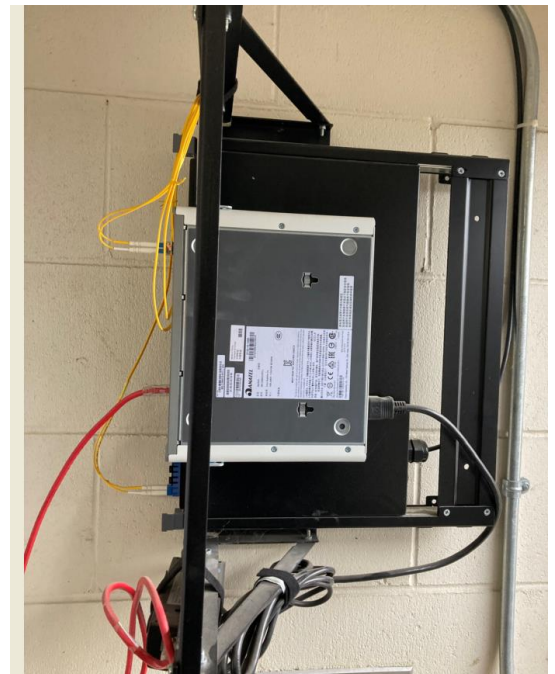
There is an existing wall mount telecommunication rack located on the lower at the front entry way that serves data for the entire guard tower. There is an existing fiber optic cable that serves the guard tower; however, it is unknown what building this fiber optic cabling runs back to. The telephone in the guard tower control room is served from existing copper backbone lines running to the guard tower. The existing copper lines do not have protectors on them when entering the building. This guard tower has not been updated like GT4, 5, 6, and 8 were with new fiber optic cabling, telecom rack, and new horizontal data cabling.

Photo GT1-T1: Existing Telecom Cabinet

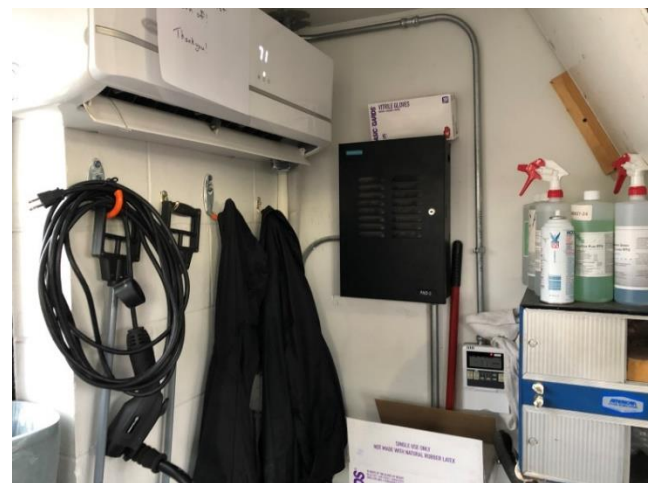
The HVAC system is composed of three ductless split systems. Each ductless split system has an indoor fan coil, an outdoor air-source heat pump, and one stand-alone thermostat. See Photos GT2-M2 and GT2-M3. The first fan coil is located in the ceiling of the tower, the second one is on the middle level, and the third one is located down at the entry level. The thermostat for the entry level fan coil is installed too close to the fan coil and the guards say it cycles off too quickly. Ventilation air is provided via operable windows. The ductless split systems are all brand new this year.

Photo GT2-M2: Existing Wall Mounted Fan Coil

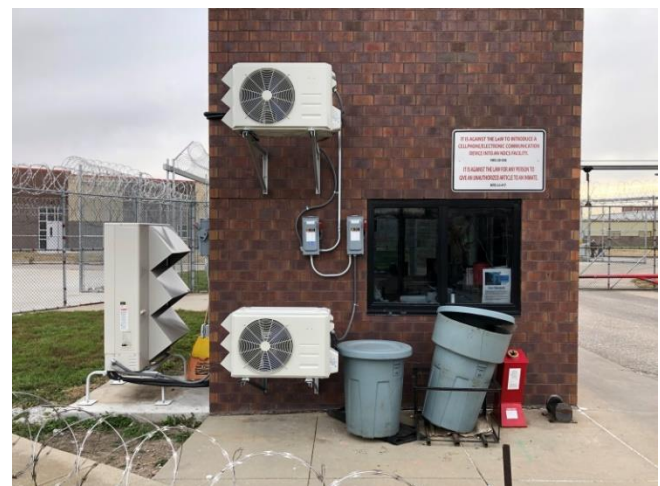
Photo GT2-M3: Existing Air-Source Heat Pump

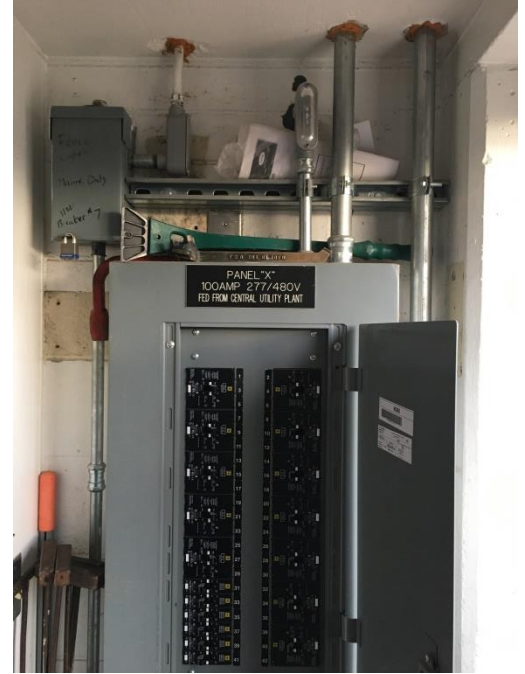
Power distribution equipment within this tower is relatively new and in good working condition. See Photo GT2-E1. Convenience receptacle quantities are fewer than what should be available for the occupancy and use of the tower. Convenience receptacle mounting heights are not compliant with modern ADA standards.

Photo GT2-E1: Existing Electrical Panel

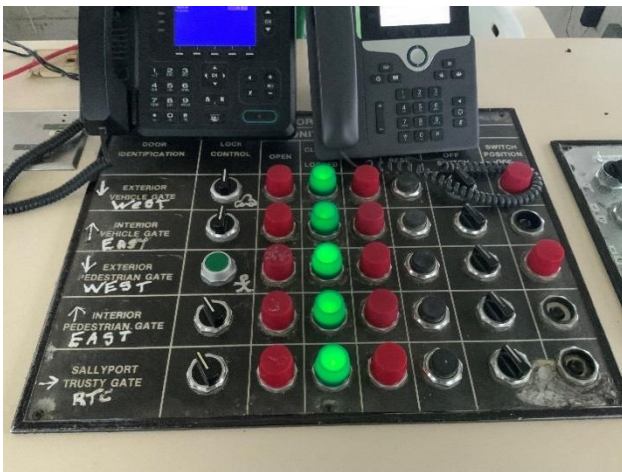
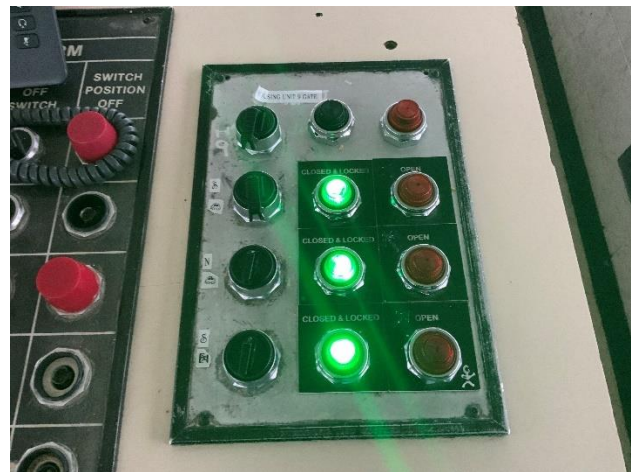
GT2 control room is responsible to observe and control movement through the West vehicle sallyport. There are two control panels that are remotely controlling, and monitoring vehicle and pedestrian gates located beneath the GT2. The smaller of the two panels controls four vehicle gates associated with entrance to HU9. Control panels consist of rotary switches and old type LED indicators installed on composite board (plastic/steel) with text engraved on their surface. Both panels are desk mounted. The existing gates are hard wired into door control relays and switches that are installed in the wall mounted enclosure. The enclosure is installed on the wall one level below the tower control room. All door control panel components are using very old technology.

Photo GT2-SEC1: GT2 Control Panels

The existing control panels are in very bad shape. There are some missing/broken rotary switches. The door control technology used to control and monitor existing field devices is obsolete and does not provide any flexibility necessary to provide more secure and efficient system.

The replacement of the existing control panels and the existing relays should be considered as a high priority considering the age and present condition of the existing door control equipment. The new door control system shall consist of a single PLC and touch screen control station. New PLC based head-end equipment (included but not limited to CPU, Ethernet communication modules, I/O modules, power supplies, relays, etc.) shall be provided in place of the existing relay-based equipment (existing wall mounted enclosure may remain in use). All new electronic security system head-end equipment and TS shall communicate over the new security system network.

New touch screen (TS) control station is recommended for the GT2 Control Room. New intercom stations and camera coverage of the gates currently controlled by the local panels is recommended. New TS control station should be provided with the capability to transfer control to the Master Control Room. The probable project cost for this scope of work is \$21,000.

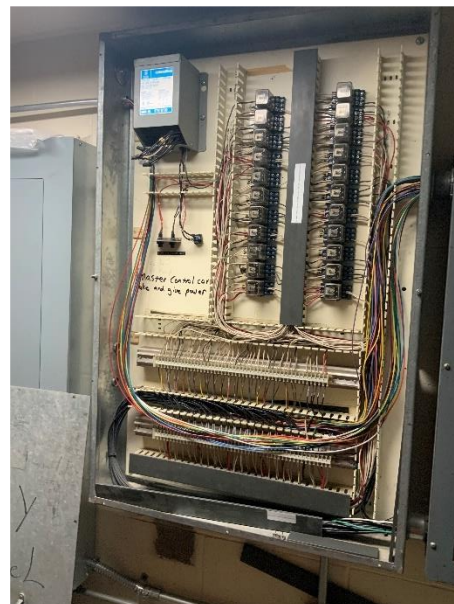
Photo GT2-SEC2: GT2 Gate Control Relays, Wire Termination Blocks, and Power Supply

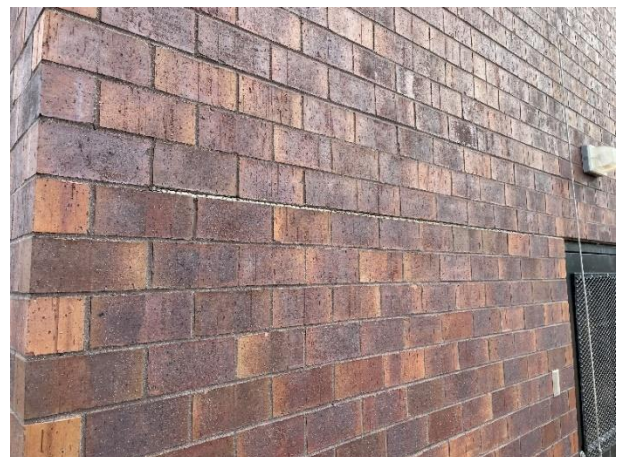
GT3 is a CMU and brick structure with cast-in-place concrete floors and intermediate landings. There were no noted structural items of concern; however, there are locations where sealant needs replaced.

Photo GT3-S1: Failed Sealant

Failed sealant requires removal and replacement to maintain envelope integrity. The probable project cost for this scope of work is \$2,000.

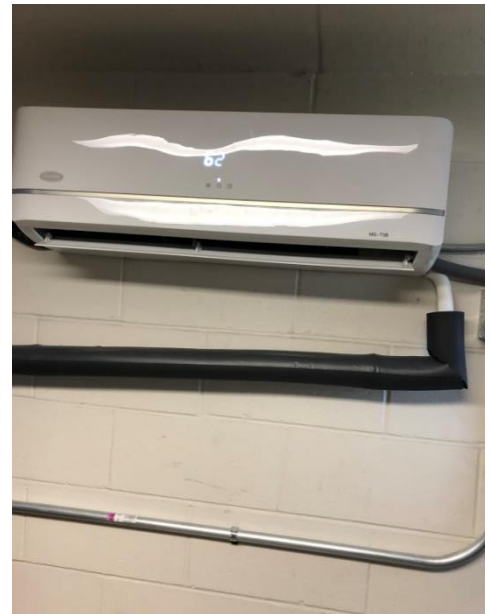
The HVAC system is composed of two ductless split systems. Each ductless split system has an indoor fan coil, an outdoor air-source heat pump, and one stand-alone thermostat. One fan coil is located in the ceiling of the tower and the other one is located down at the entry level near the door. The fan coil located at the entry level is shown in Photo GT3-M1. Ventilation air is provided via operable windows. The ductless split systems are both brand new this year.

Photo GT3-M1: Existing Wall Mounted Fan Coil

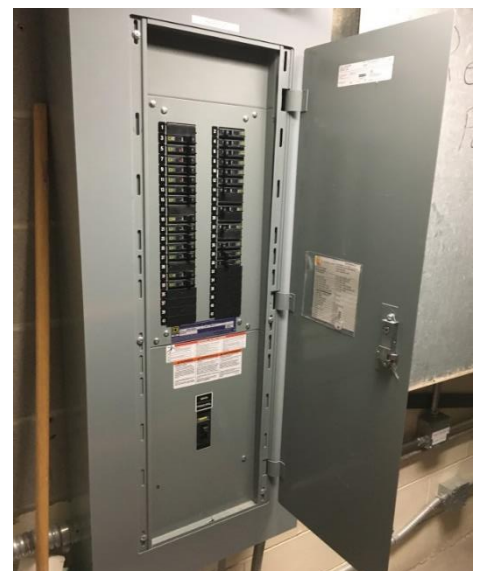
Power distribution equipment within this tower is relatively new and in good working condition. See Photo GT3-E1. Convenience receptacle quantities are fewer than what should be available for the occupancy and use of the tower. Convenience receptacle mounting heights are not compliant with modern ADA standards.

Photo GT3-E1: Existing Electrical Panel

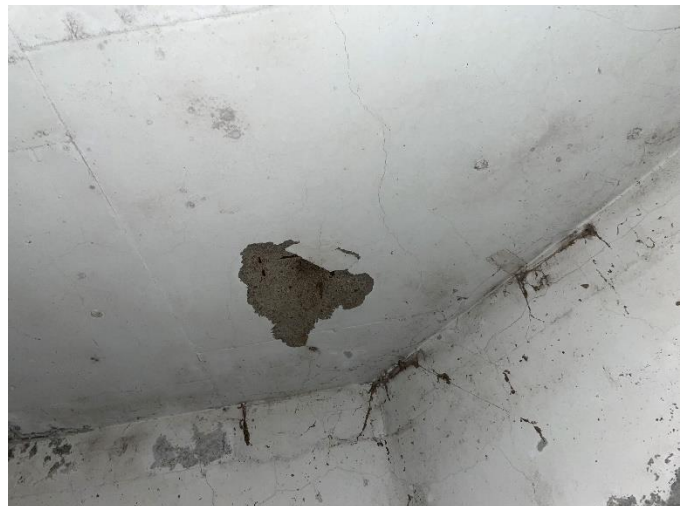
GT4 is a concrete structure. Spalling is present in small areas on the bottom of the observation level floor.

Photo GT4-S1: Spalled Slab

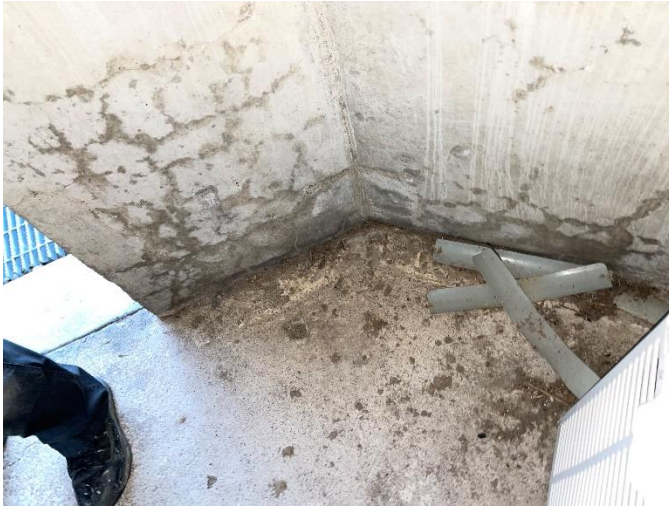
Photo GT4-S2: Map Cracking

Areas of map cracking were present in several locations on the tower.

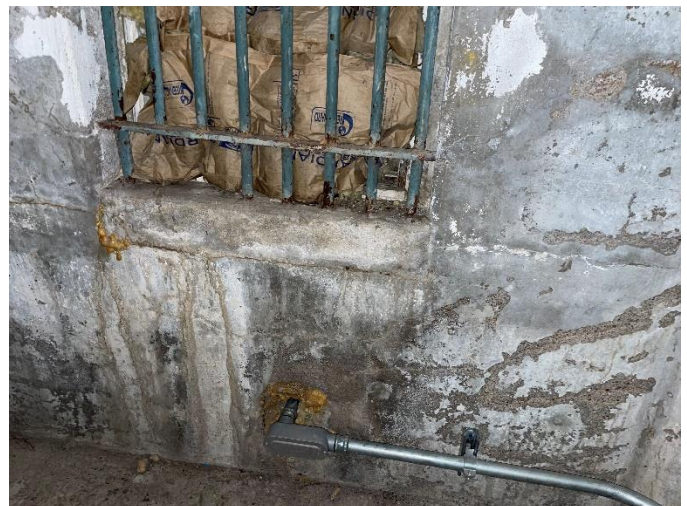
Photo GT4-S3: Concrete Deterioration at Window

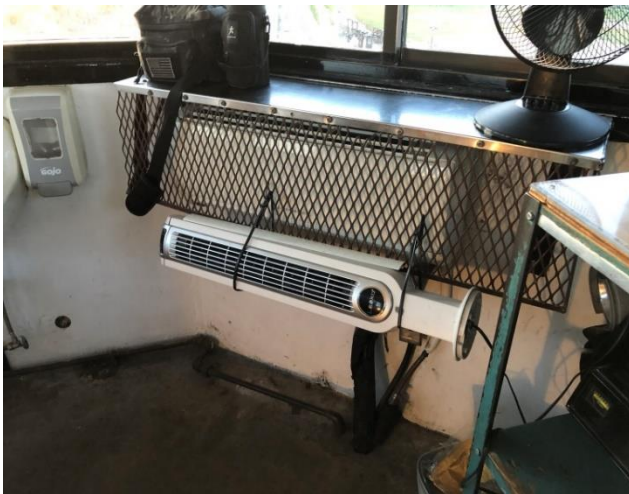
The HVAC system is composed of one ductless split system and a natural gas unit heater. The ductless split system has an indoor fan coil, an outdoor air-source heat pump, and one stand-alone thermostat. The fan coil is installed low on a sidewall of the tower as shown in Photo GT4-M1. This system had problems working this summer until it stopped working all together in June of this year. Before it stopped working the guards tied up a fan to help distribute the air from the fan coil as can be seen in the photo. Ventilation air is provided via operable windows.

Photo GT4-M1: Existing Wall Mounted Fan Coil

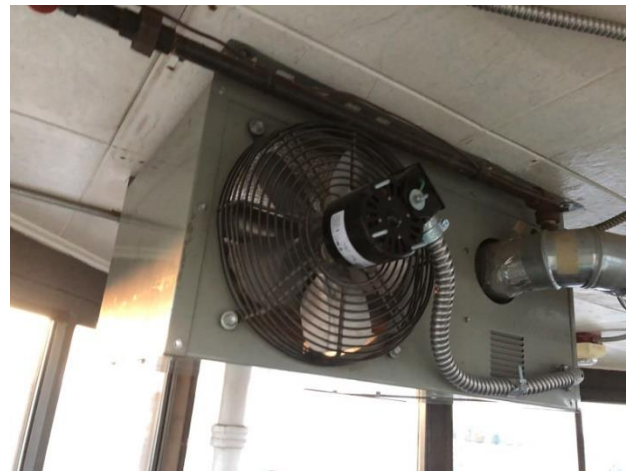
The gas unit heater was installed in the last ten years or so, but it produces too much heat. The gas unit heater as shown in Photo GT4-M2 delivers hot air in a very directional pattern so, it can overheat one side of GT4 and under heat the other side. As a result, the guards only use this on either very cold days or when the fan coil fails.

Photo GT4-M2: Existing Gas Unit Heater

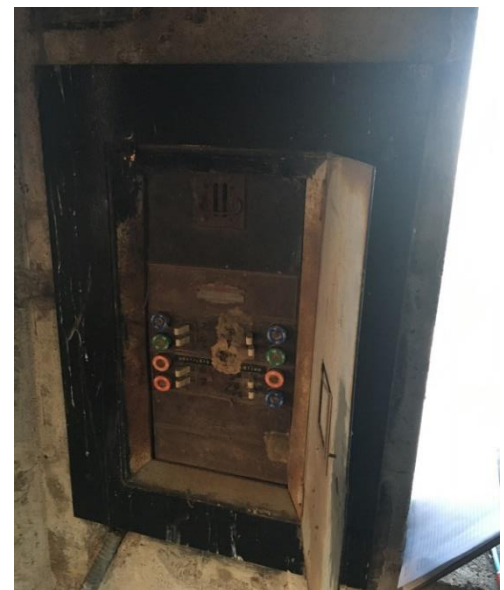
Power distribution equipment within this tower is in very poor condition and is serving well beyond its useful service life and needs to be replaced. The electrical panel was observed to have a wasp nest inside the front cover. See Photo GT4-E1. The equipment manufacturer, Frank Adam, has long since ceased to be in business. Any failure of equipment would require replacement parts that, if available, are only found on the secondary market. This particular equipment is well-known for developing dangerous electrical problems throughout its lifetime. Convenience receptacles are fewer quantities than what should be available for the occupancy and use of the tower. Convenience receptacle mounting heights are not compliant with modern ADA standards.

Photo GT4-E1: Existing Electrical Panel

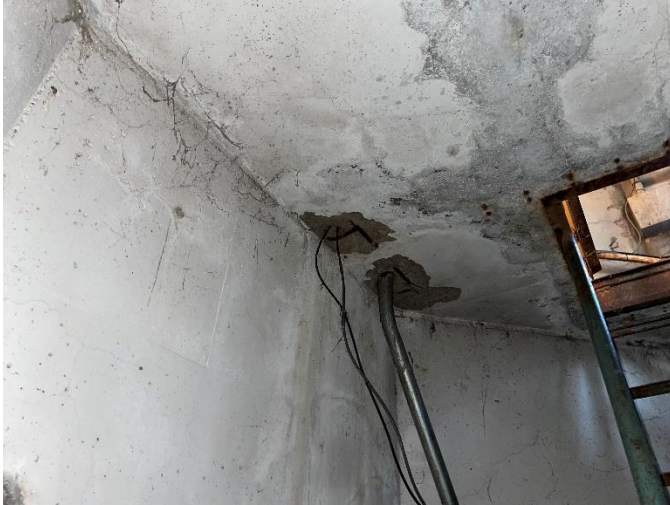
GT5 is a concrete structure. Spalling is present in small areas on the bottom of the observation level floor where utilities were run through the floor. Random cracking is present at various locations on the tower walls and observation level. Additionally, concrete has spalled from the bottom of the beam located at the edge of the intermediate landing exposing the reinforcing.

Photo GT5-S1: Spalled Concrete

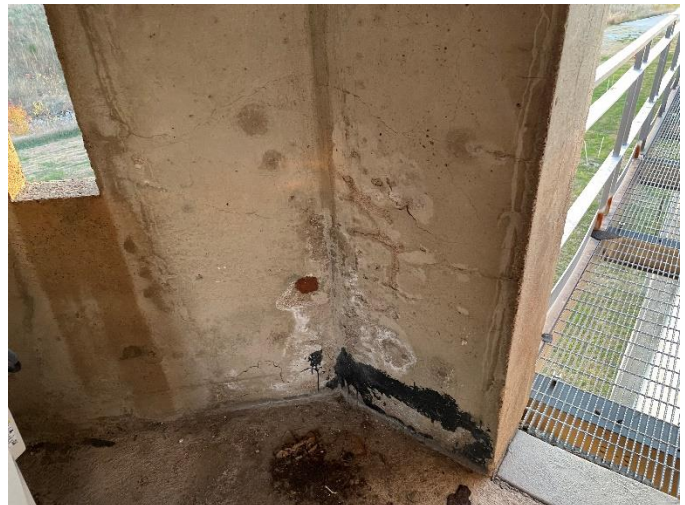
Photo GT5-S2: Random Cracking

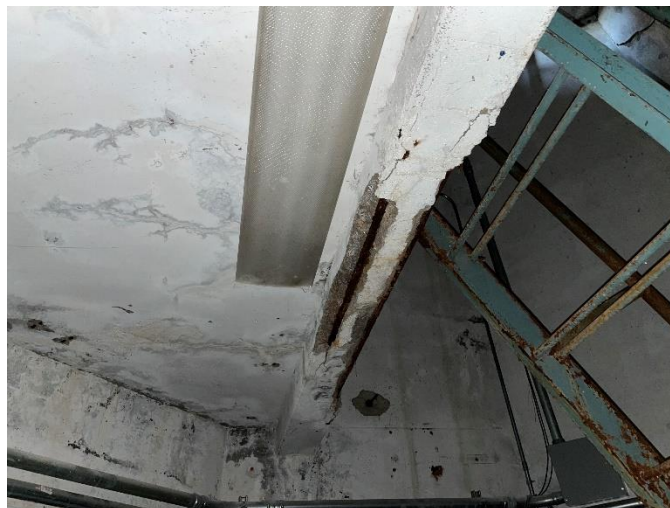
Photo GT5-S3: Spalled Concrete Beam

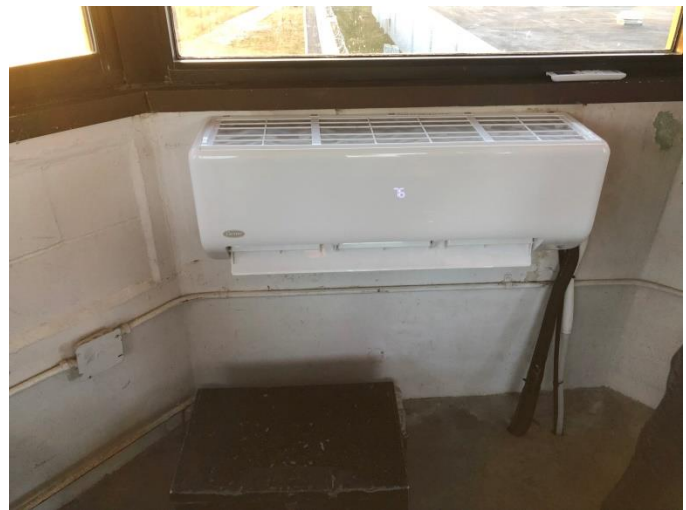
The HVAC system is composed of one ductless split system and a natural gas unit heater. The ductless split system has an indoor fan coil, an outdoor air-source heat pump, and one stand-alone thermostat. The fan coil is installed low on a sidewall of the tower as shown in Photo GT5-M1. Ventilation air is provided via operable windows. The ductless split system is brand new from this summer.

Photo GT5-M1: Existing Wall Mounted Fan Coil

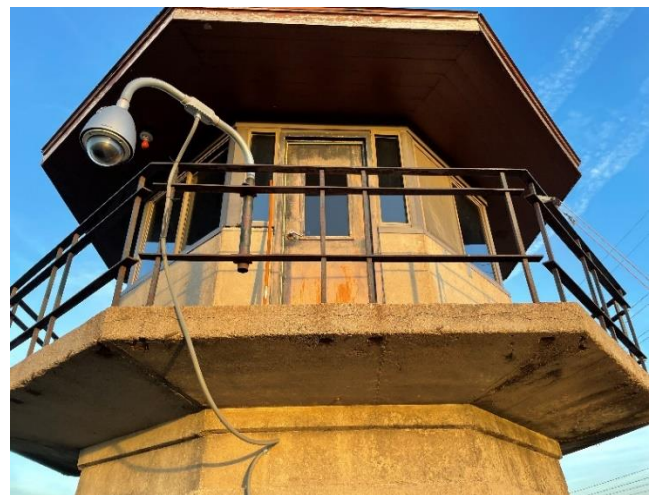
GT6 is a concrete structure. Spalling is present in random areas on tower walls.

Photo GT6-S1: Cracked/Spalled Concrete at Slab Edge

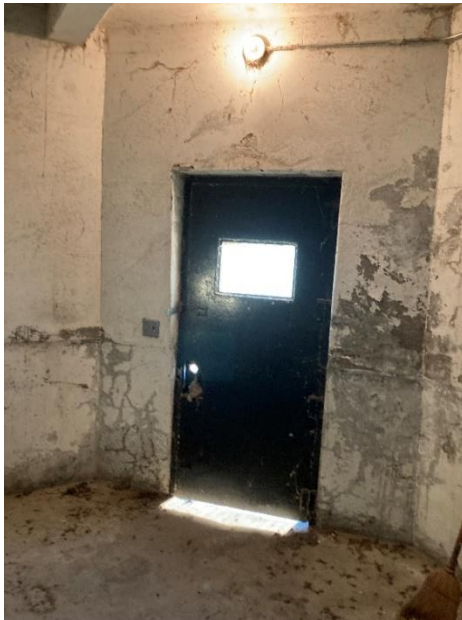
Similar to the previous towers, map cracking is present in portions of the tower walls. See Photo GT6-S2.

Photo GT6-S2: Map Cracking in Walls

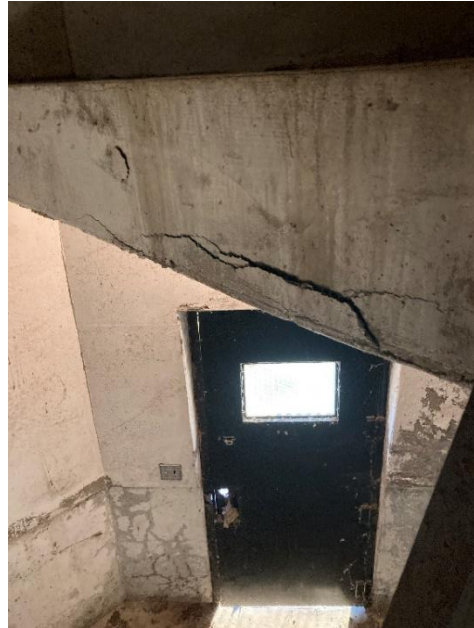
Spalling is present at the bottom of the concrete beam at the edge of the intermediate landing. See Photo GT6-S3.

Photo GT6-S3: Spalled Concrete Beam

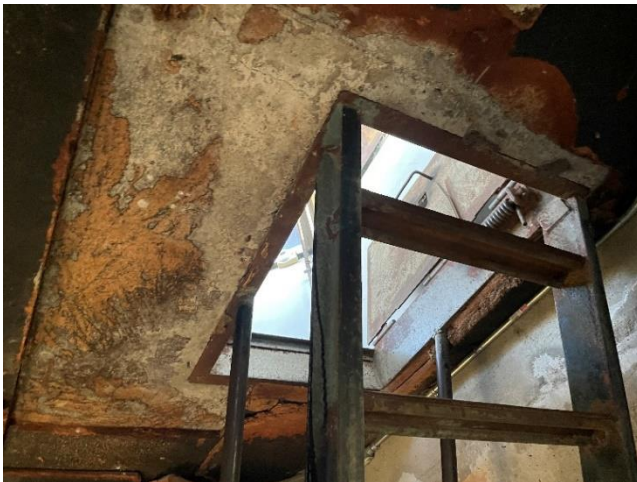
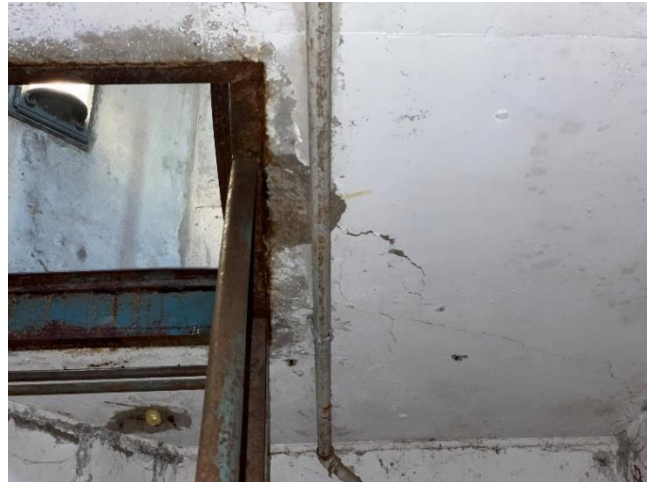
Concrete around the floor hatches is spalling and deteriorated. See Photo GT6-S4.

Photo GT6-S4: Deteriorated Concrete at Floor Hatches
