Nebraska State Penitentiary Useful Life Engineering Study

Lincoln, Nebraska

Alvine No. 2021 8777
January 2022

Prepared for:
State of Nebraska
Department of Correctional Services
Lincoln, Nebraska

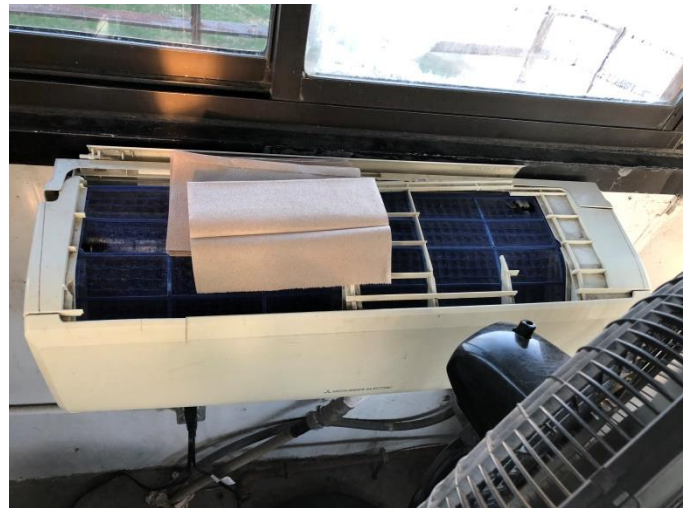
The HVAC system is composed of one ductless split system and a natural gas unit heater. The ductless split system has an indoor fan coil, an outdoor air-source heat pump, and one stand-alone thermostat. The fan coil is installed low on a sidewall of the tower as shown in Photo GT6-M1. Ventilation air is provided via operable windows.

Photo GT6-M1: Existing Wall Mounted Fan Coil

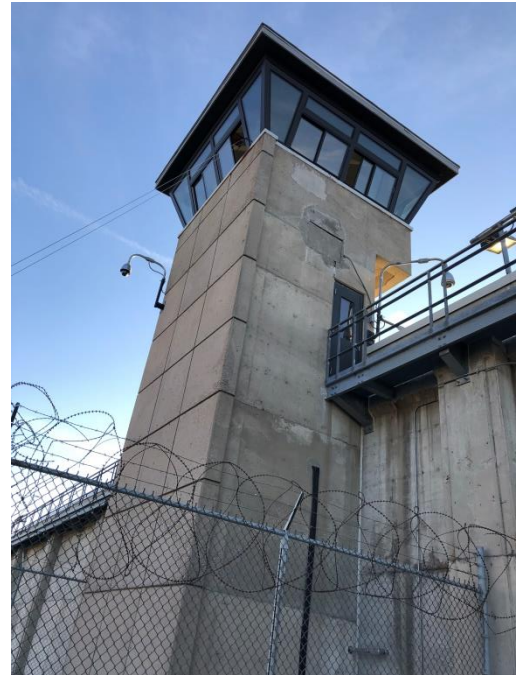
The tower is a solid concrete building with aluminum frame windows at the guard station. The lower portion of the tower is open air with no windows or doors. The roof is asphalt shingles and needs to be replaced. It was noted that there are several cracks in the wall that have been filled with caulk. There is a wood soffit and trim under the overhang of the roof over the windows. The tower ties into the concrete wall that forms a portion of the secure perimeter.

Photo GT8-1: Guard Tower No. 8

GT8 is a concrete structure. A previous opening had been infilled, as seen above the door in photo GT8-1 above. The landing at the walkway level is deteriorated.

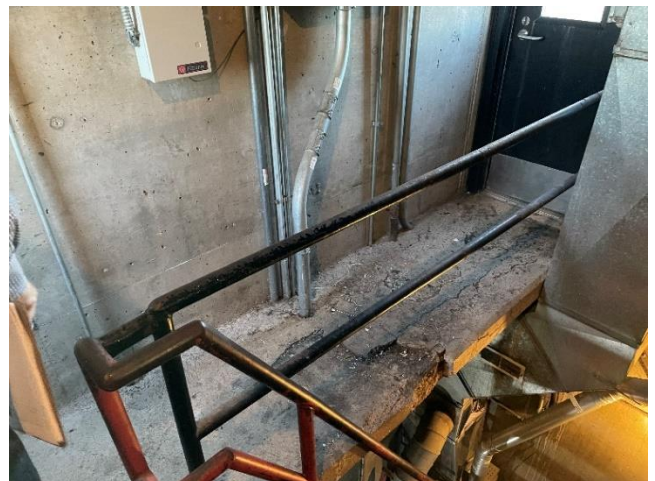
Photo GT8-S1: Deteriorated Walkway Landing

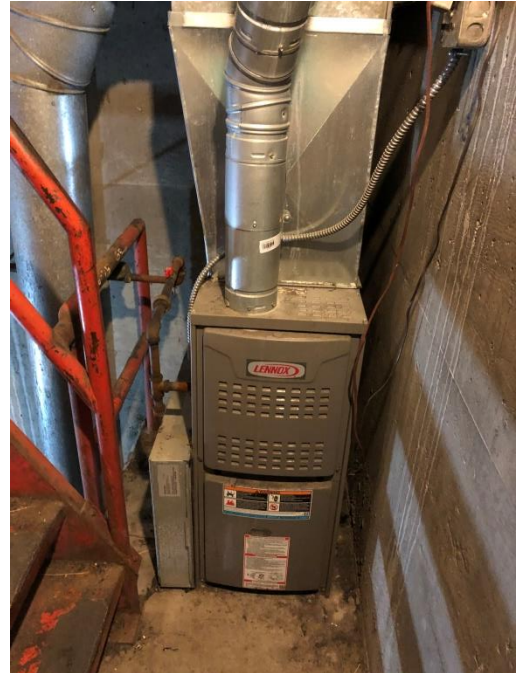
The HVAC system is composed of two furnace split systems. Each furnace split system has an indoor natural gas furnace, an outdoor Air-Cooled Condensing Unit (ACCU), and one stand-alone thermostat. One furnace is located on a stair landing at mid-height of the tower with supply air ductwork serving floor mounted registers at the observation level and the other one is located down at the entry level near the door. The furnace located at the mid-height level is shown in Photo GT8-M1. Ventilation air is provided via operable windows.

Photo GT8-M1: Existing Gas Furnace

GT8-M1: HVAC System Replacement

The furnace split systems are both about 20 years old. According to ASHRAE, most fans and coils have a median service life of about 20 years while the heat pump has a median service life of about 15 to 20 years. As a result, the existing equipment is operating beyond its expected useful life. It is recommended to replace the furnace split systems with two new ductless air-source heat pump split systems. One system would be located at the upper tower level and the other near the ground level. The probable project cost for this scope of work is \$23,000.

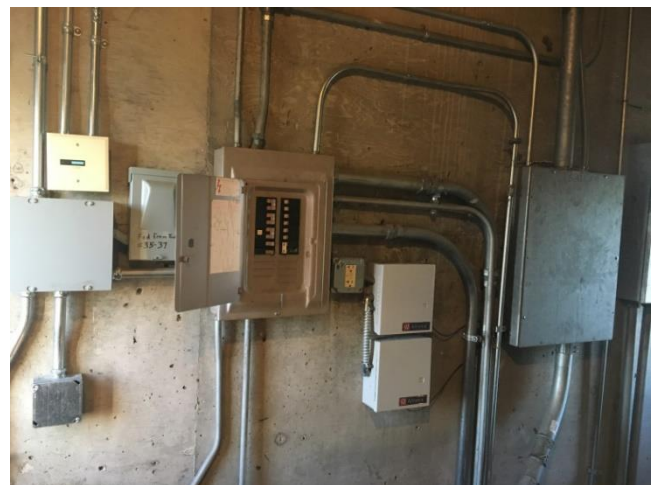
Power distribution equipment within this tower is in fair condition and is serving beyond its useful service life. See Photo GT8-E1. The distribution equipment needs to be replaced. The electrical panels are load center construction which is not suitable for long-term use in a prison. Convenience receptacles are fewer in quantity than what should be available for the occupancy and use of the tower. Convenience receptacle mounting heights are not compliant with modern ADA standards.

Photo GT8-E1: Electrical Equipment

GT8-E1: Power Distribution System Replacement

The power distribution system is serving beyond its useful service life and needs to be replaced. The probable project cost for this scope of work is \$65,000.

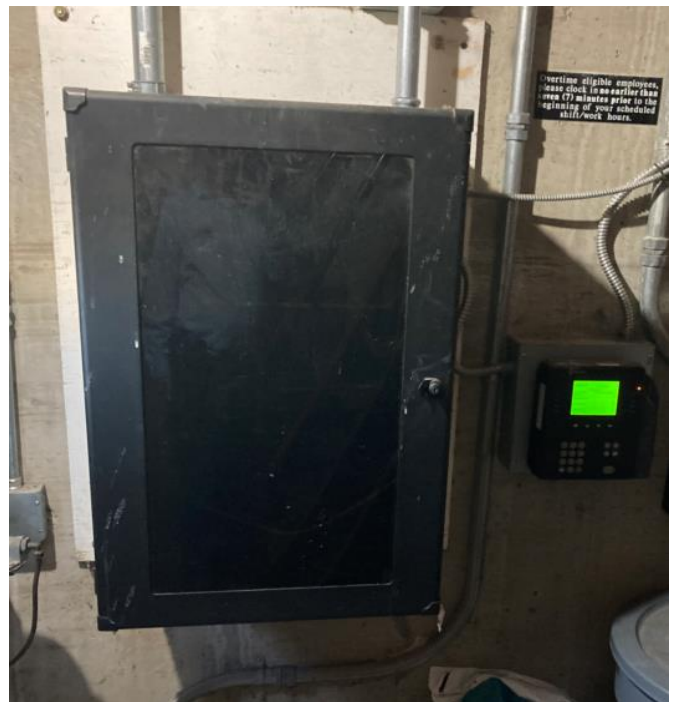
Photo GT8-T1: Existing Telecom Cabinet

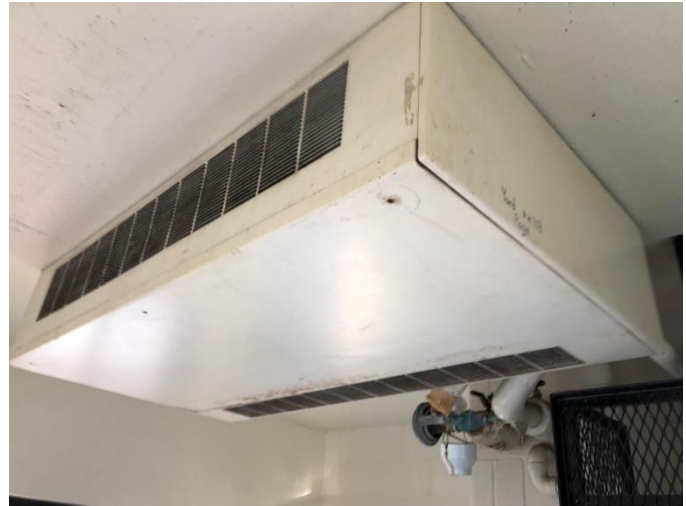
The HVAC system is composed of chilled water fan coil and perimeter heating hot water finned tube. The fan coil is shown in Photo GT10-M1. The finned tube stopped working many years ago so, an electric space heater was installed and still functions. Ventilation air is provided via operable windows.

Photo GT10-M1: Existing Ceiling Mounted Fan Coil

GT10-M1: HVAC System Replacement

The hydronic fan coil unit and finned tube system is about 40 years old. According to ASHRAE, most fans and coils have a median service life of about 20 years. As a result, the existing equipment is operating beyond its expected useful life. It is recommended to replace the existing equipment with a new ductless air-source heat pump split system. The probable project cost for this scope of work is \$11,600.

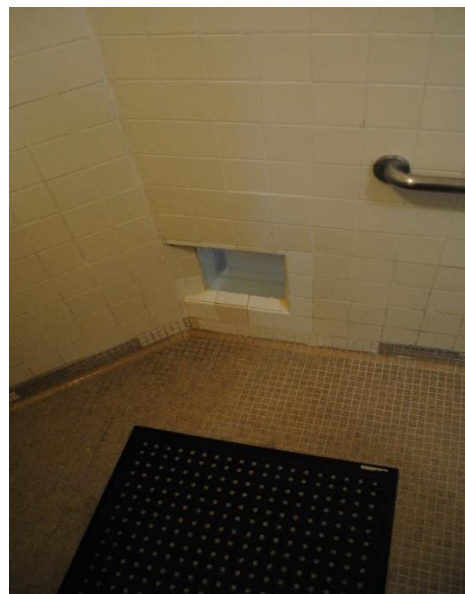
The interior of these units is all hard surfaces with CMU walls, VCT floors, and hard lid gypsum board ceilings. There are several areas with exposed sprinkler piping which is deteriorating and needs to be replaced. The showers are 1x1 tile on the floors with 4x4 subway tile on the walls and show significant amounts of damage. All the interior doors are painted security hollow metal doors. The control stations have millwork that needs to be replaced.

Photos HU1-5-A2-A3: Typical
Shower

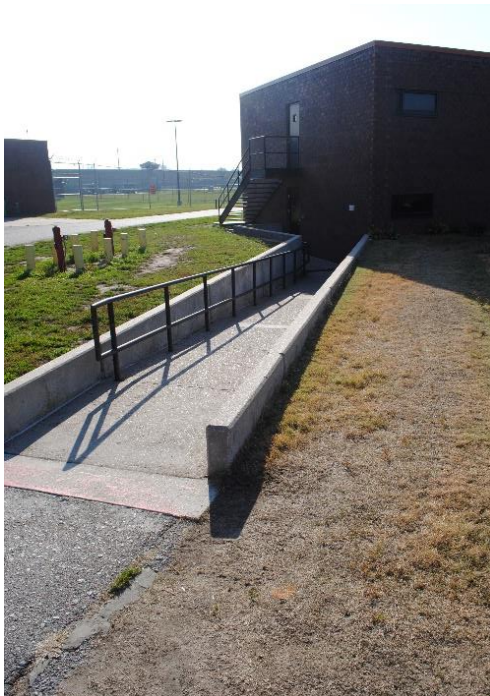
HU1 through HU4 were built pre-ADA. However, HU5 was built in 1993 just after the ADA was signed into law. None of these units meet ADA. The typical main entry is at a landing at the midpoint between the lower and upper galleries necessitating stairs to any housing level. At HU1, a ramp was cut into the grade that accesses the end of the lower gallery on the southeast wing of the unit. While this does provide ADA access to the building, there are no ADA compliant cells or showers. The facility has added grab bars and accommodations as best they can within the spaces that they have, but they still do not meet current standards. HU5 has similar issues.

Photo HU1-5-A1: ADA Ramp to HU-1

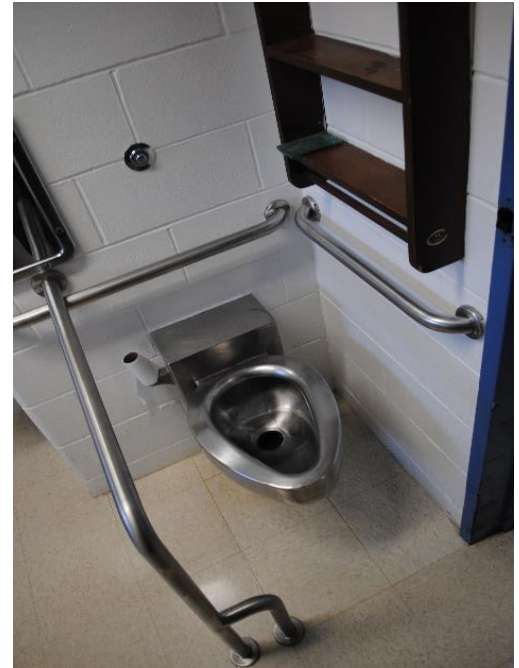
**Photo HU1-5-A4: Typical non-compliant
ADA Modifications for Inmate Cell**

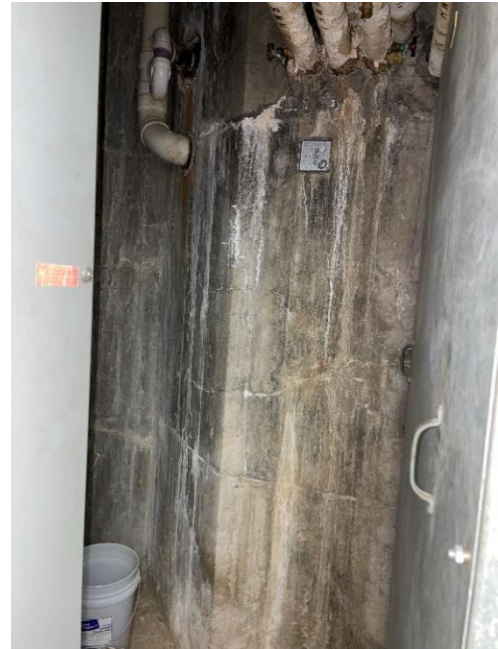
HU1 is concrete slab structure supported by concrete masonry (CMU) bearing walls above grade and concrete walls below grade. Narrow cracks were present in a small area of the lower-level mechanical room basement walls. There is staining indicating moisture has passed through these joints.

Photo HU1-5-S1: Cracks in Mechanical Room Wall

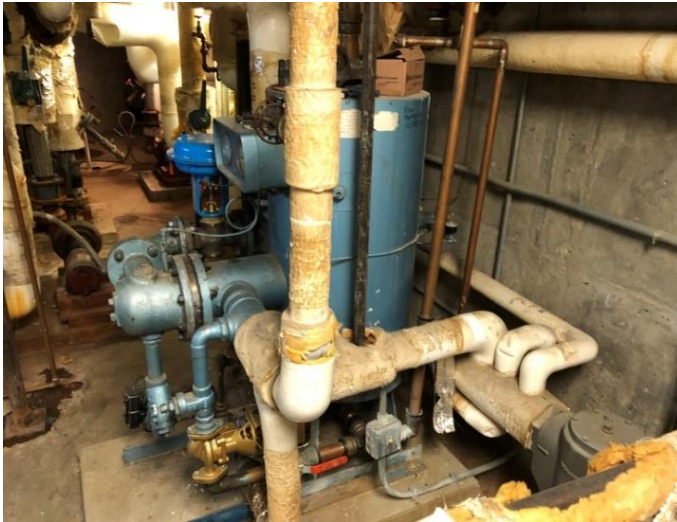
A steam water heater exists in the basement which is original from 1981. See Photo HU1-5-M1. The water heater has a pneumatic steam control valve which serves a steam tube bundle in this water tank. There is only one tube bundle in this water heater so, there is no redundancy in the case of equipment failure.

Photo HU1-5-M1: Existing Steam Water Heater

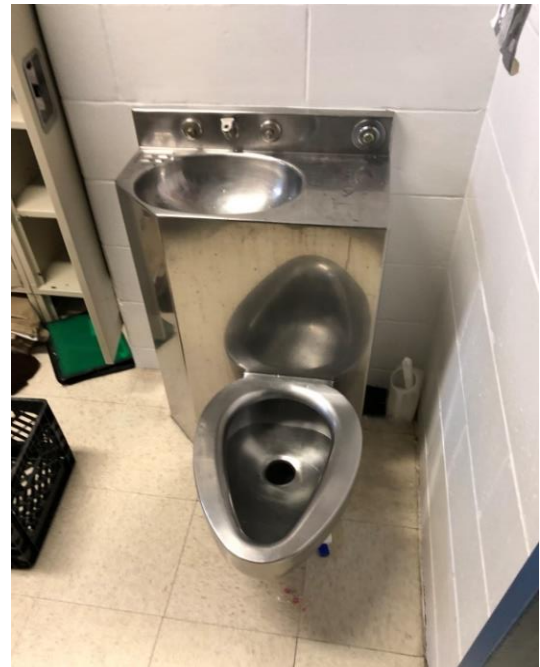
The plumbing fixtures are original from 1981. See Photo HU1-5-M2 for typical plumbing fixtures. This building was built before the EPAct of 1992 and before ADA so, the plumbing fixtures, flush valves, and shower heads are operating beyond their useful life and not conforming to modern water flow rates or ADA requirements. For a discussion on ADA issues, see architectural.

Photo HU1-5-M2: Existing Security Plumbing Fixtures

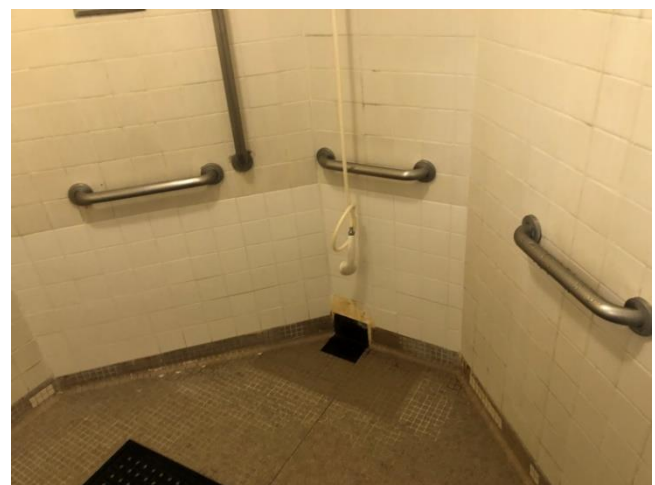
The inmate showers have problems with water drainage. See Photo HU1-5-M3. The water then leaks into the adjacent security guard office. The sanitary piping is likely corroding and getting plugged up.

Photo HU1-5-M3: Existing Shower Floor Drains

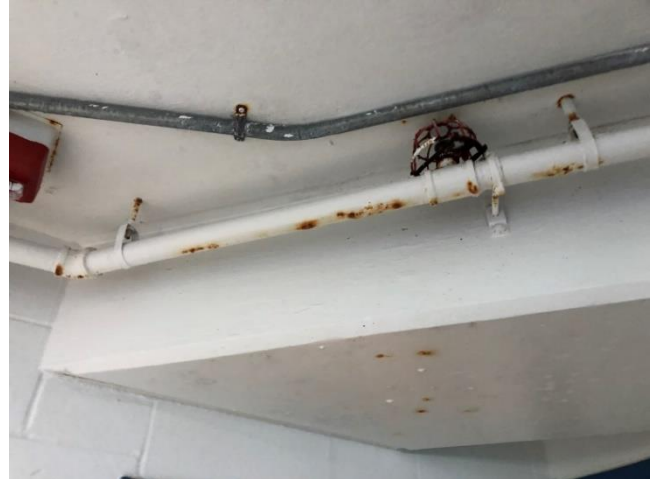
This building has a wet-pipe fire sprinkler system. The piping and heads are installed exposed and low in the corridors leading to the inmate rooms. The piping and sprinkler heads are low and not ligature resistant. The piping near the shower rooms has visible corrosion on it. See Photo HU1-5-M4.

Photo HU1-5-M4: Exposed and Rusting Fire Sprinkler Piping

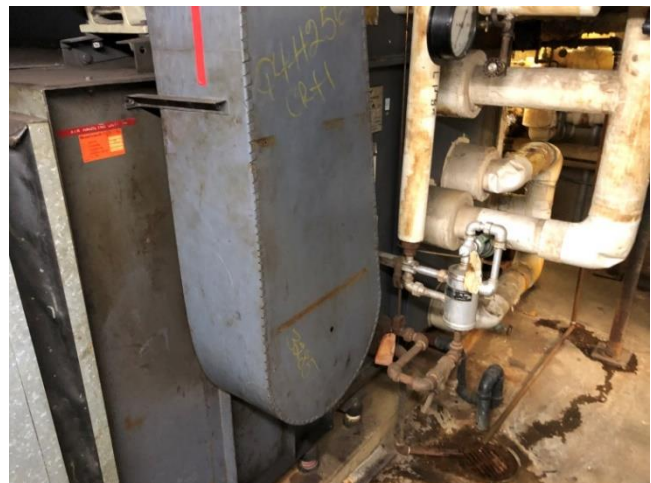
The AHU is constant volume with ducted supply and return air systems, a steam humidifier, heating hot water coil, and chilled water coil. See Photo HU1-5-M6 for a typical existing AHU. The AHU fans have a belt-driven fan motor. Ventilation air is provided via outdoor air louvers mounted in the exterior walls at the roof level.

Photo HU1-5-M6: Existing AHU

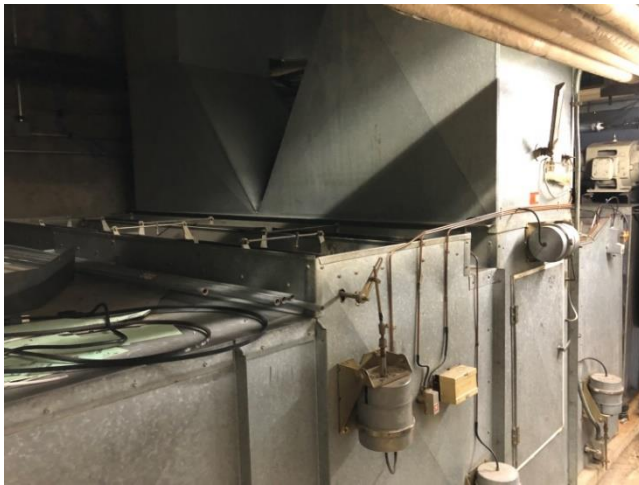
The temperature controls are still pneumatic, but there are direct digital control panels installed in each mechanical room which are interfaced with the pneumatic controls to allow for remote monitoring and control of the building via the Honeywell building automation system.

Photo HU1-5-M7: Existing Pneumatic Controls

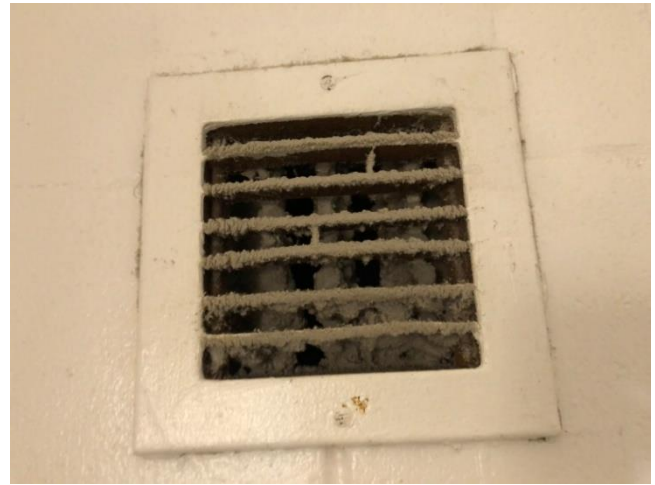
There is a lack of exhaust air noticed, particularly in the shower rooms. The moisture remains in the air and travels out of the shower rooms into the corridors and causes corrosion on steel items. The security type exhaust grilles are not easy to see through, but this exhaust grille in the security office is and the dirty exhaust air ductwork can be observed. See Photo HU1-5-M7. It is likely that the supply air and return air ducts are also dirty after 40 years of use.

Photo HU1-5-M8: Dirty Exhaust Air Ductwork

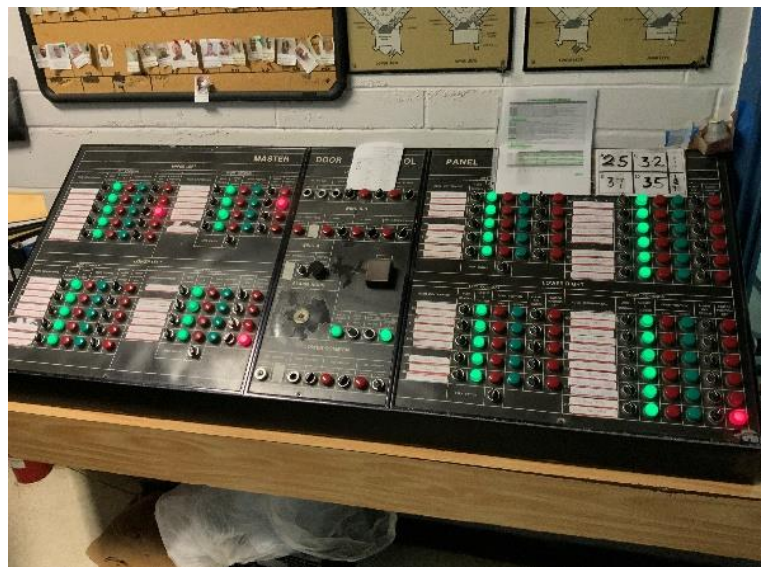
Both control locations use obsolete control panels to control and monitor their areas. Control panels consist of rotary switches and old type LED indicators installed on composite board (plastic/steel) with text engraved on their surface. Both panels are installed on desk mounted turrets. The system does have capability to transfer control to Central Control.

Photo HU1-SEC1: Control Panels in A Wing

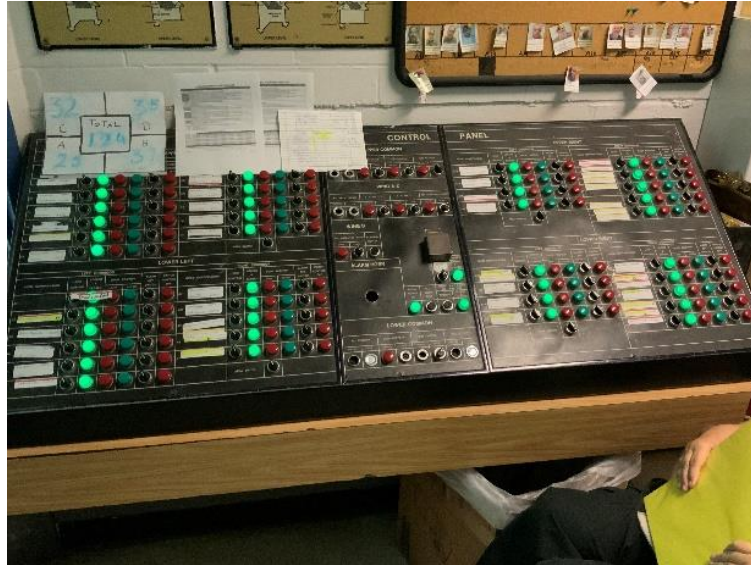
Photo HU1-SEC2: Control Panels in B Wing

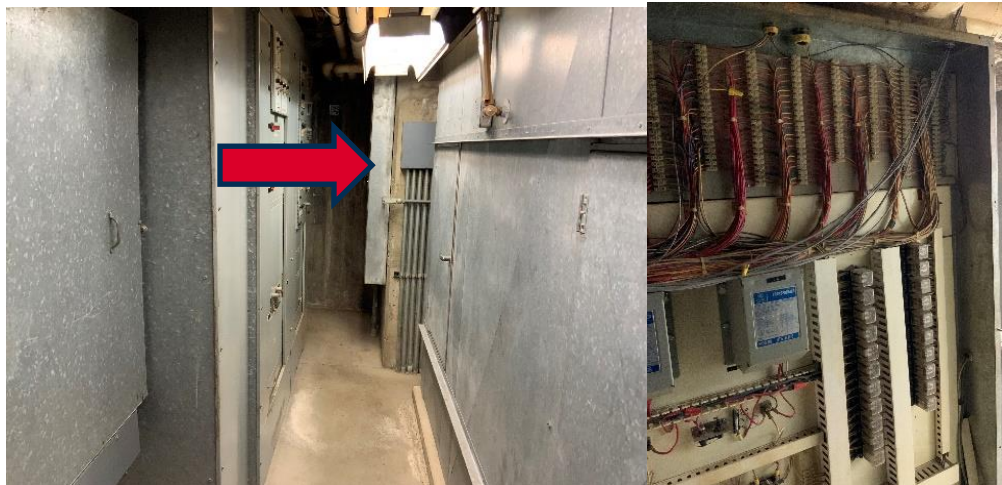
The existing doors are hard wired into door control relays and switches that are installed in the wall mounted enclosure. The enclosures are installed in the Mechanical space/chase below the control rooms. The room/chase is very difficult to access and does not meet National Electrical Code required work clearance space in front of the security enclosures.

Photo HU1-SEC3: Existing Door Control Enclosures-Typical for both A and B Wing

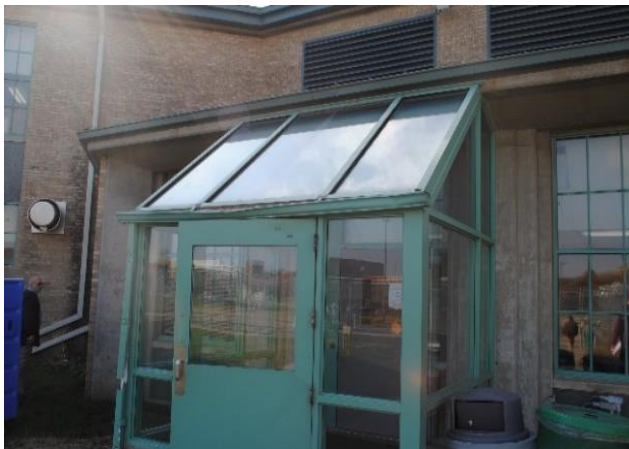
The building is a masonry building with CMU back-up. The windows have recently been replaced with double paned aluminum frame storefront. The roof is a standing seam metal roof and appears to be in good condition. The main entry was an addition to the building and consists of storefront framing and standing seam metal roof and is in poor condition with some significant damage.

Photo HU6-A1: Weather Vestibule with Worn Door Hardware and Damaged Window Framing

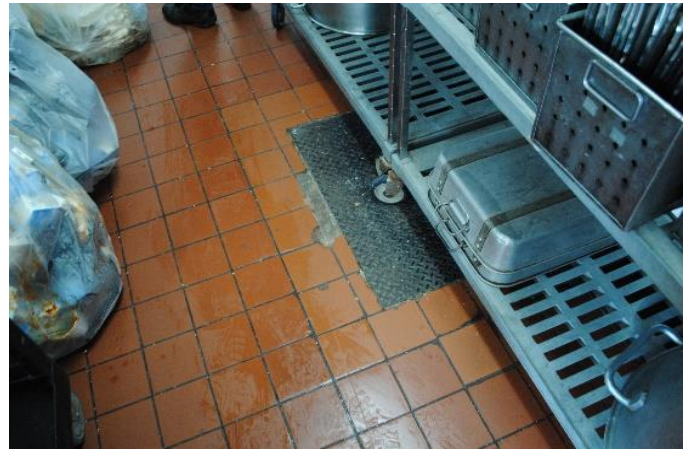
Photo HU6-A2: Floor Tile Damage and Missing in Kitchen

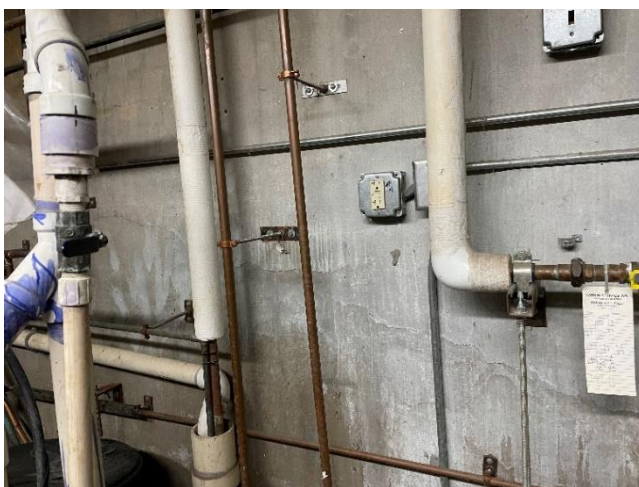
HU6 is a concrete slab and frame building with concrete masonry (CMU) infill. Cracks were present in the lower-level mechanical room walls. A portion of the steam tunnel lid was damaged from previous work and the historic metal lathe was unsupported.

Photo HU6-S1: Crack in Mechanical Room Wall

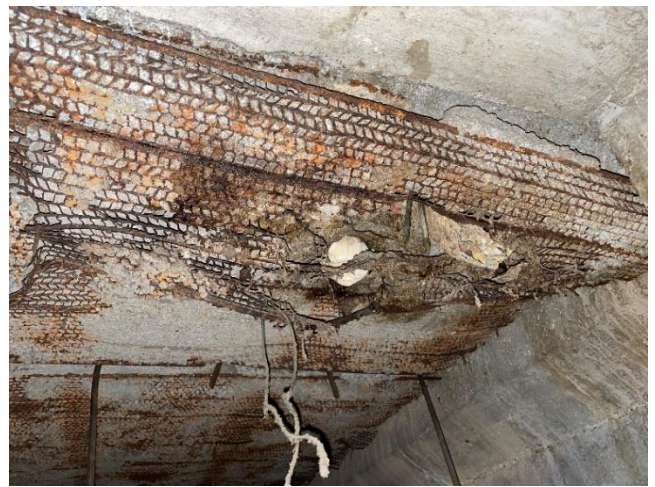
Photo HU6-S2: Damaged Lathe at Steam Tunnel Ceiling

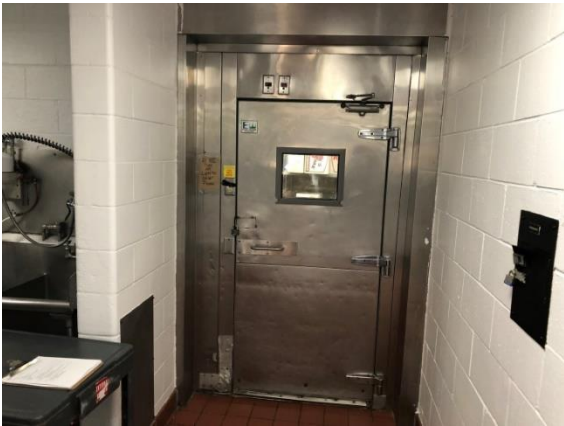
The walk-in cooler and freezer compartments appear to be original equipment from 1992. The freezer door has been previously replaced with a replacement door and frame, and the cooler door has numerous dents and damaged viewport frame. See Photos HU6-FS1 and HU6-FS2. The evaporator coils appear to be deteriorating from their age and humid operating conditions. See Photos HU6-FS3 and HU6-FS4. The food service manager noted that there is a gap in the cooler wall where it meets the floor, but the gap is located behind the storage racks and not easy to get to for repairs.

Photo HU6-FS1: Existing Walk-in Cooler Door

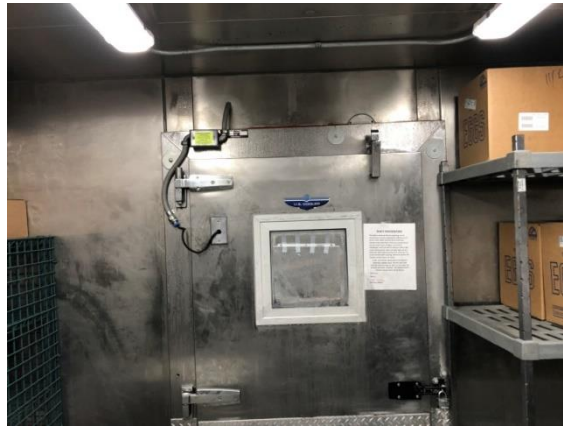
Photo HU6-FS2: Existing Walk-in Freezer Door

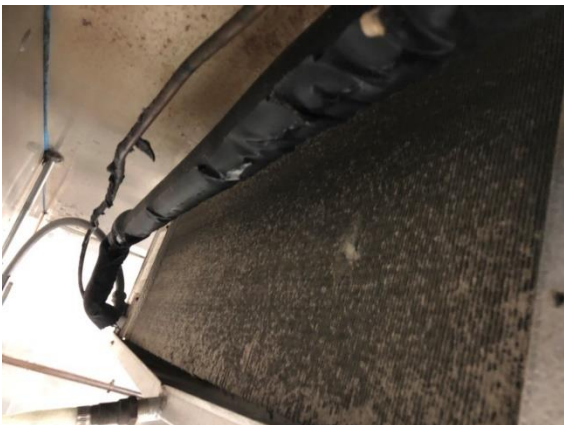
Photo HU6-FS3: Existing Cooler Evaporator Coil

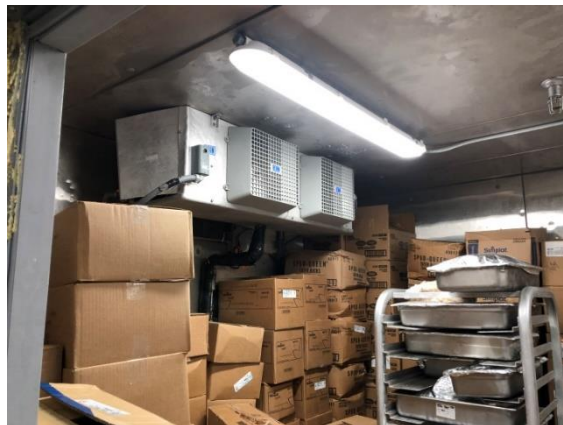
Photo HU6-FS4: Existing Freezer Evaporator Coil

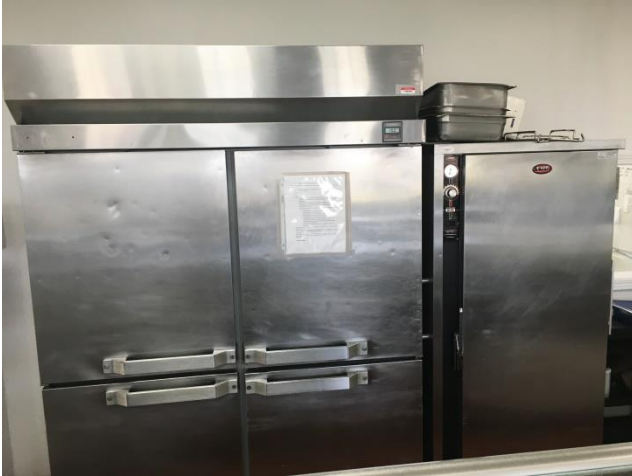
All reach-in refrigerator and milk coolers are older units and have sagging doors and numerous dents on exterior of units. See Photos HU6-FS5 and HU6-FS6. These units also require a discontinued refrigerant to operate.

Photo HU6-FS5: Existing Reach-in Refrigerator

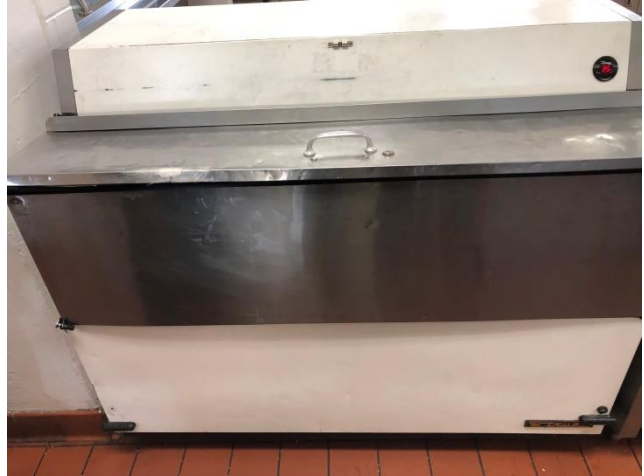
Photo HU6-FS6: Existing Milk Cooler

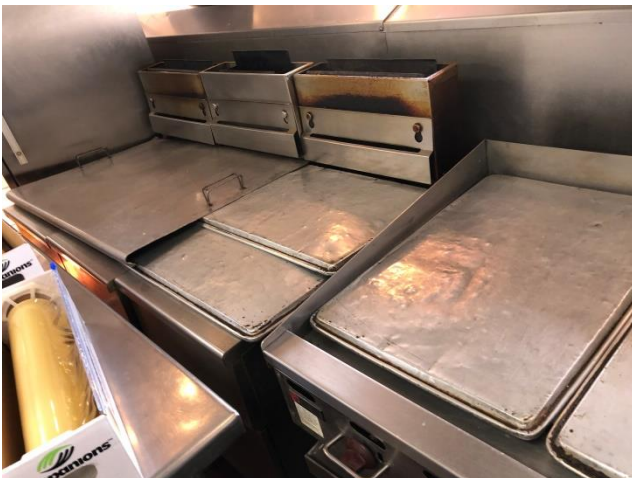
The fryers and tilt skillet are older units and show signs of extensive use with high heat. See Photos HU6-FS7 and HU6-FS8.

Photo HU6-FS7: Existing Fryers

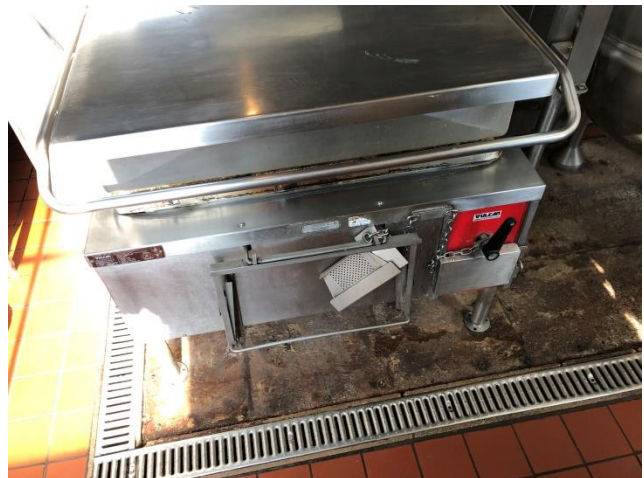
Photo HU6-FS8: Existing Tilt Skillet

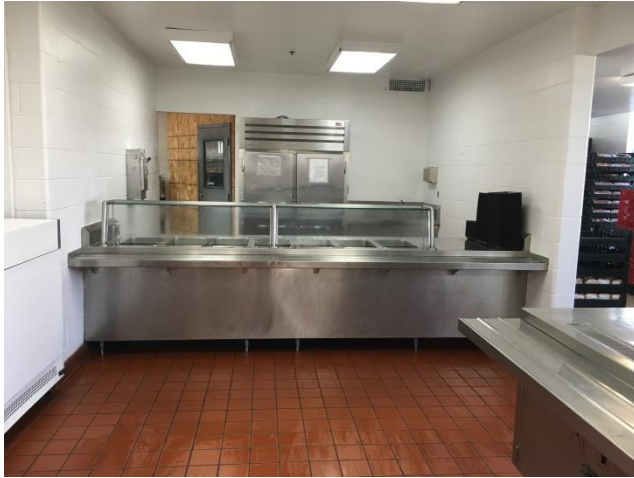
The hot and cold serving counters appear to be original equipment from 1992 and show signs of extensive use and nearing the end of its serviceable life. See Photos HU6-FS9 and HU6-FS10.

Photo HU6-FS9: Existing Hot Serving Counter

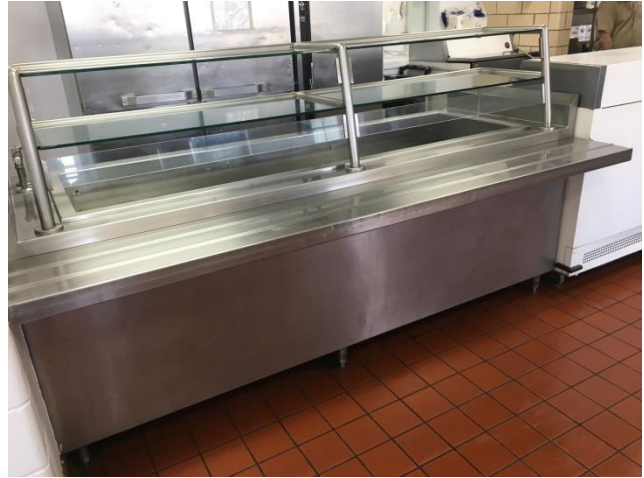
Photo HU6-FS10: Existing Cold Serving Counter

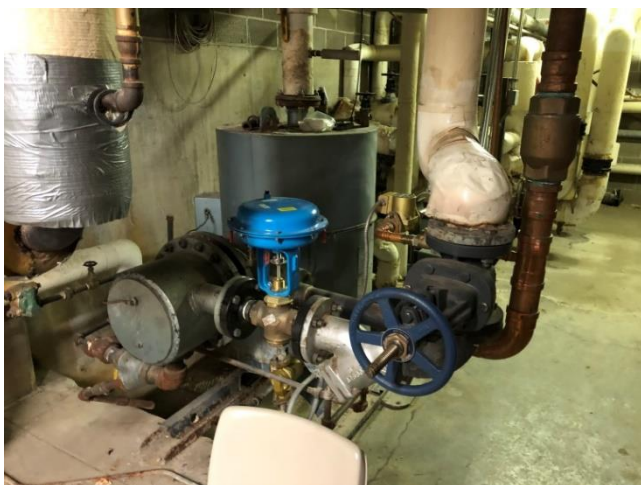
A steam water heater exists in the basement which is from 1995. See Photo HU6-M1. The water heater has a pneumatic steam control valve which serves a steam tube bundle in this water tank. There is only one tube bundle in this water heater so there is no redundancy in the case of equipment failure.

Photo HU6-M1: Existing Steam Water Heater

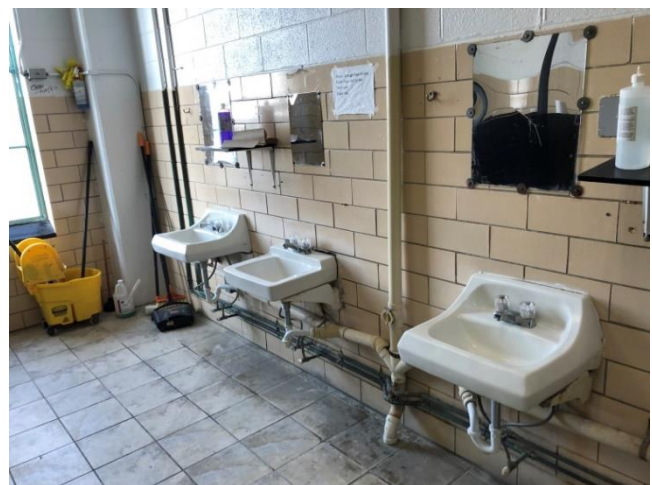
Photo HU6-M2: Exposed Restroom Plumbing

The restrooms get washed down once a week. The floor tiles are an ongoing maintenance issue with regard to grout joints and caulking to contain the water on the floor. The water closets on second floor are difficult to keep sealed to the floor so, the water follows the sanitary piping down to the ceiling cavity of first floor. This also occurs whenever the water closets overflow, by accident or intentionally.

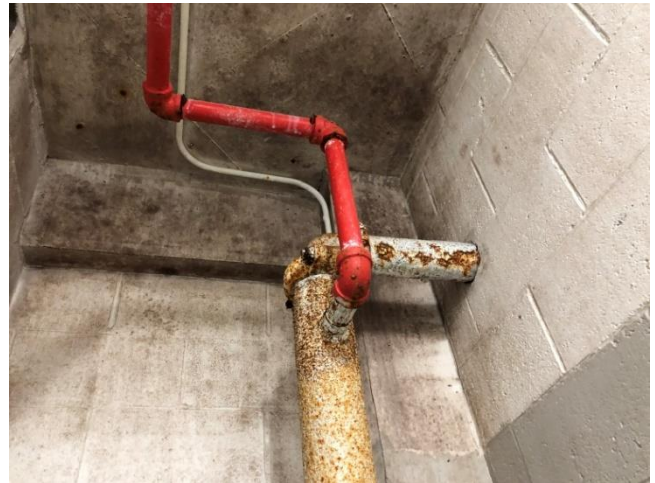
Photo HU6-M4: Rusting and Leaking Fire Sprinkler Piping on Second Floor

This building has a wet-pipe fire sprinkler system. The piping and heads are installed exposed in most spaces. The sprinkler main in a janitor's closet, next to a shower room on second floor, has excessive corrosion on it. See Photo HU6-M4. The janitor's closets are poorly ventilated and are humid thus leading to the growth seen on the walls and ceiling in Photo HU6-M4. The maintenance staff indicates that this has been occurring for so long that they've tried to paint the vertical piping white several times, but it keeps rusting through. The white pipe is now actively leaking onto the floor and a constant puddle exists.

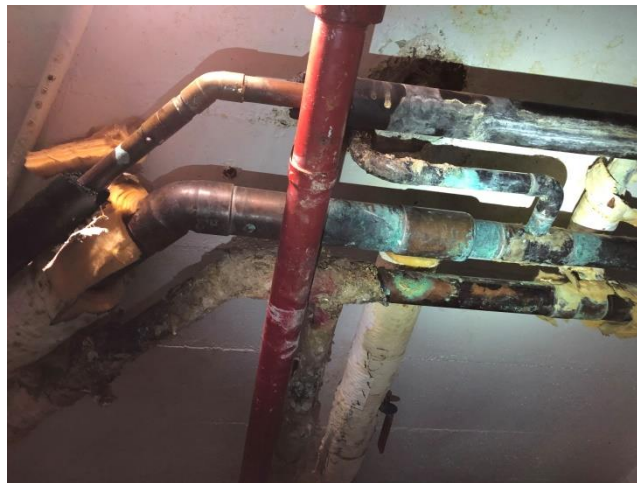
Photo HU6-M5: Rusting Fire Sprinkler Piping on First Floor

The same piping from Photo HU6-M4 continues down to first floor where the water follows it and continues to cause corrosion and humidity problems. This room is so damp and humid that the horizontal sprinkler piping in it rusted through and started leaking so, that red section of piping in Photo HU6-M5 was replaced in the last two years. However, the newer red sprinkler piping already has rust forming on it again and there is extensive water damage to the other piping and pipe insulation in this room.

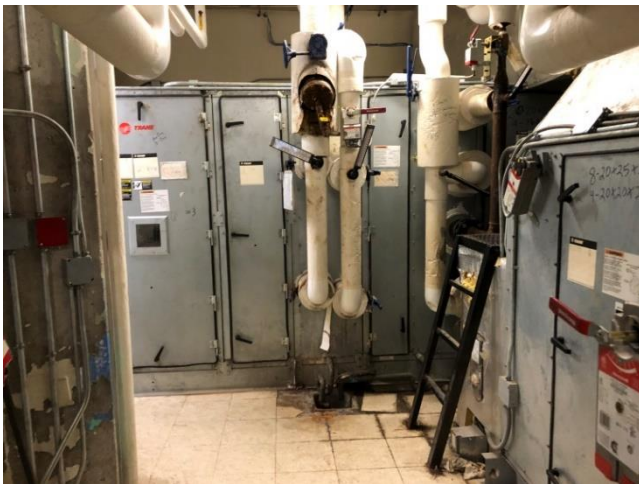
Photo HU6-M6: Typical Existing AHU

The AHUs are all constant volume with ducted supply and return air systems, heating hot water coils, and chilled water coils. See Photo HU6-M6 for a typical existing AHU. The AHUs have plenum fans. Ventilation air is provided via outdoor air louvers mounted in the exterior walls on second floor.

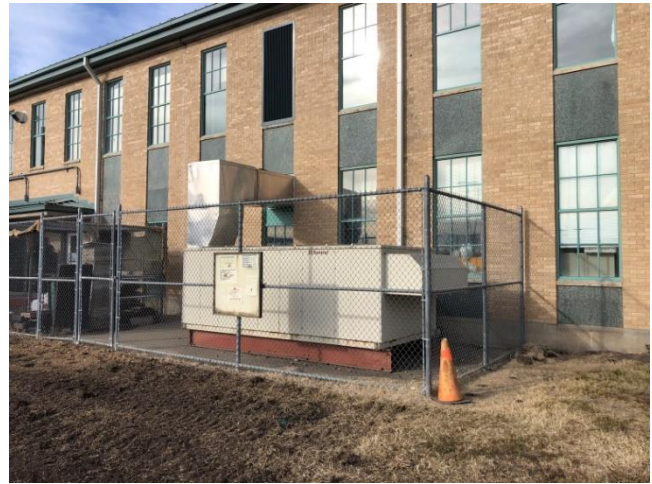
Photo HU6-M7: Existing Kitchen Make-Up Air Unit

The kitchen make-up air unit does not work because it's heating coil froze a couple of years ago, so it no longer is interlocked to run with the kitchen exhaust hoods causing excessive negative air pressure inside the building during most of the day.

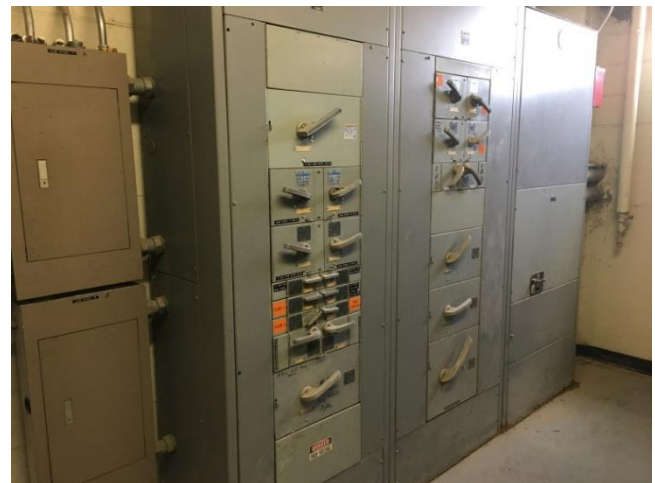
Photo HU6-E1: Main Electrical Service

The majority of the electrical distribution system is original to the building construction. See Photo HU6-E1. This equipment is serving beyond its useful service life and needs to be replaced. Convenience receptacle mounting heights are not compliant with modern ADA standards.

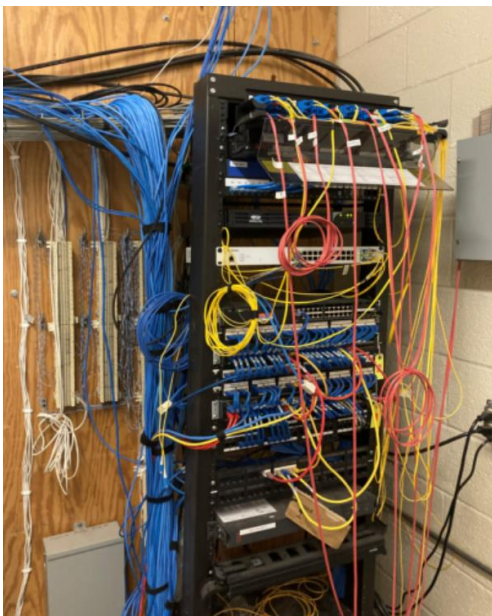
**Photo HU6-T2: Existing Telecom
Room 008**

the Ancillary building and the control unit for distribution of the CATV systems. There is a 24-stand, single mode fiber optic cable that routes back to the Ancillary building. The horizontal data cabling to work area outlets is all Category 6 copper cabling, which is in line with current industry standards for horizontal copper cabling. The telecommunications rack is not grounded per BISC standards.

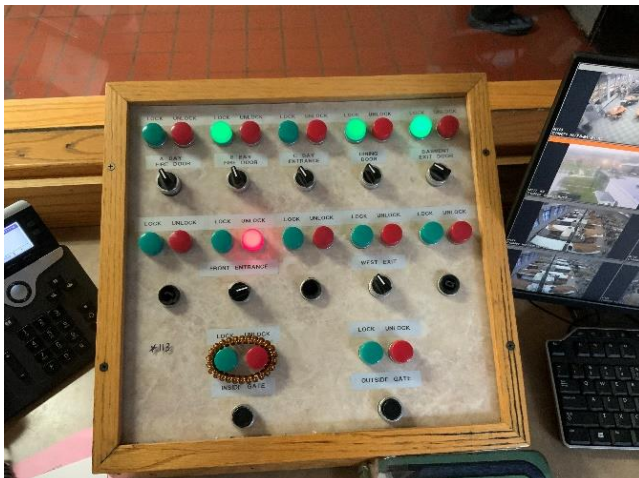
Photo HU6-SEC1: Existing Control Panel

The control location uses an obsolete control panel to control and monitor security devices. The control panel consists of rotary switches and old type LED indicators installed on composite board (plastic/steel) with text engraved on their surface. The panel is installed on a desk mounted turret. The system does not have capability to transfer control to any other control location. The existing doors are hard wired into door control relays and switches that are installed inside the control panel turret.

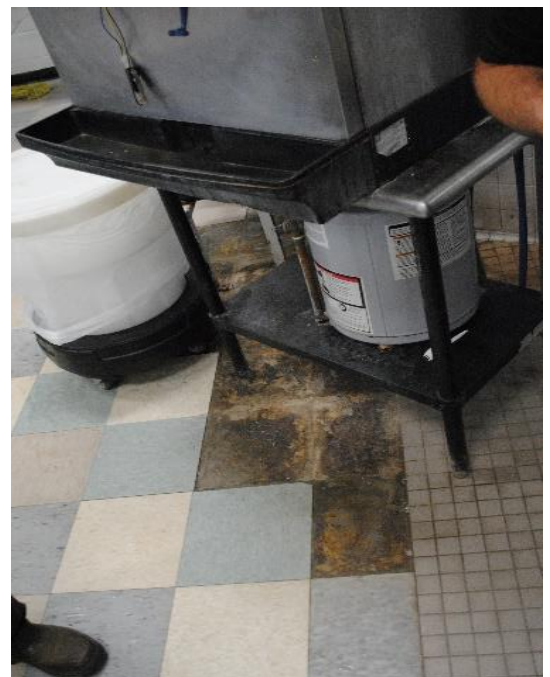
Photo HU7&8-A1: Flooring in Dayroom of HU7&8

The interior of the building consists of 4 units. Each unit consists of a sleeping area and a dayroom. The sleeping area is a dorm with exposed concrete structure and painted walls and VCT flooring. There are several tiles missing in the dayrooms. The room is separated from the dayroom by a hollow metal window wall. These window walls appear to have a fair amount of damage due to heavy use. The dayroom opens to a toilet and shower area with 2x2 tile floors and 4x4 subway tile walls. The tile is missing in several areas and the hand lavatories have exposed piping. The toilet accessories have a fair amount of calcium build up and rust. Between the units is a control station with VCT floors and an ACT ceiling. The windows between the control station and the dayroom are hollow metal. The millwork at this control station should be considered for replacement.

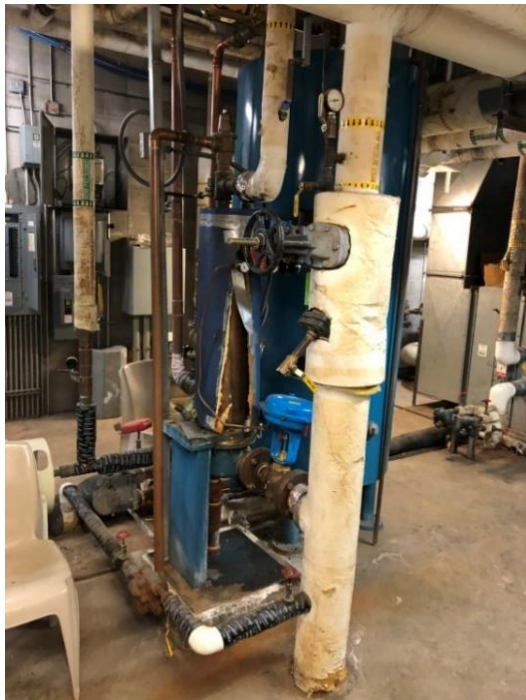
**Photo HU7&8-M1: Existing Steam
Water Heater**

A steam water heater exists in the basement which is original from 1998. See Photo HU7&8-M1. The water heater has a pneumatic steam control valve which serves a steam tube bundle for this water tank. There is only one tube bundle serving this water heater. There is not an existing water softener serving this system.

The steam water heater is original from 1998 which makes it about 23 years old. According to ASHRAE, a steam tube bundle heat exchanger, which is part of this water heater, has a median service life of about 24 years. As a result, the existing water heater is at the end of its useful life and needs to be replaced. The water heater also has no redundancy so, if the steam tube bundle should fail, the building would be without domestic hot water until it can be repaired.

It is recommended to replace this water heater with two storage tank steam water heaters and two equally sized pumps which are piped in parallel. Each water heater would be capable of providing 100% of the heating load so, there is full domestic hot water heating redundancy. A water softener, digital mixing valve, and two inline hot water circulation pumps would also be provided. The probable project cost for this scope of work is \$349,000 per building or \$698,000 for both buildings.

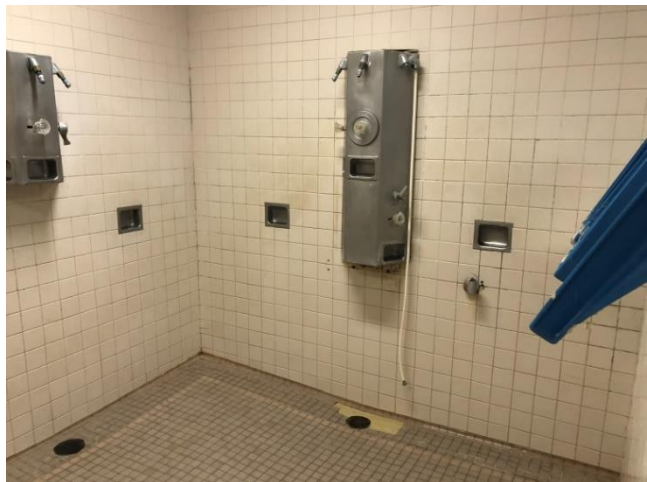
Photo HU7&8-M2: Typical Showers

The inmate population for these housing units is about double what they were designed for, so the showers are in constant use during the day which puts extra stress on the sanitary piping system, ventilation, and exhaust systems, and often leads to clogs in the piping. See Photo HU7&8-M2.

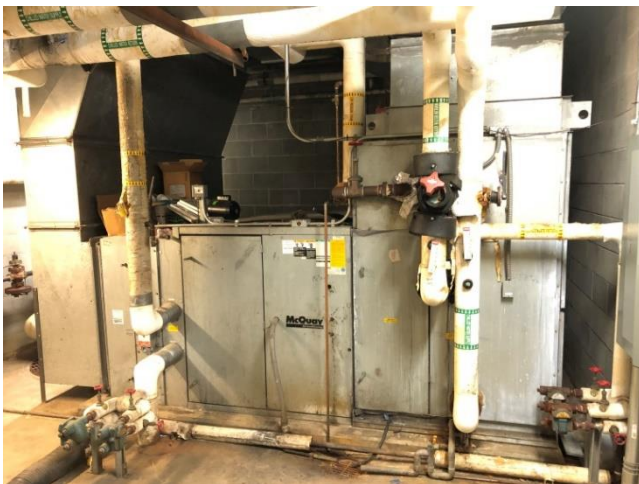
Photo HU7&8-M4: Typical Existing AHU

The AHUs are both constant volume with ducted supply and return air systems, steam heating coils, and chilled water coils. See Photo HU7&8-M4 for a typical existing AHU. Ventilation air is provided via outdoor air intake hoods mounted on the roof. The housing units are humid and have moisture damage on walls and ceilings.

The HVAC systems are original from 1998 which makes them about 23 years old. According to ASHRAE, most fans, coils, pumps, and controls have a median service life of about 20 years. As a result, the existing equipment is operating at about 3 years beyond its expected useful life and needs to be replaced. The building occupancy has doubled since 1998 and the HVAC systems are not keeping up with current demands. The AHUs also have no redundancy on their air-side so, if the single supply fan for each system should fail, portions of the building would be without HVAC until it can be repaired.

It is recommended to replace the existing HVAC equipment, clean and reuse ducts, install new security supply air registers and return air grilles, and to upgrade the building to a full digital Building Automation System (BAS). The new AHU will be provided with a fan array which is composed of multiple direct drive fans which can automatically speed up to provide redundancy in the event that one fan should fail. The AHUs will also include MERV 13 filters, UV lights at the cooling coils, and humidifiers to provide improved indoor air quality for the occupants. The exhaust fans will be replaced with larger capacity exhaust fans. The probable project cost for this scope of work is \$1,360,000 per building or \$2,720,000 for both buildings.

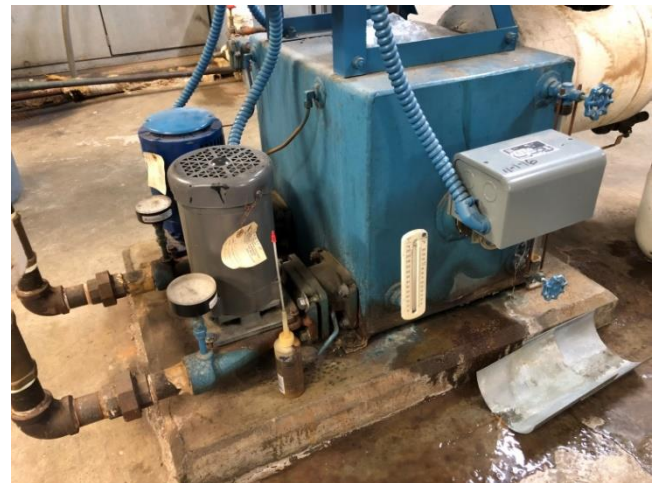
Photo HU7&8-M5: Leaking Steam Condensate Return Pump

The steam condensate return pump was observed to be leaking. See Photo HU7&8-M5.

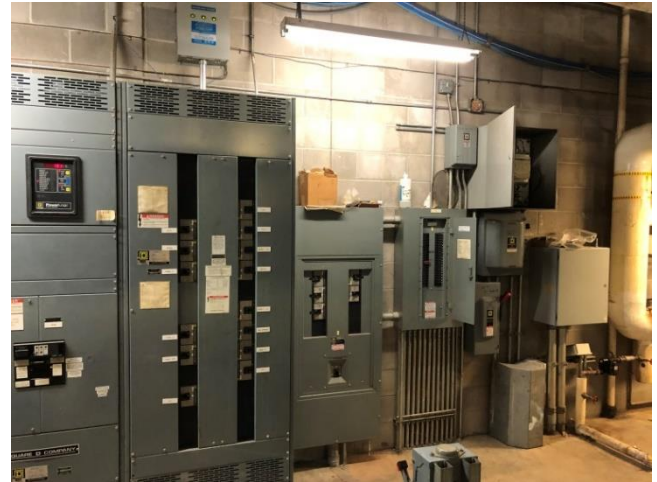
Photo HU7&8-E1: Main Electrical Service

The power distribution system is a mixture of original building equipment and some newer replacement equipment. See Photo HU7&8-E1. The original building equipment is in good operational condition, but is getting within a few years of reaching its end of useful service life. Convenience receptacle mounting heights are not compliant with modern ADA standards.

Equipment original to the building should be replaced as it approaches its end of useful life. The probable project cost for this scope of work is \$432,500 per building or \$865,000 for both buildings.

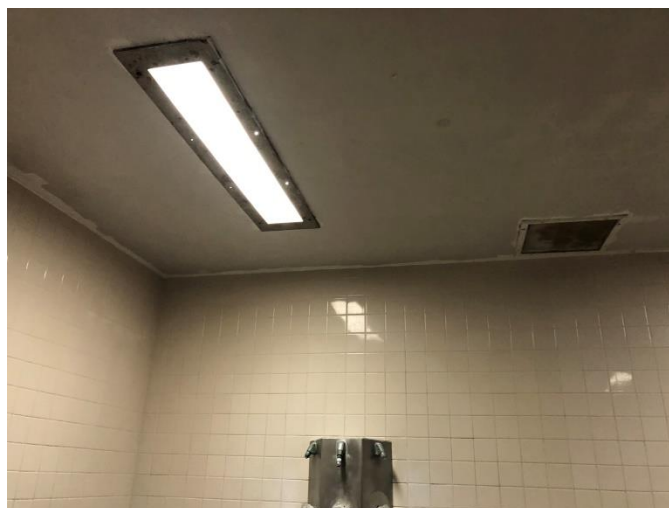
Photo HU7&8-E2: Rusted Lighting Fixture in Shower Area

Lighting throughout the building is fluorescent type. See Photo HU7&8-E2. In areas where inmates are present, the fixtures are confinement rated type. All of the fixtures appear to date to the original building construction and are in need of replacement.

Lighting throughout the building is serving beyond its useful service life and needs to be replaced. The probable project cost for this scope of work is \$722,500 per building or \$1,445,000 for both buildings.
