Nebraska State Penitentiary Useful Life Engineering Study

Lincoln, Nebraska

Alvine No. 2021 8777
January 2022

Prepared for:
State of Nebraska
Department of Correctional Services
Lincoln, Nebraska

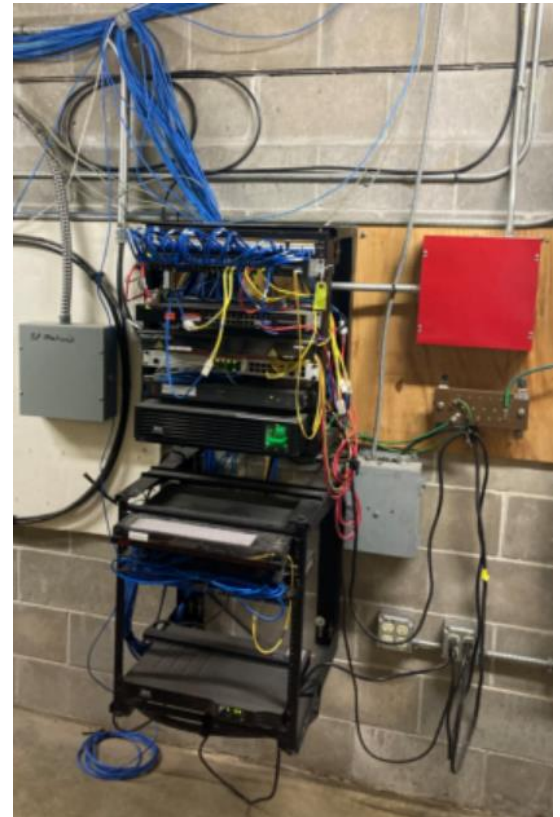
Photo HU7&8-T1: Existing Telecom Cabinet

There are two existing wall mount telecommunication racks located in the Mechanical Room 126 that serve data for both HU7&8. The building is served by a 24-strand, single mode fiber optic cable that runs back to the telecommunications rack located on the lower level telecommunications room 008 of Housing Unit 6 building. The horizontal data cabling serving the buildings are a mixture of Category 5 and 6 copper cabling. Current industry standards for data cabling would be a minimum of Category 6 for horizontal copper cabling. There is a UPS within the telecommunications rack that supports the telecommunication network. There is a telecommunication ground bar that provides grounding to the telecommunications rack. There is existing coaxial cabling routed to televisions within the building from Mechanical Room 126. The paging amplifier for the building paging system is located in Mechanical Room 126. The JPAY network equipment and UPS are located in the telecommunication rack as well.

The existing telecommunications racks in mechanical room 126 are in a shared space with other mechanical equipment and have no cooling. BICSI standards recommend that the telecommunications equipment cabinets should be control against unauthorized access. It is recommended that the existing telecommunications wall mounted racks be replaced with a telecommunication lockable wall mounted cabinet that has integrated cooling for the equipment. The replacement of this cabinet would require down time for the network it serves and a level of risk that existing equipment or cabling may get damaged during the move. The probable project cost for this scope of work is \$40,000 per building or \$80,000 for both buildings.

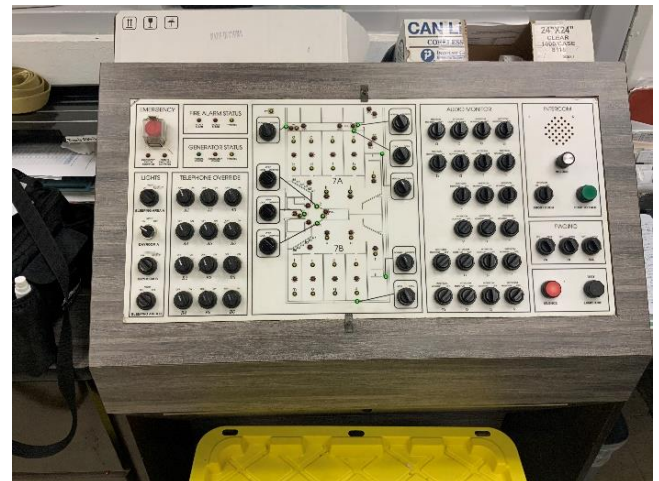
Photo HU7&8-SEC1: Existing Control Panel

Both control locations use obsolete control panels to control and monitor security devices in their areas. Control panels consist of rotary switches and old type LED indicators installed on composite board (plastic/steel) with text engraved on their surface. Both panels are installed on desk mounted turrets. The system does not have capability to transfer control to any other control location. The existing doors are hard wired into door control relay boards and controlled via Crestron Professional Media Controller. The door control equipment is installed in wall mounted cabinets in Security Equipment Closet 125. The Security Equipment Closet is conveniently located between two housings.

The replacement of the existing control panels and the existing relays should be considered as a high priority considering the age and present condition of the existing door control equipment. New door control systems shall consist of a single PLC and two touch screen control station. New PLC based head-end equipment (included but not limited to CPU, Ethernet communication modules, I/O modules, power supplies, relays, etc.)

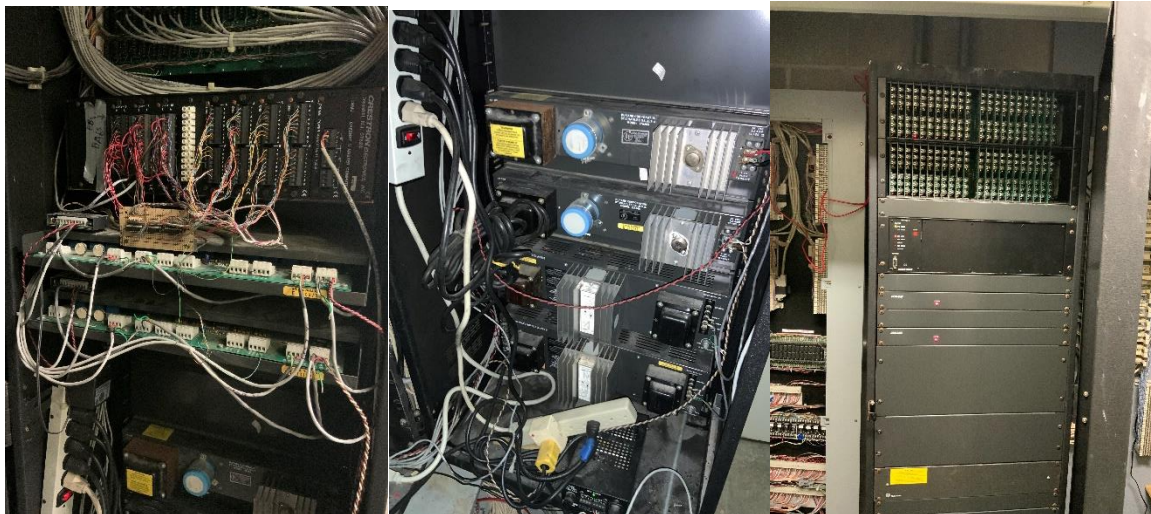
Photo HU7&8-SEC3: Existing Intercom and Paging System Head-End Equipment

The existing intercom and paging system for HU7 and HU8 is not integrated with the door control system equipment. The system uses Dukane relay boards for field devices (intercoms and paging speakers) interface with Crestron Professional Media Controller. Dukane amplifiers are used for intercoms and paging speakers' amplification.

The existing intercom and paging system head-end equipment shall be replaced with the new digital intercom and paging system. All existing intercom and paging system field devices and their associated wiring should be reused (intercom stations, paging speakers and call buttons). The Intercom system would be integrated into the new touch screen control system. The probable project cost for this scope of work is \$23,000 per building or \$46,000 for both buildings.

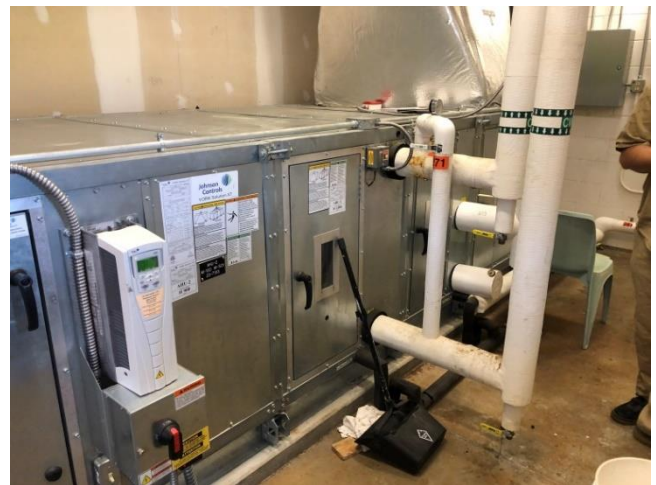
Photo LAUN-M1: Typical Existing AHU

The AHUs have ducted supply and return air systems, heating hot water heating coils, and chilled water coils. See Photo LAUN-M1 for a typical existing AHU. Ventilation air is provided via outdoor air wall louvers. The occupants note that when there is a thunderstorm outside that the variable frequency controller (VFC) for the supply fan of the north AHU, trips off.

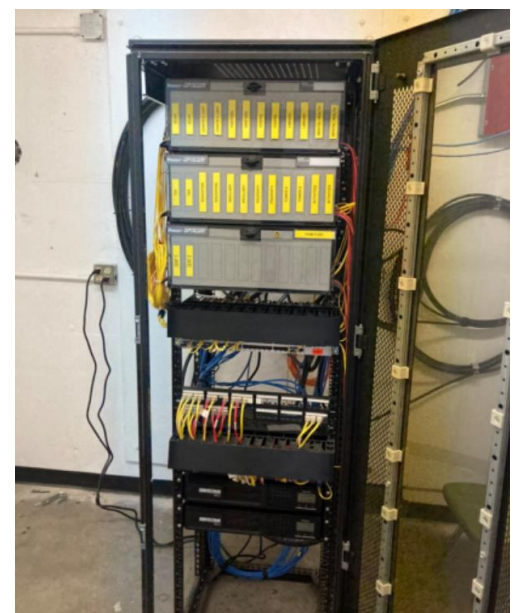
Photo LAUN-T1: Existing Telecom Cabinet

EDU, PEB, GT4, and ACT. There is also a 144-stand OS2 fiber optic cable that routes from Laundry to the CERT building. The horizontal data cabling serving the building is all Category 6 copper cabling, which is in line with current industry standards for horizontal copper cabling. There is a UPS within the telecommunications rack that supports the telecommunication network. The telecommunications cabinet is not properly grounded per BICSI standards.

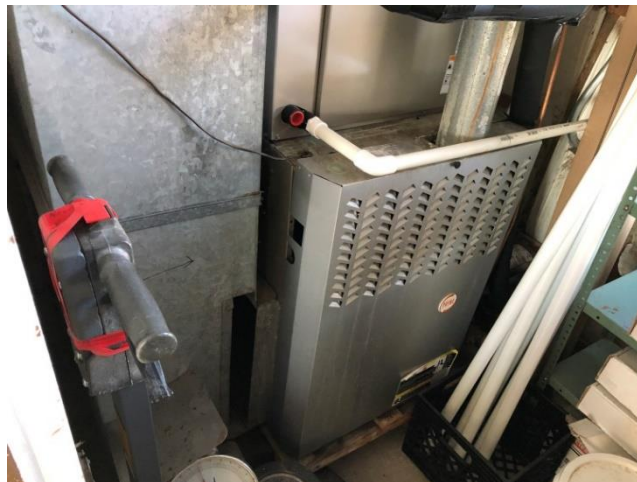
Photo LIB-M1: Typical Existing Gas Furnace

The HVAC system is composed of two natural gas furnaces, two Air-Cooled Condensing Units (ACCUs) with one from 1998 and the other one brand new this summer, two thermostats, above ceiling supply air ductwork serving ceiling diffusers, a return air ceiling plenum, and one restroom exhaust fan. The furnaces are both over 20 years old and have a DX refrigerant cooling coil. See Photo LIB-M1.

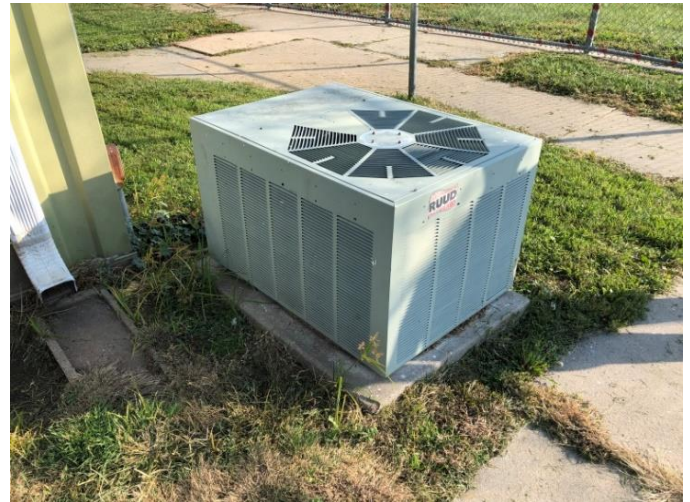
Photo LIB-M2: Existing ACCU

The ACCU from 1998 is about 23 years old. See Photo LIB-M2. There is not an outdoor air louver in the exterior wall for ventilation purposes. As a result, the building's only source of ventilation air is from operable windows which are only used during mild weather conditions.

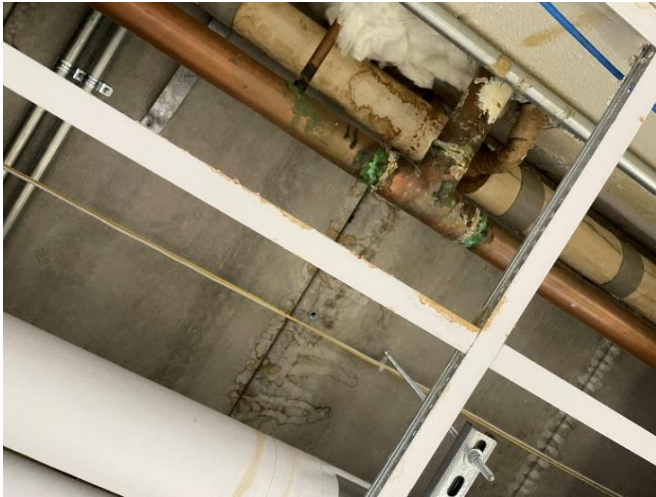
The MENT building is constructed with concrete masonry (CMU) bearing walls with roof framing constructed with hollow core planks at the original portion and hollow core planks at the addition. There is evidence of moisture infiltration which is coming from the roof. It was not clear whether this is active, or old. Staining suggests this is an historic issue.

Photo MENT-S1: Water Staining at Roof

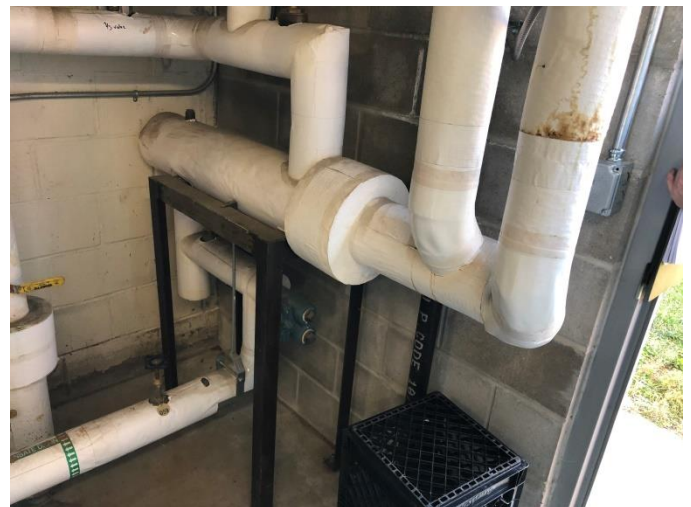
The HVAC system is composed of multiple horizontal and vertical four pipe fan coil units, one steam to heating hot water shell and tube heat exchanger, see Photo MENT-M1, supply air and return air ductwork, and one restroom exhaust fan.

Photo MENT-M1: Existing Steam to Heating Hot Water Shell and Tube Heat Exchanger

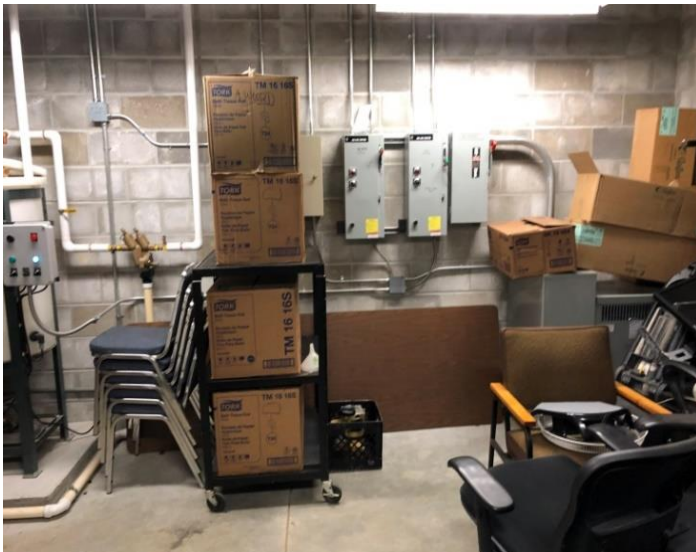
The electrical distribution system in this building was renovated in approximately 2011. The electrical equipment is in good, serviceable condition. See Photo MENT-E1. Convenience receptacle mounting heights are not compliant with modern ADA standards.

Photo MENT-E1: Main Electrical Panel

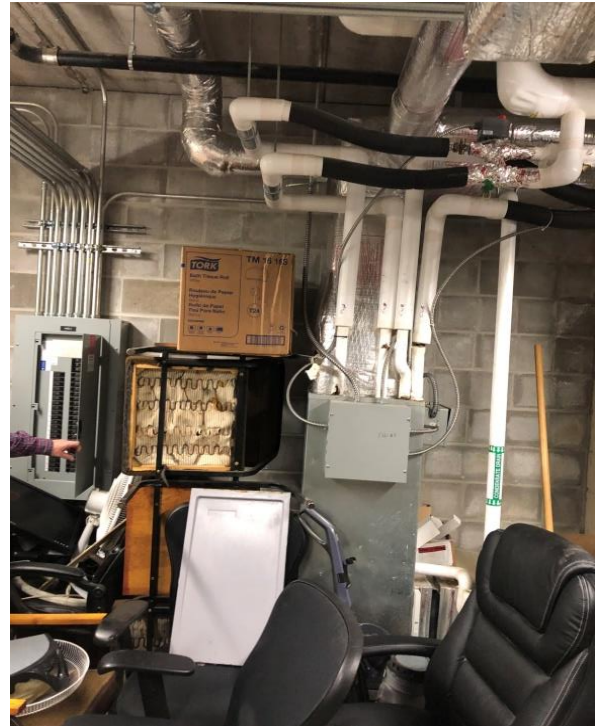
The fan coil units are all constant volume and are about 10 years old. See Photo MENT-M2. There is an outdoor air louver in the exterior wall for ventilation purposes which is directly ducted to the return air ductwork of some of the fan coil units.

Photo MENT-M2: Typical Existing Vertical Fan Coil Unit

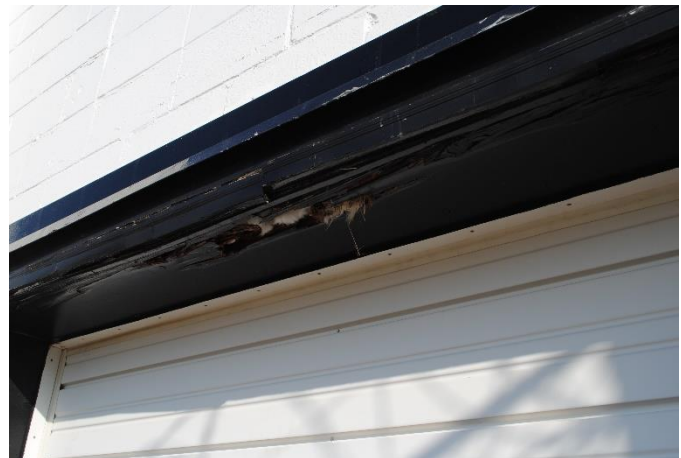
Photo PEB-A1: Overhead Door Damage at Pre-Employment Building.

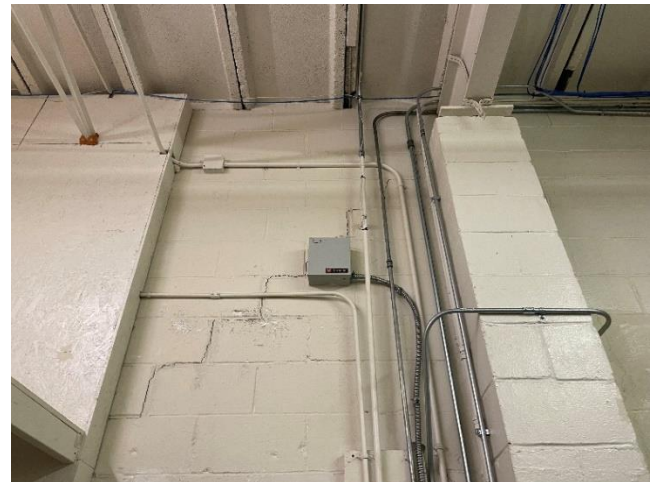
The PEB building is constructed with concrete masonry (CMU) bearing walls. The roof is framed with precast roof panels supported by steel open-webbed bar joists. Some of the roof panels are spalled and stair-stepping cracks are present in some wall locations.

Photo PEB-S1: Spalled Roof Panels and Cracked Masonry Walls

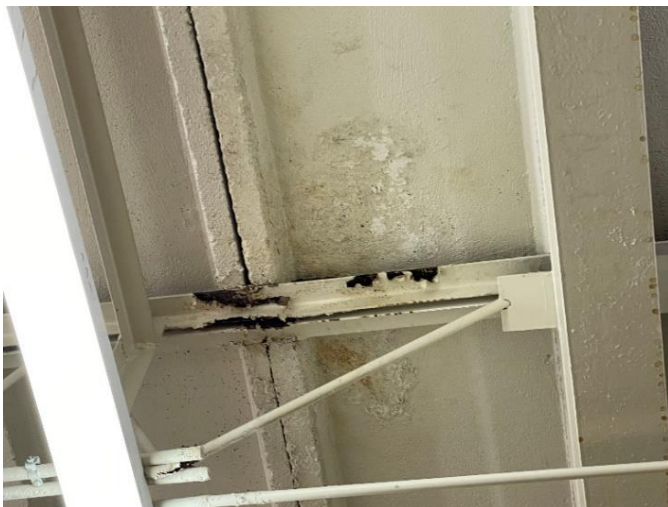
Previous roof leaks were noted which resulted in rusting of the top chord of some of the roof joists.

Photo PEB-S2: Rusted Roof Joist

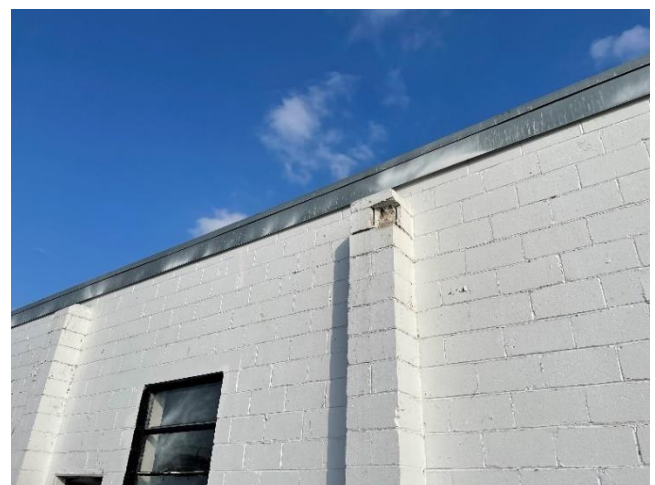
There is spalled CMU at the top of some of the masonry pilasters on the building exterior.

Photo PEB-S3: Spalled CMU at Pilasters

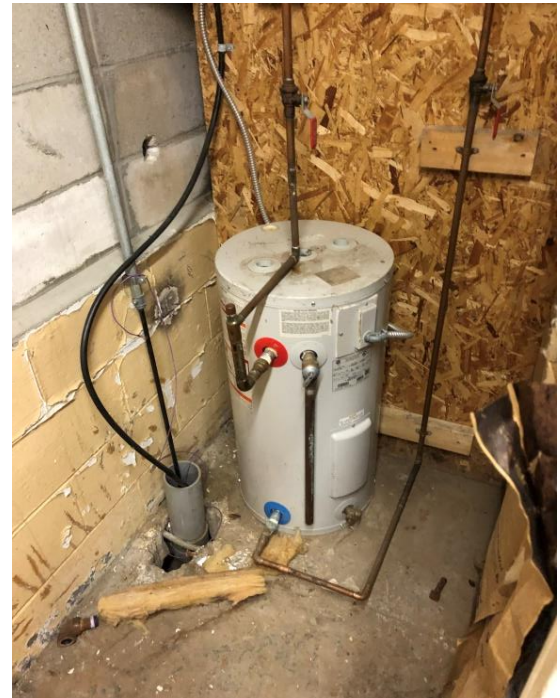
A gas water heater exists which is about 8 years old. See Photo PEB-M1. The hot water piping insulation is missing on all of the piping.

Photo PEB-M1: Existing Electric Water Heater

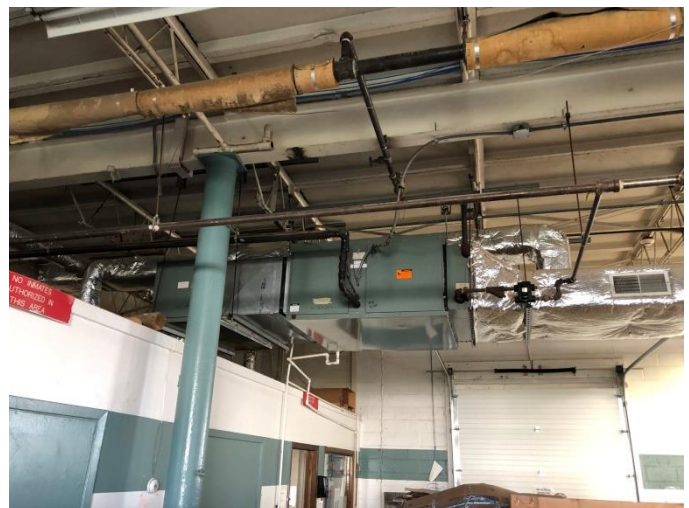
The steam unit heaters were reported to not be functional. There is not an outdoor air louver or roof hood for ventilation purposes, but there are operable windows.

According to ASHRAE, fan coil units have a median service life of 20 years and ACCUs have a median service life of about 15 to 20 years. As a result, the existing fan coil unit and associated ACCU in the recycling center are operating beyond their expected useful life. The other systems in this building are similar in age and condition except for the system serving Prison Fellowship and ABC Construction which is from 2019.

Photo PEB-M2: Existing Fan Coil Unit with Steam Heating Coil

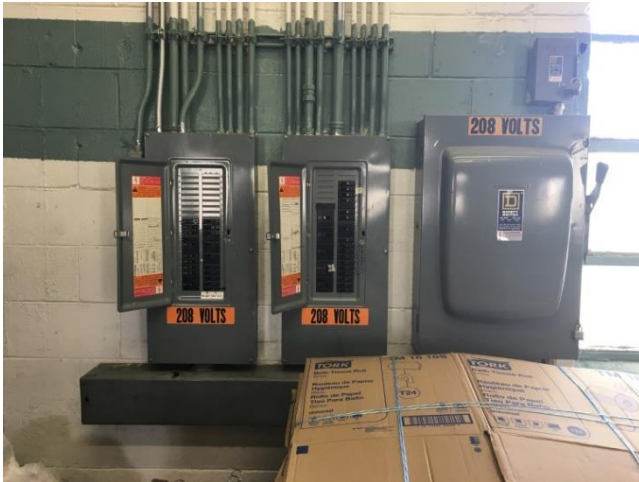
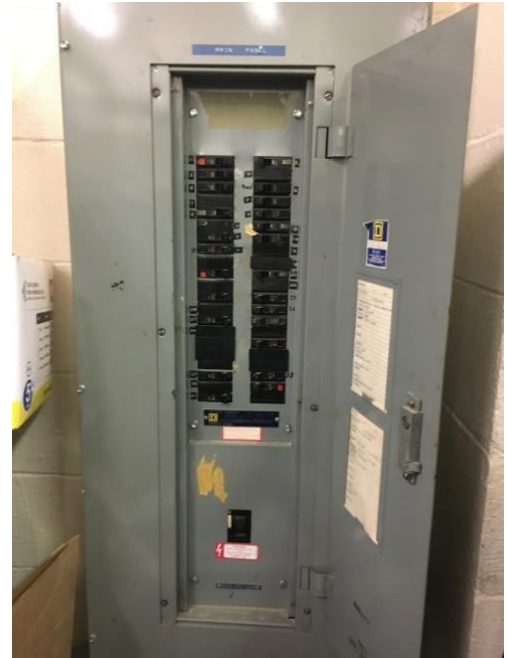
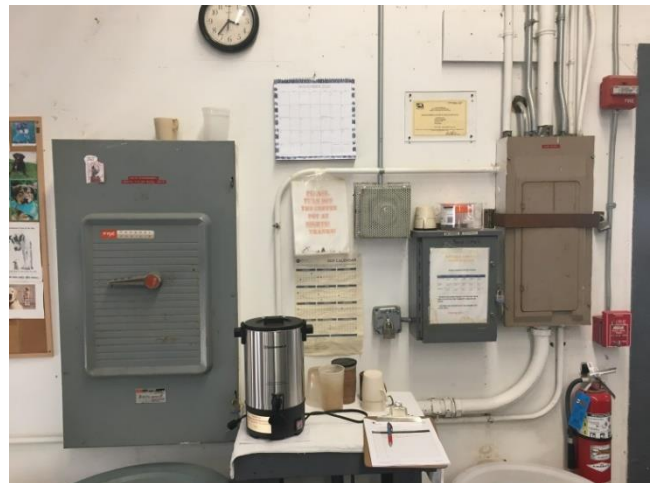
This building has an electrical distribution panel in three of the four separate use spaces. See Photos PEB-E1, PEB-E2, and PEB-E3. Each of the panels is older vintage, serving beyond its useful service life. In general, convenience receptacle mounting heights are not compliant with modern ADA standards.

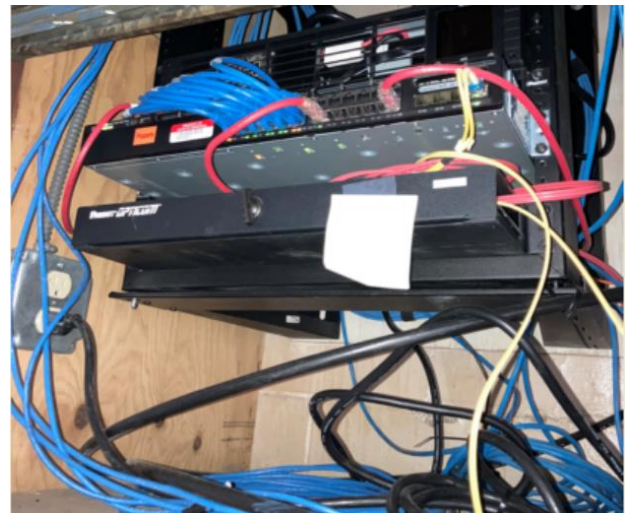
Photo PEB-T1: Existing Telecom Cabinet

There is an existing wall mount telecommunication rack located in Office 116 that serves data for the entire building. The building is served by a 24-strand, single mode fiber optic cable that runs back to the telecommunications rack located in the basement telecommunications room of the Laundry building. The horizontal data cabling serving the building is all Category 6 copper cabling, which is in line with current industry standards for horizontal copper cabling. There is a UPS within the telecommunications rack that supports the telecommunication network. The telecommunications cabinet is not properly grounded per BICSI standards.

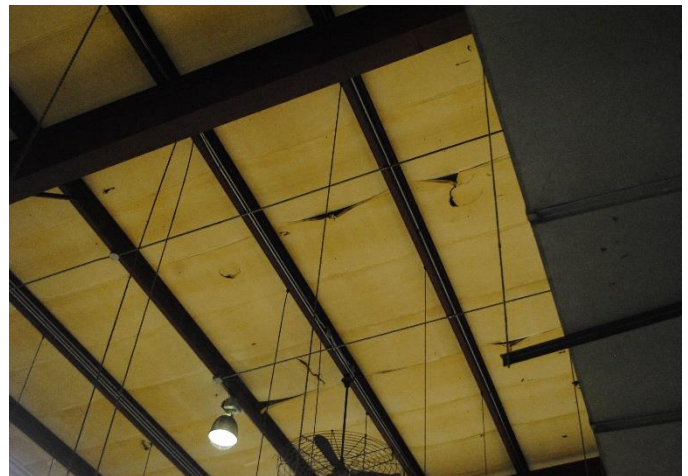
Envelope

Photo PVB-A1: Tears in Insulation at Ceiling

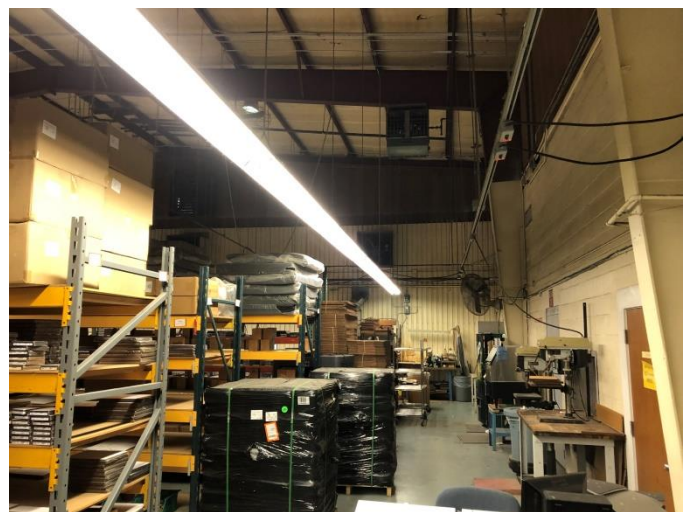
No plumbing fixtures or water heaters were observed. Natural gas piping exists to serve four unit heaters, but the unit heaters are disconnected. See Photo PVB-M1.

Photo PVB-M1: Gas Piping to Unit Heater

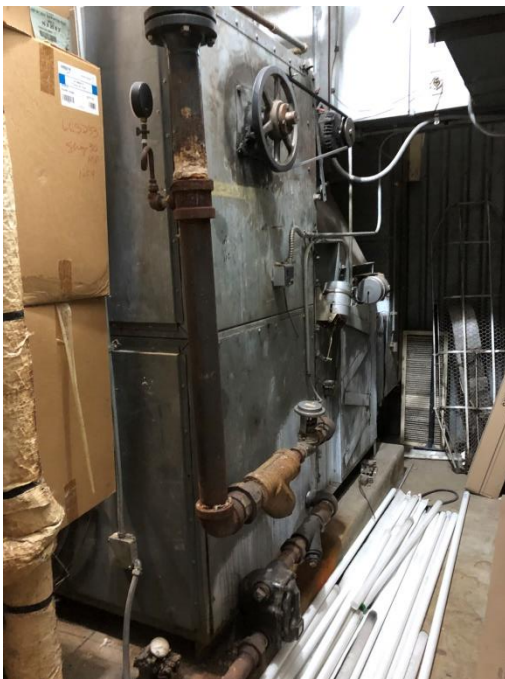
According to ASHRAE, AHUs have a median service life of about 20 years. As a result, the existing fan coil unit and associated ACCU in the recycling center are operating beyond the expected useful life.

Photo PVB-M2: Existing AHU

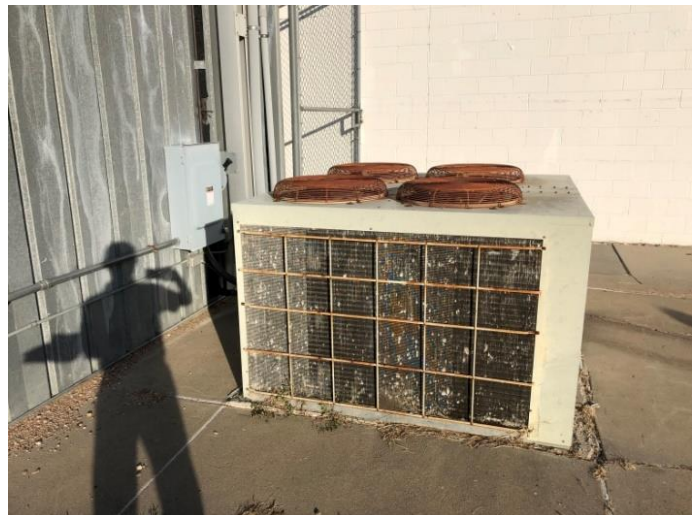
Photo PVB-M3: Existing Abandoned ACCU

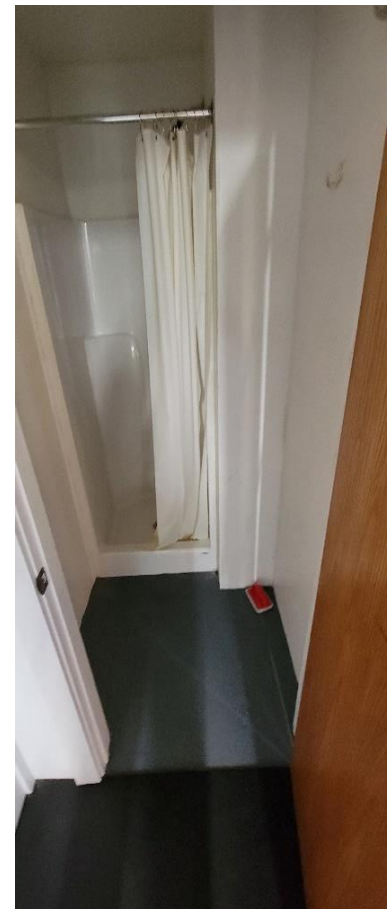
The WELL was built pre-ADA. The toilet and shower do not meet current standards.

Photo WELL-1: Non-ADA Compliant Shower at Wellness

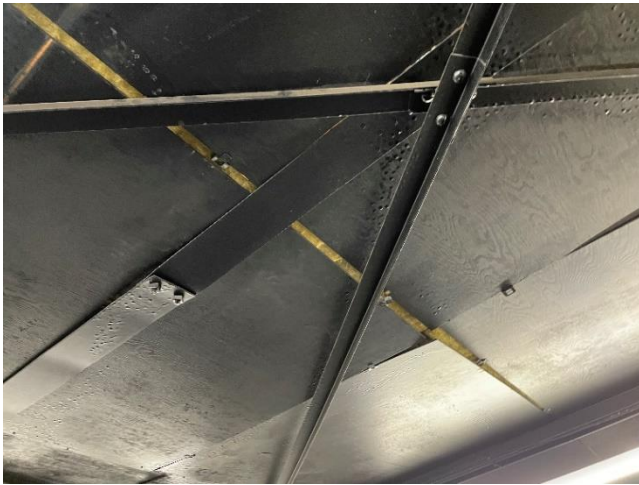
The WELL is a PEMB. A make-shift ceiling consisting of plywood sheets connected with H-clips at various locations around their edges was observed. The ceiling is sagging in some locations.

Photo WELL-S1: Sagging Ceiling

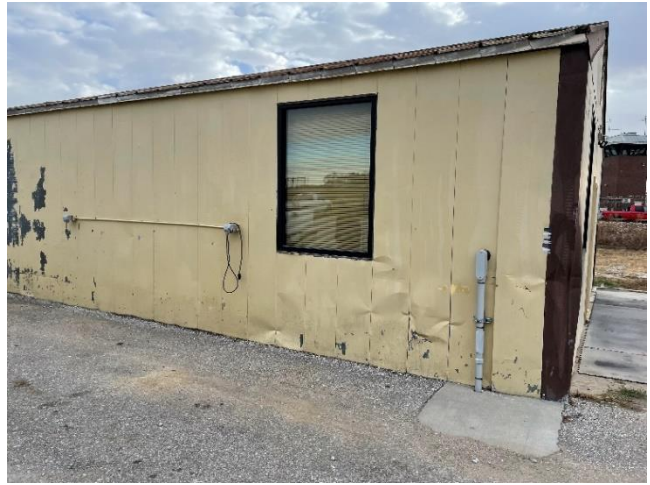
Photo WELL-S2: Damaged West Wall

The building is damaged on its southwest corner and along the west wall what appears to be multiple impacts, most likely vehicular.

The damaged west wall is the only structural concern observed.

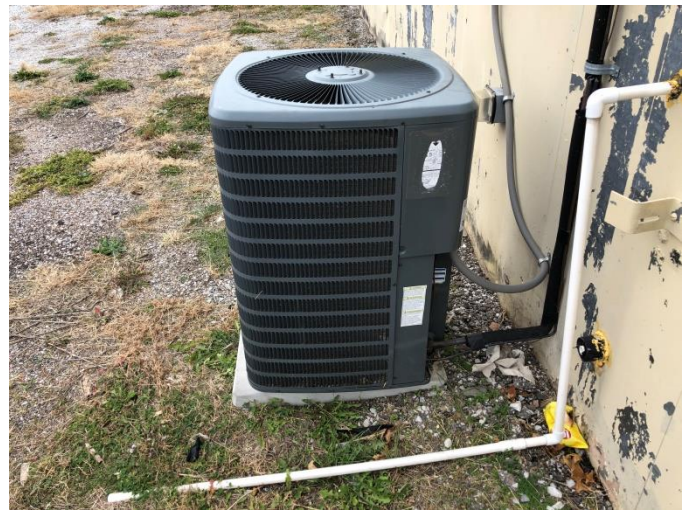
The ACCUs are about five years old and the cooling coil condensate spills onto grade outside near the ACCUs. See Photo WELL-M3. There is not an outdoor air louver or hood for ventilation purposes and the windows are not operable so, there are no means to provide ventilation air to the occupants of the building in a controlled manner.

Photo WELL-M3: Typical Existing ACCU

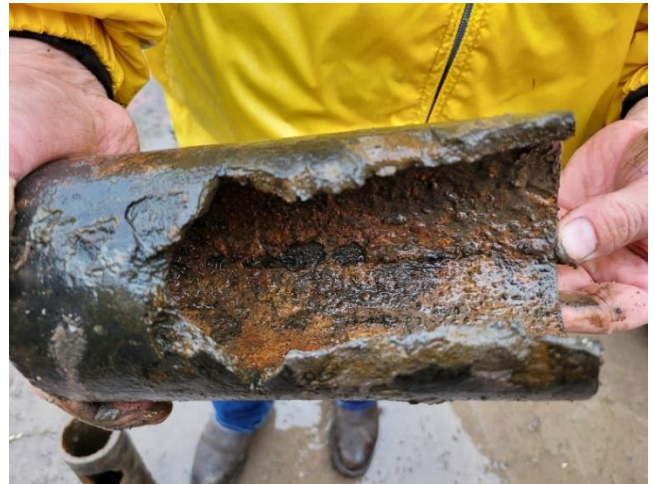
The NSP has experienced 16 breaks in the site domestic cold water piping over the past two years. The most recent breaks happened in October 2021 with three of them occurring at one time. This made the local news since the NSP domestic cold water systems had to be shut down for several days to isolate the leaking piping so, emergency repairs could be made. One of these most recent breaks was in the 67-year old piping located just to the south of HU6 as shown in Photo DW&FP-1.

From review of the trenches and broken main sections it is apparent that the predominant water main material type is Ductile Iron and or Cast Iron. These pipes were not wrapped in polywrap (thin plastic liner), which has been a standard for many years. The purpose of polywrap is to protect the pipe from corrosion. Soils in this area of Lincoln are highly corrosive. From review of recent pipe sections that have been repaired it is apparent that corrosivity of the water main pipe infrastructure within this complex is a major issue.

**Photo DW&FP-1: Domestic Cold Water Pipe Break
Near Housing Unit No. 6**

Water main pressures in this section of Lincoln are consistently around 100psi which is quite high and good for fire suppression, but weakened pipes are more susceptible to failure under such high pressures.

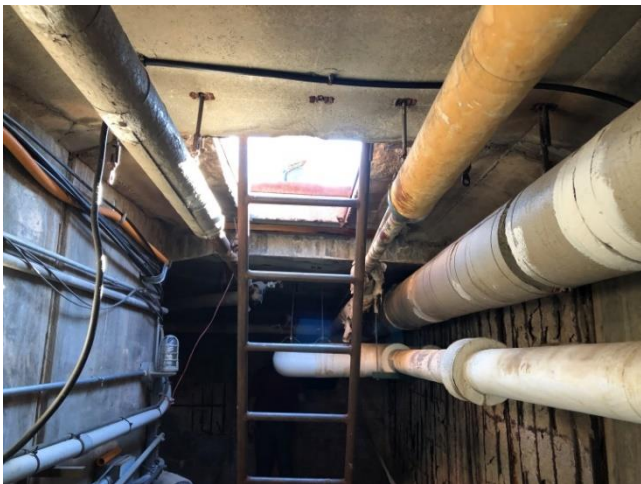
The south side of the campus has site domestic hot water piping installed in the utility tunnels to serve a variety of buildings from two centralized hot water heaters as shown in Photo DW&FP-2. The first steam hot water heater is located in the basement of HU6 and the second one is located in the basement of the SOAP. This piping was primarily installed between the 1950s and 1982.

**Photo DW&FP-2: Domestic Hot Water Piping
(Top Left) in Tunnel SW of Chapel**

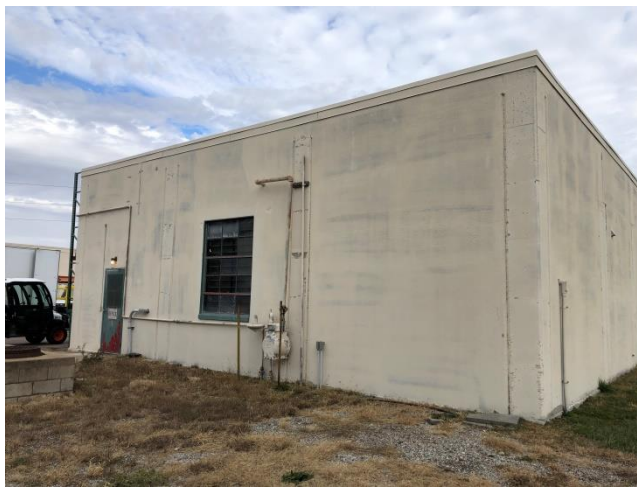
A very old gas meter is noted to exist at the Central Warehouse (CW) as shown in Photo NG-1.

Photo NG-1: NG Meter at CW

No major NG system deficiencies were noted by NSP staff when discussed during this study. NG lines are nearly all underground and therefore not accessible for inspection. Many segments are of unknown age in the southern section of the campus. Given the age of the records which show this piping as existing and the age of the buildings in this area of campus, it is believed that this piping is in excess of 50 years old. Therefore, it is recommended to incrementally replacing the NG piping system over the next 10 years to allow for safe continued operation of this system. The probable project cost for this scope of work is \$390,000.

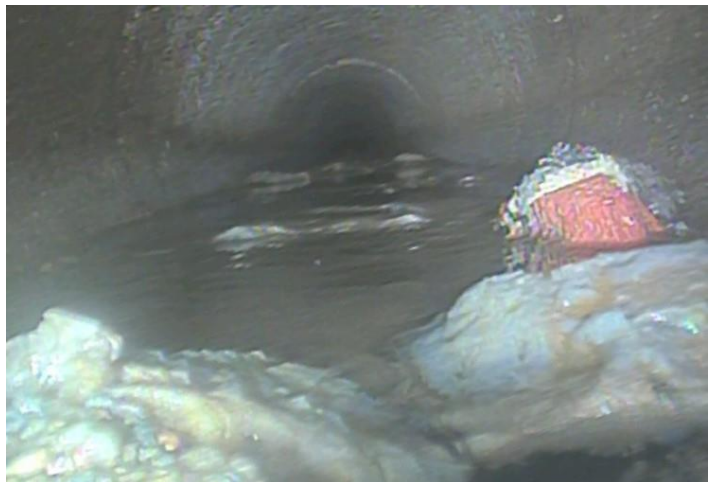
A large amount of debris was found in this piping as shown in Photo SAN-1.

Photo SAN-1: Debris Found in SAN Piping

From our representative review of segments of the sanitary sewer system via video investigation, the entire south half of the complex has over 50% of the pipe ways filled with debris and sediment. The general condition of the piping is poor with several pipe cracks and areas of deterioration observed and more expected in the next five years. There are approximately 30 site sanitary sewer manholes on the campus. The general condition of the manholes is fair and to expect failures in the next five to ten years. A major rehabilitation effort is imminently necessary.

Typical sanitary sewer pipe maintenance involves jetting with water. However, these pipes are too blocked with random concrete, sediment, and other debris that would make traditional maintenance methods unacceptable. Traditional methods of open cut remove and replace would also be very disruptive to paving and proximity to buildings. We would, therefore, suggest a method of pipe bursting to replace these pipes. Pipe bursting basically has a mechanical means of auguring out the existing pipe and then bursting and inserting a new pipe in its place. All of the associated manholes would be removed and replaced as part of this type of rehabilitation process. The probable project cost for this scope of work is \$1,900,000.

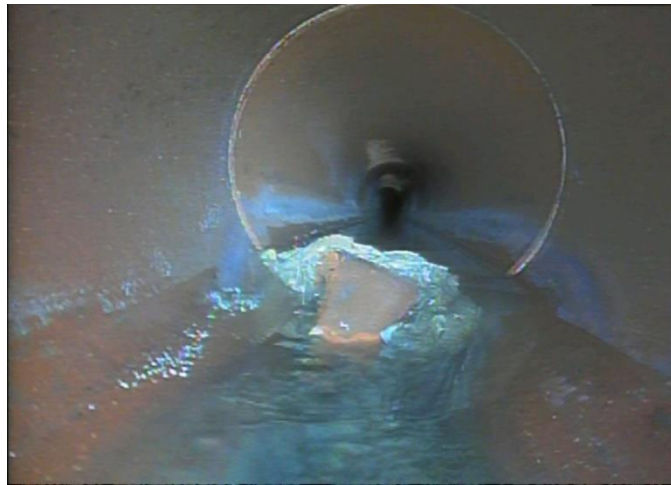
Photo SAN-2: Debris Found in SAN Piping

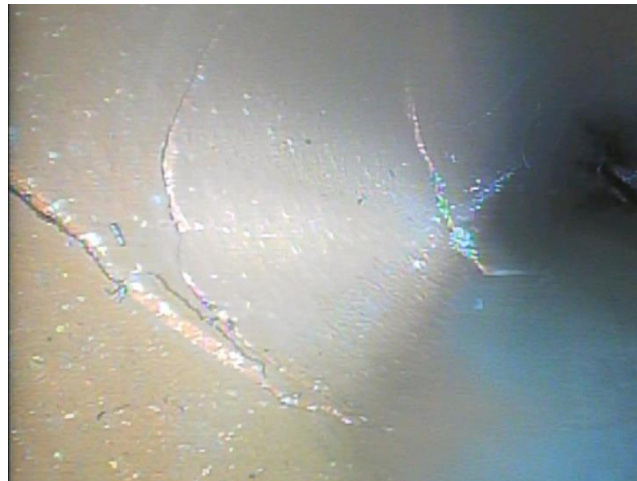
Photo SAN-3: Fractures Found in SAN Piping

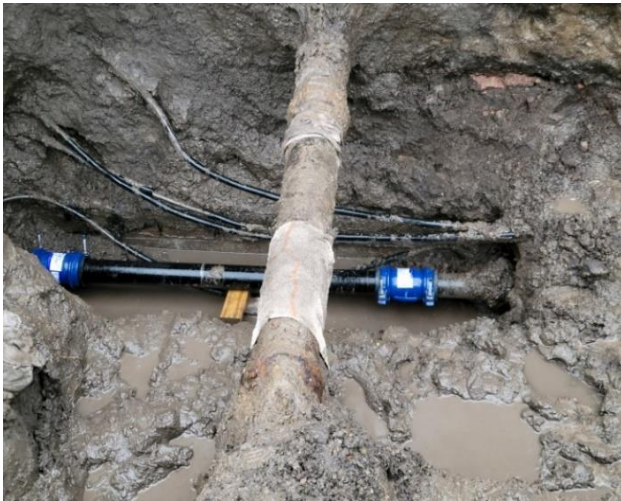
In October 2021, three water main breaks occurred. When the piping was excavated for repair, existing storm sewer piping was also observed such as that shown in Photo STORM-1.

Photo STORM-1: Storm Piping (Top Pipe) Near Housing Unit No. 6

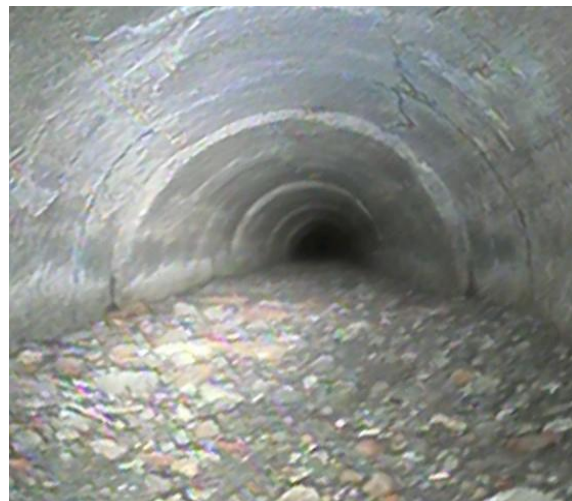
A representative sample of site storm piping was investigated with a video camera, and the report for that work is located in the Site Sanitary Sewer and Storm Drainage Systems Investigation Report located in Appendix K. Large debris was found in this piping near the PEB as shown in Photo STORM-2.

Photo STORM-2: Debris Found in STORM Piping which will Obstruct Water Flow

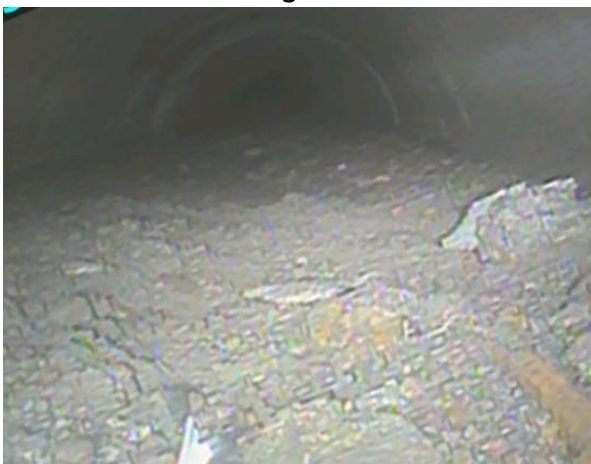
Photo STORM-3: Debris Found in STORM Piping which will Obstruct Water Flow

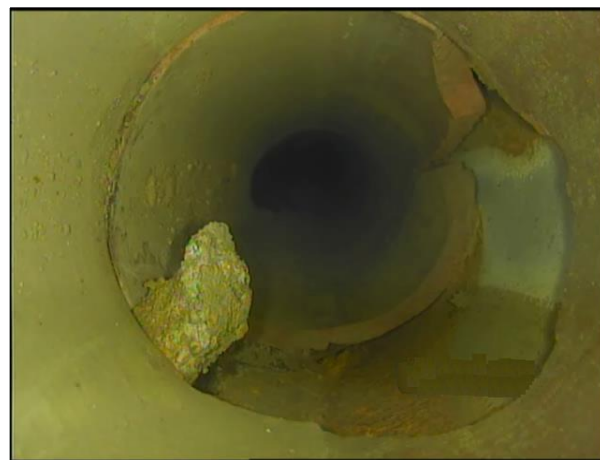
Photo STORM-4: Severely Broken STORM Piping which Needs Immediate Replacement

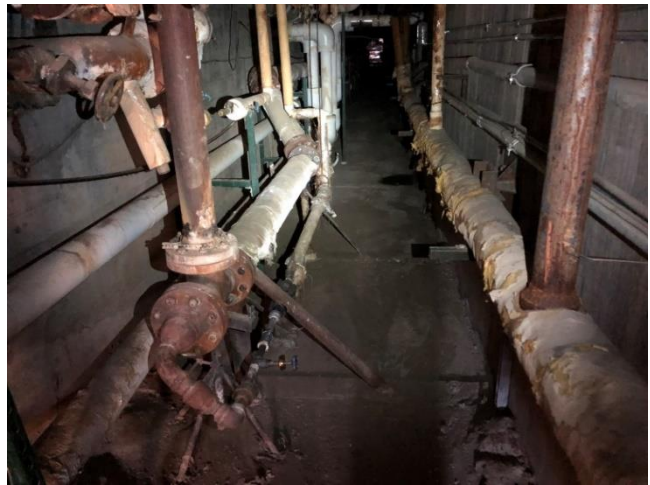
In general, the steam and steam condensate pipe insulation in the utility tunnels and chases is in bad shape, falling off the piping, or missing altogether. Humidity in the tunnels is contributing to insulation failures and to external corrosion of the piping. Humidity is coming from seasonal changes, site storm drainage issues, ground moisture, and from leaking steam piping systems. Evidence of steam piping leaks was observed during a tour of the tunnels where it was noted that the air temperatures were very high and humid in sections of the tunnels.

Photo STM-1: Steam Piping in Tunnel West of Chapel

The vast majority of steam piping on this campus is 40 years old or older. The expected life before replacement of this type of utility is a maximum of 50 years. Therefore, it is recommended to replace 16,000 linear feet of steam and steam condensate piping over the next several years. All new or existing steam piping to remain in tunnels shall have the pipe insulation replaced and have pipe jackets installed to help limit future pipe insulation deterioration. Incidental demolition and replacement of sidewalks, pavement, and tunnels will be required and is included in this scope of work. The probable project cost for this scope of work is \$2,800,000.

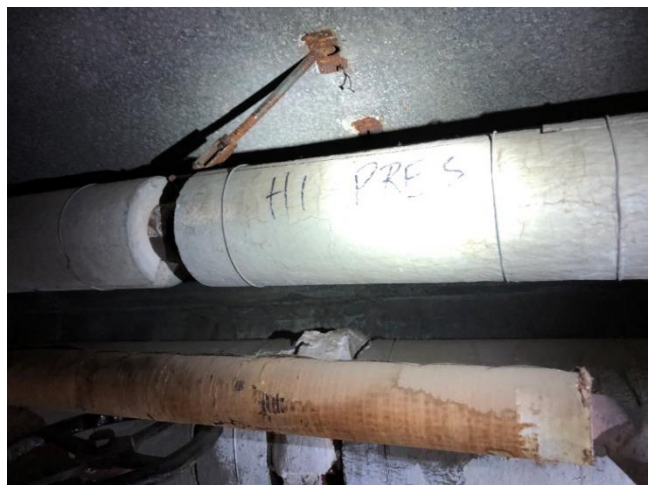
Steam piping is subject to wide temperature differences and will expand a lot especially when steam systems are first turned on for the heating season. The piping must be designed to account for thermal expansion otherwise, piping failures can occur. An example of a pipe hanger being stressed by thermal expansion is shown in Photo STM-2.

Photo STM-2: Bent Steam Pipe Hanger in Tunnel West of Chapel

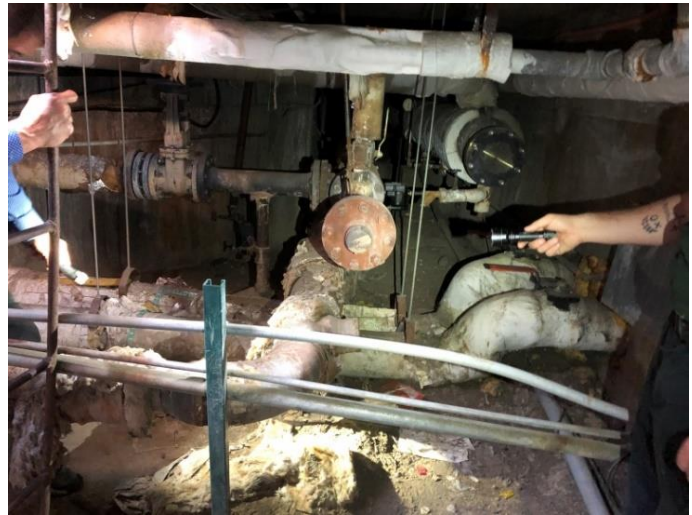
About half of the chilled water piping is located in the tunnels, while the other half of the chilled water piping is direct buried. In general, the chilled water pipe insulation in the utility tunnels is in bad shape, falling off the piping, or missing altogether as shown in Photo CWS-1.

Humidity in the tunnels is contributing to insulation failures and to external corrosion of the piping. Humidity is coming from seasonal changes, site storm drainage issues, ground moisture, and from leaking steam piping systems.

Photo CWS-1: Chilled Water Piping (Left to Right, Down Low) in Tunnel NE of Laundry

Chilled water lines have not been flagged as a significant problem. In regards to future maintenance, we recommend to replace 25% of the chilled water piping over the next 10 years. All new or existing chilled water piping to remain in tunnels shall have the pipe insulation replaced with cellular glass insulation and have pipe jackets installed to help limit future pipe insulation deterioration. Incidental demolition and replacement of sidewalks, pavement, and tunnels will be required and is included in this scope of work. The probable project cost for this scope of work is \$325,000.

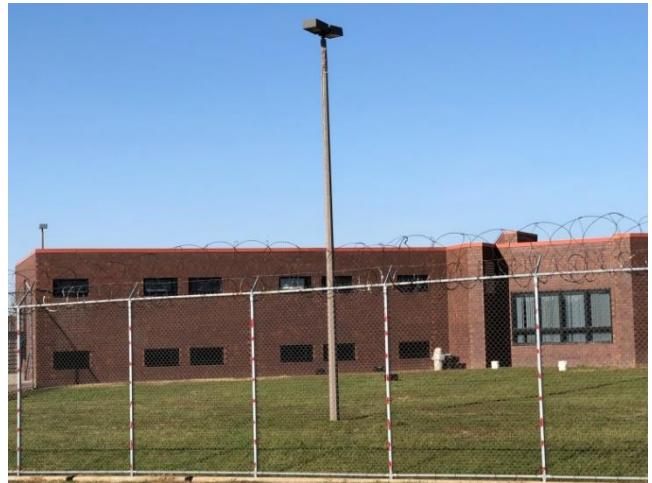
Photo LTG-1: Concrete Light Pole South of Housing Unit No. 5

Concrete high-mast lighting poles are deteriorating and are in poor condition. These deficient poles present safety and security hazards. These poles need to be replaced with new, steel poles and modern LED lighting fixtures. The probable project cost for this scope of work is \$700,000.

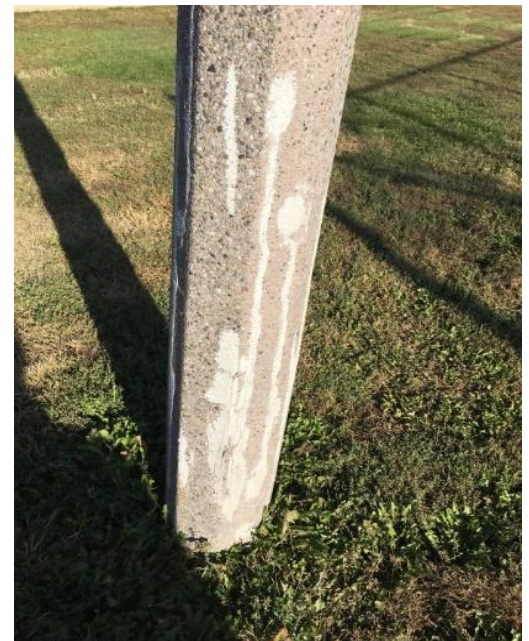
Photo LTG-3: Image of Concrete Light Pole North of Laundry Facility

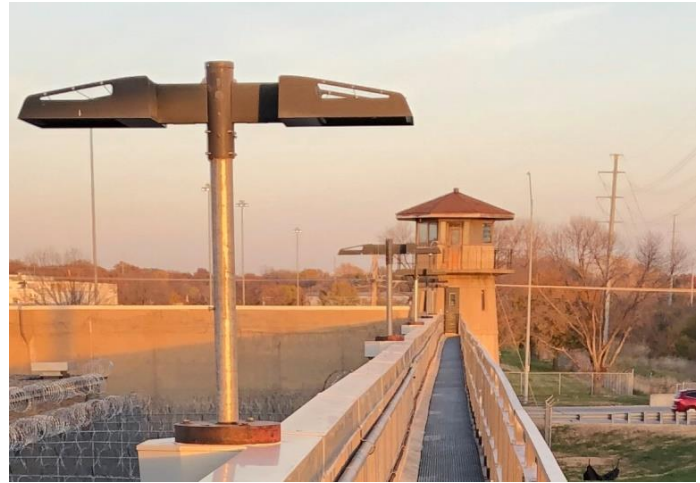
Security lighting mounted on the exterior original prison walls is LED and appears to be in generally good, serviceable condition. See Photo LTG-4.

**Photo LTG-4: Security Lighting at Wall Between
Guard Tower 5 and Guard Tower 6**

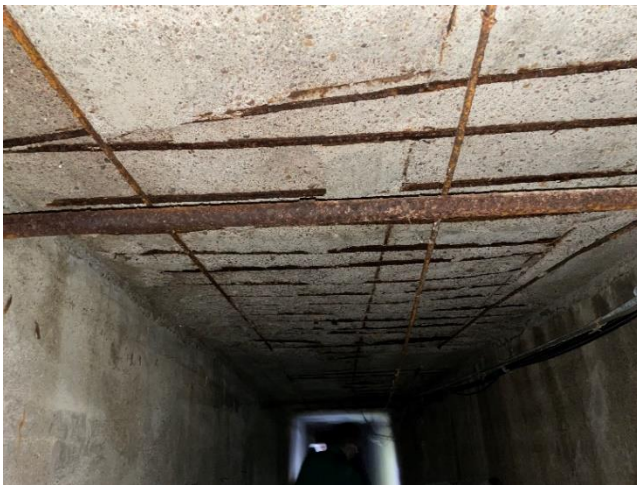
Some of the walkable UT's were assessed, the condition of which varied. Approximately 400 linear feet of tunnel was observed. Of this, approximately 150 linear feet of the tunnel lid requires replacement. See Photo UT-S1. Approximately 40 feet of the observed wall requires repair or replacement. See Photo UT-S2. This sample tunnel observation results in approximately 38 percent of the lid needing replaced and 5 percent of the walls required repair or replacement. The tunnels are approximately 8-feet wide and 8-feet tall. The tunnel structure under the road between CFACT and Chapel is in such poor condition that recent construction work in that area required smaller than normal truckloads of debris, and lightly loaded material trucks in an effort to prevent tunnel collapse. This added significant time and cost to the work performed.

Photo UT-S1: Deteriorated Tunnel Lid

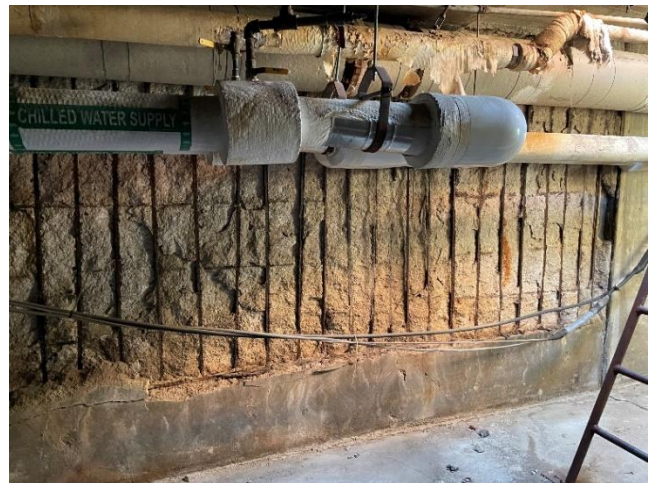
Photo UT-S2: Deteriorated Tunnel Wall

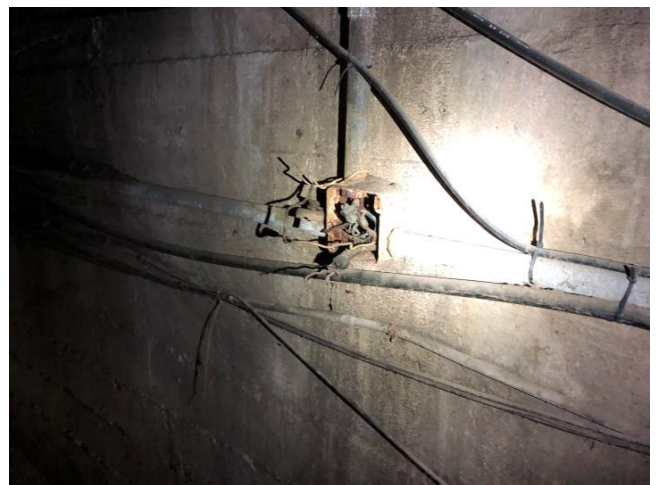
There are locations in the tunnel system where there are open junction boxes with wires protruding from the box. This creates a dangerous condition for working in the tunnels. This is also a National Electrical Code violation. See Photo UT-E3. These locations need to be repaired to provide a safe working environment for facility maintenance staff and contractors.

Photo UT-E3: Representative Photo of Rusty Electrical Box with Exposed Conductors
