Nebraska State Penitentiary Useful Life Engineering Study

Lincoln, Nebraska

Alvine No. 2021 8777
January 2022

Prepared for:
State of Nebraska
Department of Correctional Services
Lincoln, Nebraska

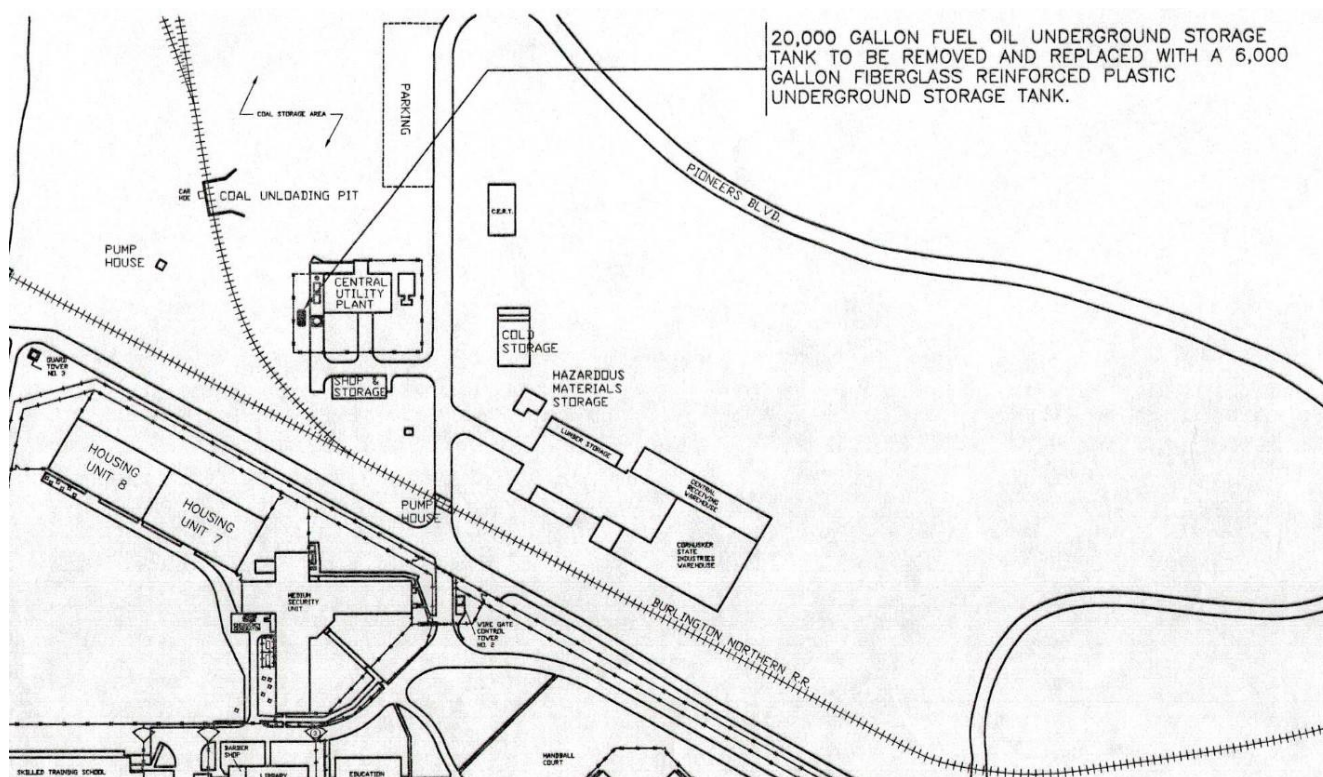
Figure CS-1: Fuel Oil Tank Location

When the OCUP was constructed in 1980 there was a 20,000 gallon underground storage tank on the south side of the plant. Then in 1998 the original 20,000 gallon underground storage tank was removed and replaced with a new 6,000 gallon fiberglass underground storage tank. Since the new District Energy Center has been constructed the old CUP has been repurposed and the underground storage tank is no longer useful. The State Fire Marshal has required that the tank be emptied. NSP Maintenance also directed that the tank be removed. Soils around the old tank area should be tested and removed if found to be contaminated by past fuel spills or leaks.

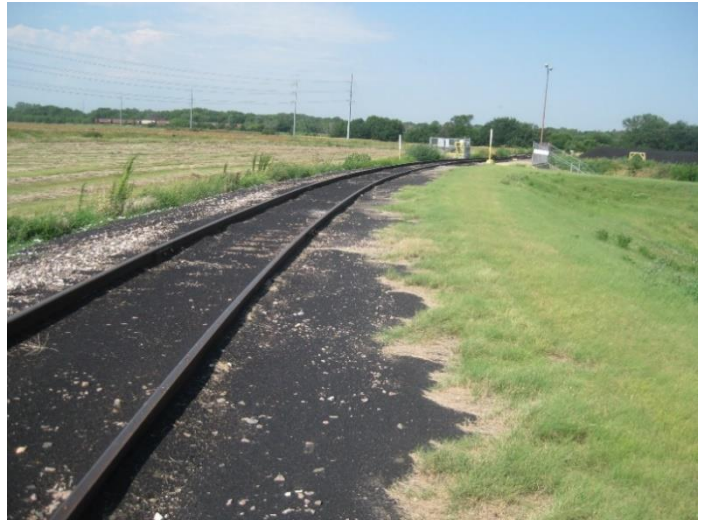
There are two piles of coal remaining on site that should be disposed of. The volume of coal was estimated as 2000 Cubic Yards. Disposal of waste coal is regulated by the Nebraska Department of Energy & Environment (NDEE). The NDEE considers waste coal to be special waste. Waste coal may be disposed of in permitted municipal solid waste landfill or buried at the site. Burial on site is the preferred disposal method. Burial on site must have NDEE approval as required by Title 132. A disposal trench or pit must be excavated 4 to 10 feet deep. Trench or pits must be lined with 20-mil plastic liner sheet. Then the coal that is deposited must be covered with 20-Mil plastic liner sheet and covered with a minimum of 2 feet of earth material. Although NDEE would prefer it be buried on site we feel it would be better for any future site development to remove it from site and dispose of it at a permitted landfill. The existing rail tracks no longer serve a function now that the new District Energy Center plant has been constructed in 2018. To facilitate the Off Loading structure removal and coal waste cleanup it would be wise to remove all of the railroad tracks and regrade the area.

Photo CS-1: Coal Along Railroad Tracks

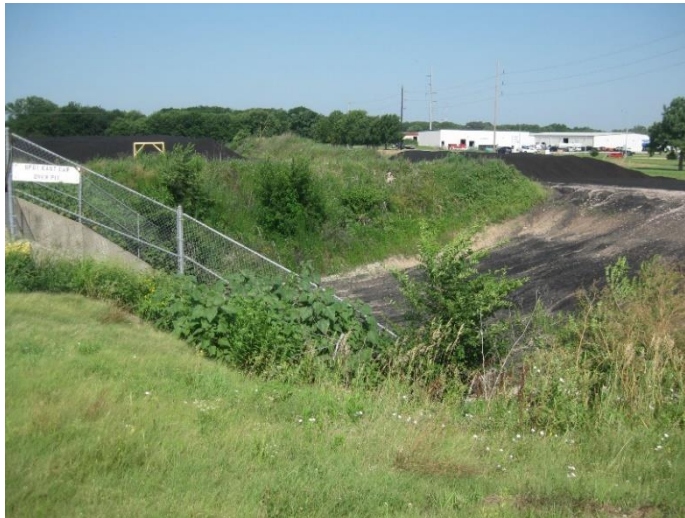
This left the coal off loading and coal storage piles obsolete and decommissioned. Coal was off-loaded by belly dump to a temp storage area below a structure that is no longer of value. The area at the bottom of the structure ponds a significant amount of water with nowhere to drain. It is assumed when operations were previously ongoing this low area may have been pumped out, but no visible pumps were apparent at the time of our review. This ponding of water can become stagnant and a possible mosquito breeding ground and health hazard. There is also another storm sewer pipe draining to the area that should be rerouted. The structure could be left in place and the sump area filled in with compacted soil.

Photo CS-2: Coal Off Loading Area

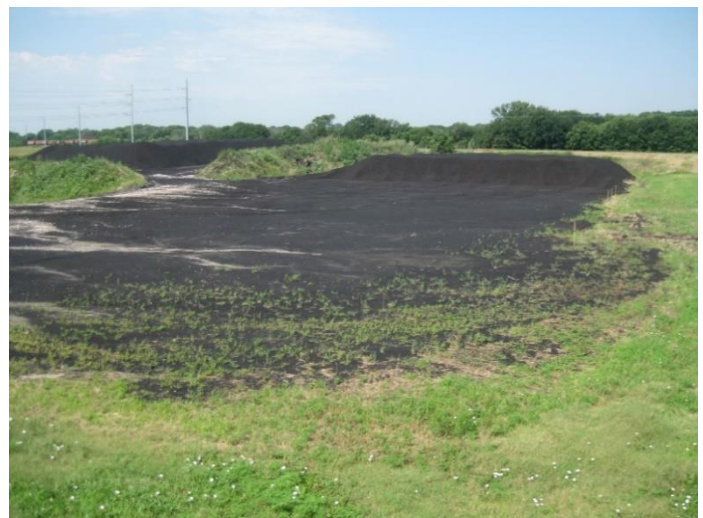
Photo CS-3: Coal Pile
